**REPAIR, EVALUATION, MAINTENANCE, AND
REHABILITATION RESEARCH PROGRAM**

TECHNICAL REPORT REMR-CO-3

**CASE HISTORIES OF CORPS BREAKWATER
AND JETTY STRUCTURES**

Report 1
SOUTH PACIFIC DIVISION

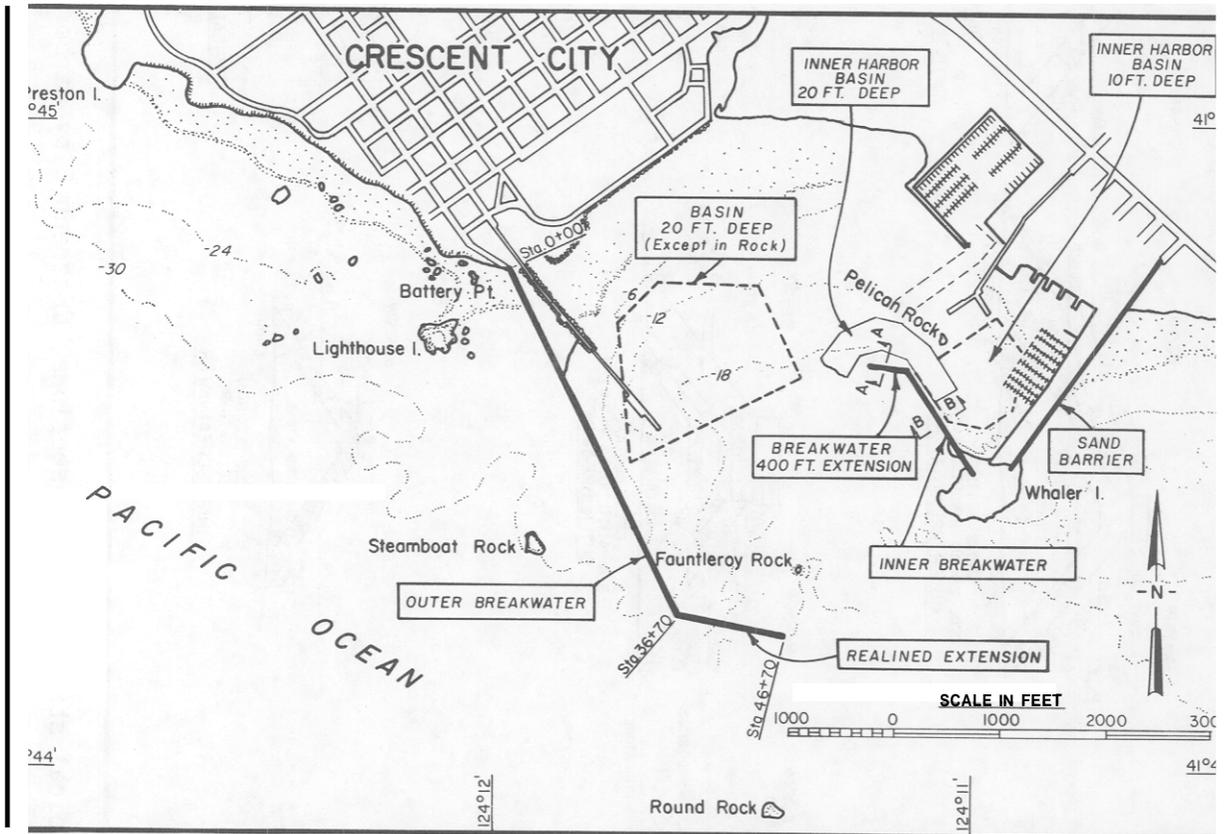
Figure 3. Crescent City Harbor, California

1974	Construction of a 400-ft-long extension of the inner breakwater was completed (Figure 3). Model testing was conducted to determine optimum wave conditions (Senter and Brasfeild 1968, Senter 1971).
1979	Repairs were made to the following reaches of the outer breakwater using 18- to 30-ton stone: sta 19+00 to 20+00, 22+00 to 24+00, 24+60 to 27+20, 28+90 to 29+50, 30+50 to 31+00, and 37+00 to 41+20. Repairs to sta 15+50 through 17+50 also were made using stone in the 14- to 25-ton range.
1983	Major storms in the winter of 1983 resulted in broken dolosse on the outer breakwater. Estimated damage to the structures was \$4,400,000.
1984	Approximately 23,300 tons of stone were placed to repair various sections of the outer breakwater between sta 17+30 to 33+90.
1986	The outer breakwater is presently in poor condition. The problem area is primarily between sta 34+70 through 37+00 where missing and/or damaged dolosse are apparent. A contract was issued to rehabilitate the dolosse section of the outer structure (sta 34+70 through 37+00) with 700 fiber-reinforced 42-ton dolosse. The dolos perimeter used special placement, and the dolosse on the outer portion of the seaward transition were entrenched and buttressed with 25-ton stone (Baumgartner, Carver, and Davidson 1985). About 80 of the constructed dolosse were stockpiled on the leeward side of the jetty for repair contingencies. This rehabilitation effort was also used to gather data on prototype forces on dolosse. Twenty of the dolosse (painted red) were instrumented and placed in the main dolos section at about sta 36+00. As of this date, no data have been received from the prototype dolos study.

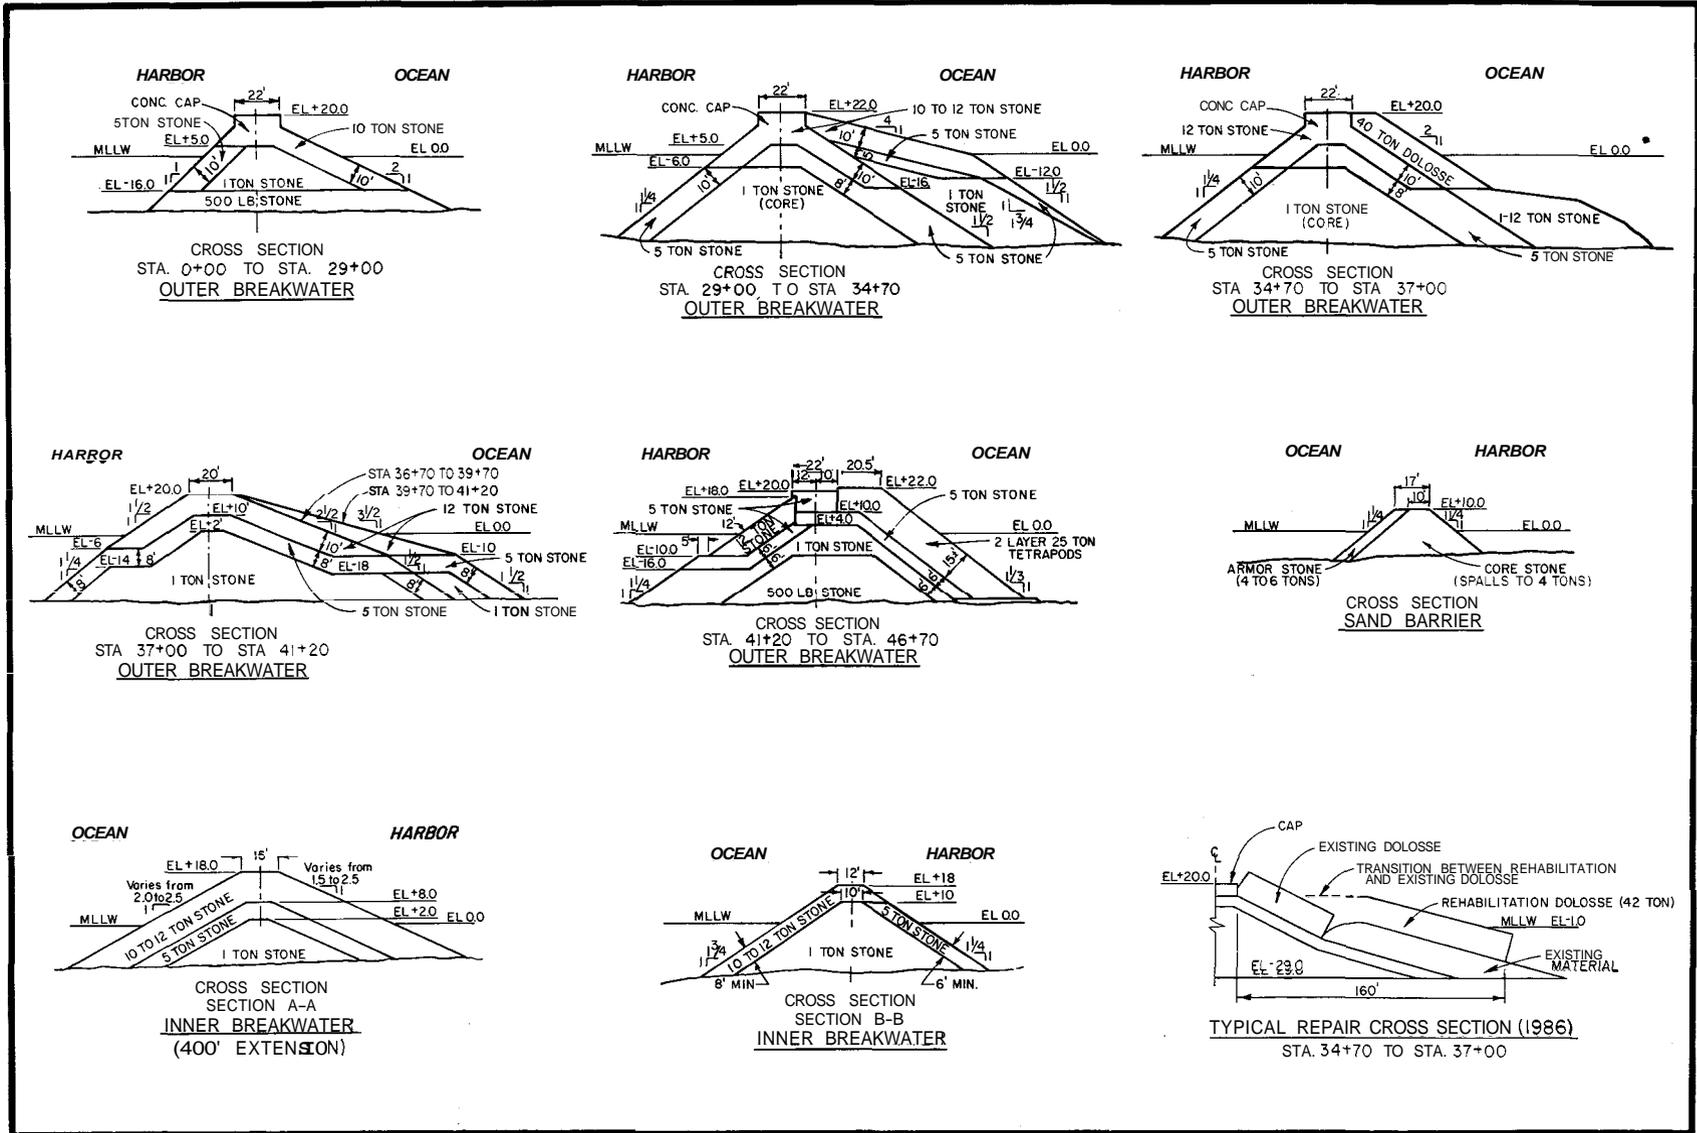
Figure 4. Typical structure cross sections, Crescent City Harbor, California

1946	Construction of a 1,200-ft-long inner breakwater was completed to provide protection to a small-craft basin. The inner breakwater extended from Whaler Island northwest (Figure 3). The crest el of the structure was +18 ft mllw (Figure 4) and 10- to 12-ton armor stones were utilized during construction.
1948	A 1,000-ft-long extension of the original (outer) breakwater extending toward Round Rock (Figure 3) was completed. Ten- to 12-ton armor stones were used.
1948- 1949	During storms of 1948 and 1949, the 1,000-ft-long extension of the outer structure suffered considerable damage.
1950	The crest el of the entire outer breakwater, with the exception of a 300-ft segment (sta 12+50 to 15+50), was raised to +20 ft mllw with a 22-ft-wide concrete cap to prevent overtopping.
1950- 1951	Winter storm seasons resulted in further damage to the outer breakwater. Damages consisted of displacement of the concrete cap and armor stones down to about 0.0 mllw in all of the extension located seaward of sta 37+00.

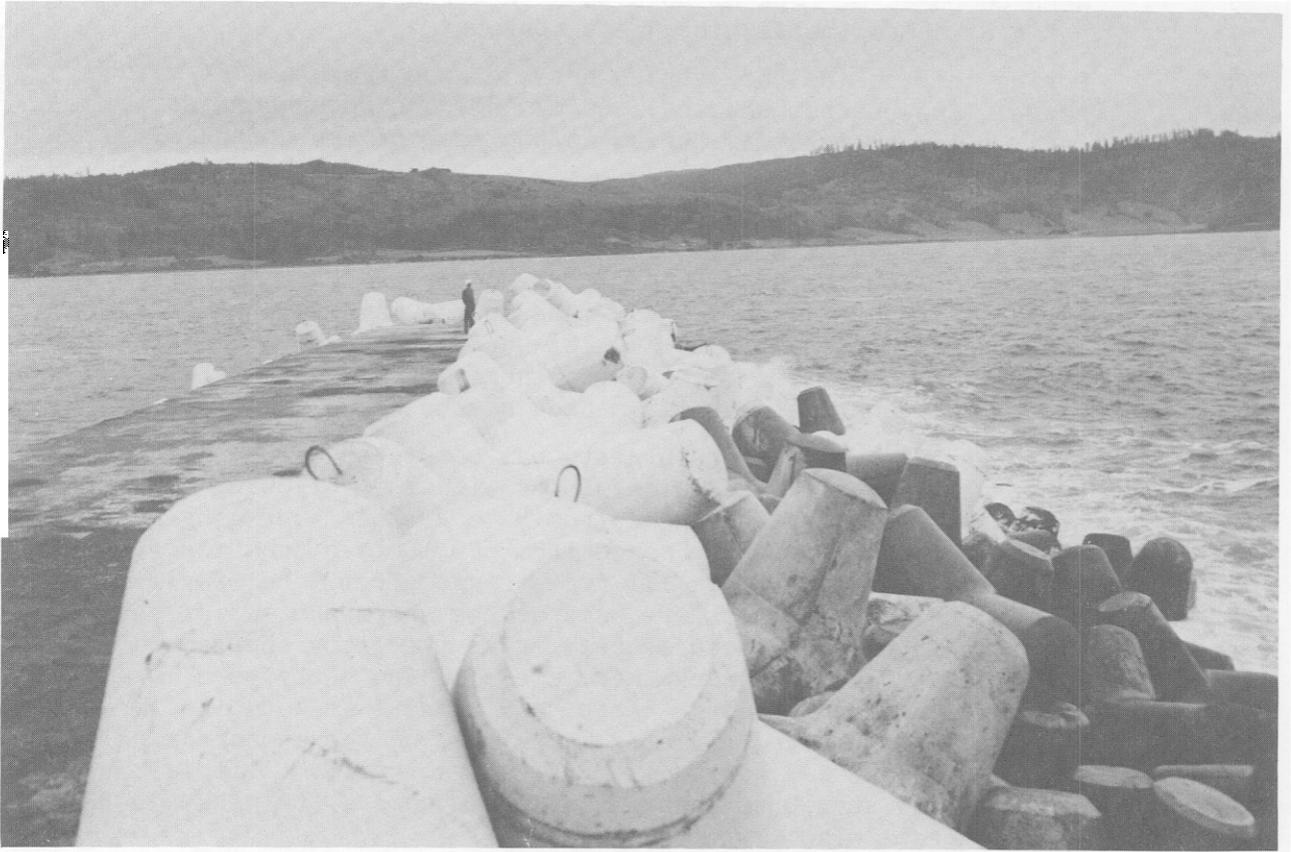
Figure 5. View of tetrapods at head of Crescent City Harbor outer breakwater

Date(s)	Construction and Rehabilitation History
1957	The 1,000-ft-long outer breakwater extension, as authorized in 1952, was completed. Twelve-ton stone protection was used from sta 36+70 to 41+20. From sta 41+20 to 46+70, 25-ton unreinforced tetrapods (1,836 units) were placed on the seaward slope (Figure 5). Model tests were conducted (US Army Engineer Waterways Experiment Station (WES), Hydraulics Laboratory (HL) 1953, 1956).
1957- 1964	Damages occurred to a portion (sta 36+70 to 41+20) of the outer breakwater, and in 1964 were repaired using 12-ton stones and 140 25-ton tetrapods. The tetrapods were not model tested for their adequacy for placement in this area, and they were destroyed over a period of years.
1973	Repairs were made to the concrete cap of the outer breakwater between sta 35+40 and 37+00.
1974	Rehabilitation of the outer breakwater between sta 34+70 to 37+00 was completed. Two layers of 40-ton unreinforced dolosse (246 units) were placed on the seaward slope.

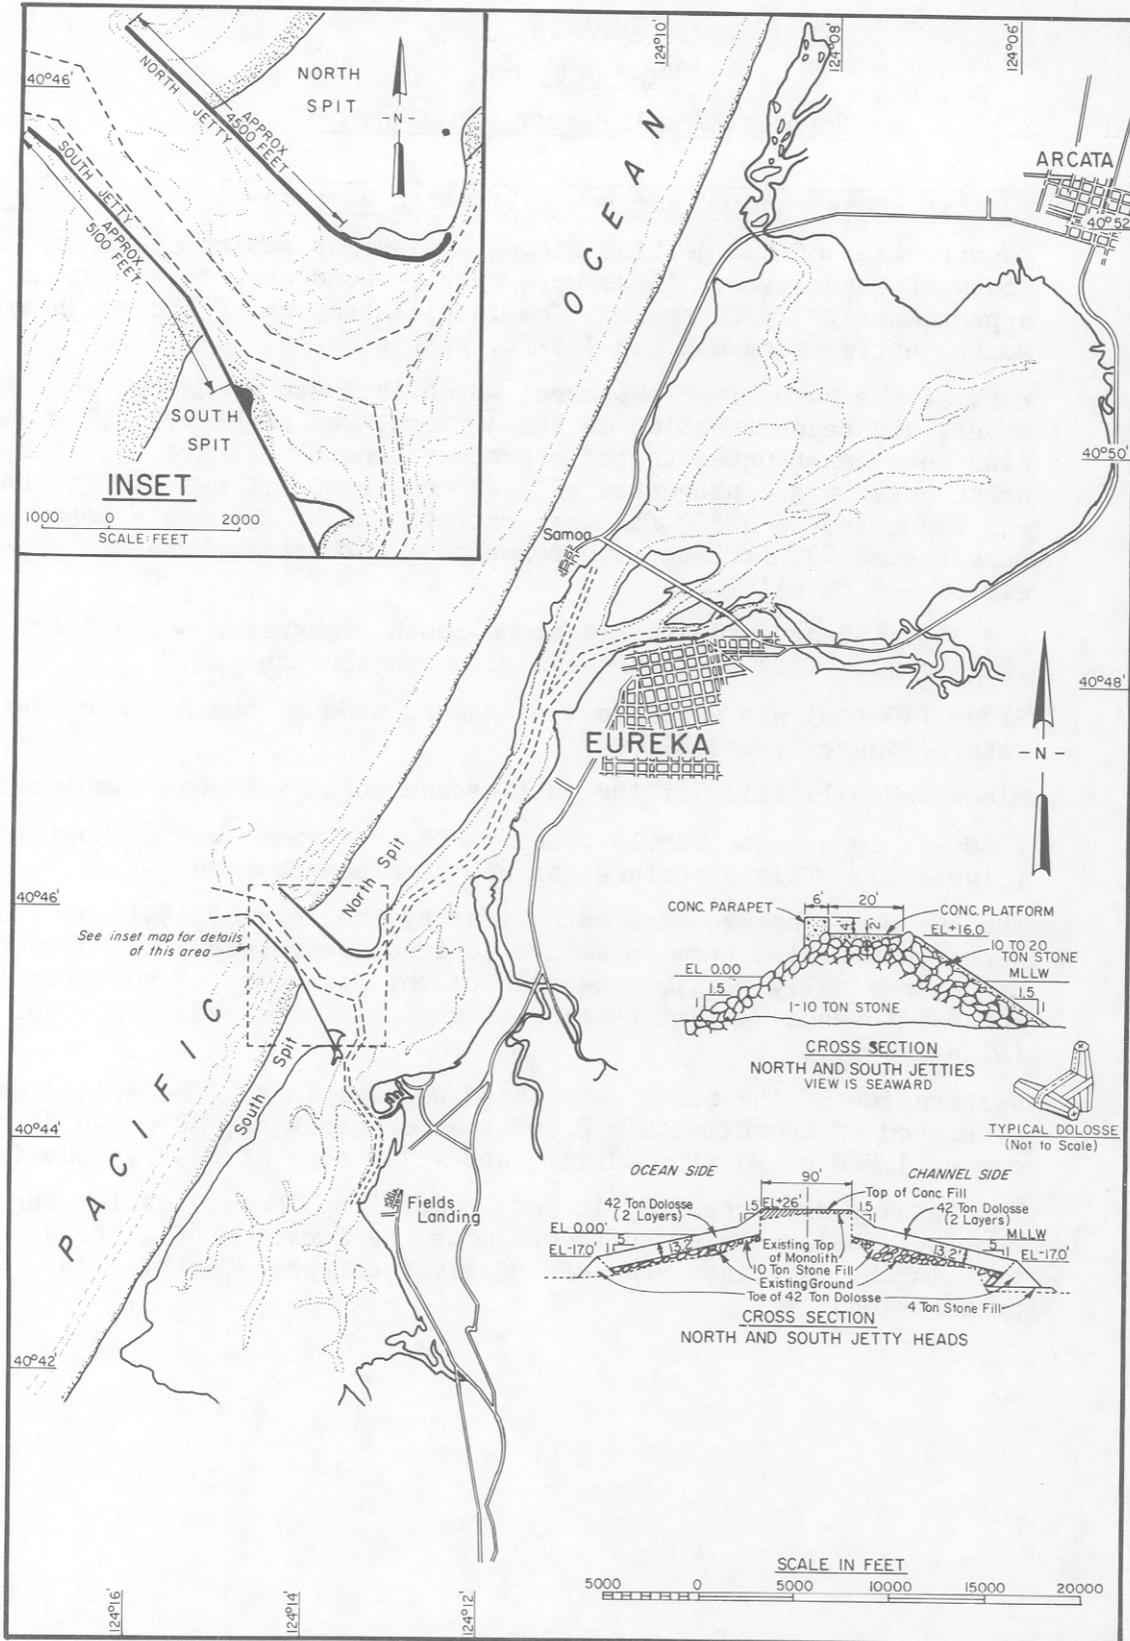
Figure 6. Humboldt Harbor and Bay, California

1937	South jetty repairs using 1,552 cu yd of concrete were completed at a cost of \$25,400.
1939	Heavy storms caused great damage to both jetties. The monoliths at the outer end of the south jetty were undermined, causing them to tilt and sink. Breaches occurred in the jetty immediately shoreward of the monolithic end. A partial breach occurred through the north jetty just shoreward of its monolithic end. In addition, considerable damage was done to the side slopes of both jetties. During the year south jetty repairs were completed using 12,450 cu yd of concrete at a cost of \$151,025.
1940	North jetty repairs using 7,418 cu yd of concrete and 2,200 tons of stone and south jetty repairs using 29,772 cu yd of concrete were completed at a cost of \$311,848.
1941	North jetty repairs using 15,158 cu yd of concrete and 1,705 tons of stone were completed at a cost of \$141,220.
1942	North jetty repairs using 8,809 cu yd of concrete were completed for a cost of \$124,220.

1957- 1958	Severe winter storms deteriorated the north and south jetties to such an extent that repair work constituted a major construction project.
1958	Mass concrete was poured to fill eroded areas on crests, and armor stones were replaced in areas that were breached and washed out. Concrete blocks (11 by 11 ft) weighing 100 tons and 12-ton tetrahedrons were placed on the heads of both jetties.
1959	Major side slope losses on the south sides of both the north and south jetties occurred.
1960- 1963	Rehabilitation of both jetties was accomplished. Jetty trunks were repaired with 12-ton stones placed on 1V:1.5H slopes in the eroded areas. Jetty heads were reconstructed using 20-ton blocks to form head perimeters, and centers were filled with mass concrete. Two-hundred and fifty 100-ton concrete blocks were placed around the seaward tip of the south jetty head. The concrete monolith at

1973	South jetty repairs using concrete and stone were completed at a cost of \$20,400.
1975	An earthquake of 5.2 magnitude on the Richter scale occurred near the site. Inspection trips subsequent to the earthquake revealed fresh cracks along the south jetty running along the edges of the crest and slope for a distance of about 800 ft on the channel side and 300 ft on the seaward side. Blowout holes also were observed at several locations on the south jetty. On the north jetty, three of the dolosse had moved about 50, 100, and 150 ft from the placement area, respectively. Only minor settling of the remaining dolosse had occurred, and no cracking or unraveling of the dolosse units was apparent.
1977	South jetty repairs using concrete and rock were completed. Approximately 15,000 tons of stone ranging from 1 to 20 tons were used for these repairs.
1977-1978	The jetties were subjected to severe storms combined with high tides and winds. On occasion, waves covered both jetties over their entire lengths. Waves also were observed breaking over the dolosse and concrete monoliths of the jetty heads. North jetty repairs using stone were completed at a cost of \$450,000.

Date(s)	Construction and Rehabilitation History
1978	An inspection revealed that the north jetty slope was eroded at several locations, and 12 blowout holes were apparent in the concrete cap. Also, at the north jetty head, waves had broken away a 20-ton concrete block from the concrete monolith which washed across the monolith and was resting against a tip of a dolos. The slope of the south jetty had eroded in numerous locations, and the parapet wall had broken at four stations. Nineteen blowout holes were observed in the south jetty concrete cap. Also a 7-ft stone had broken out of the parapet wall and was deposited on the concrete cap.
1983	Major storms resulted in an estimated \$2,000,000 in damages to the jetties.
1984	Repair of the south jetty consisting of 4,900 tons of 15- to 25-ton stones and replacement of 20-ton concrete blocks at the jetty head was completed. Also 16,665 tons of 15- to 25-ton stones and 16,665 tons of 18- to 31-ton stones were stockpiled on the harbor side of the jetty.

1985	Repair of the jetty heads was completed using a total of approximately 1,000 42-ton dolosse in various areas and the construction of toe berms.

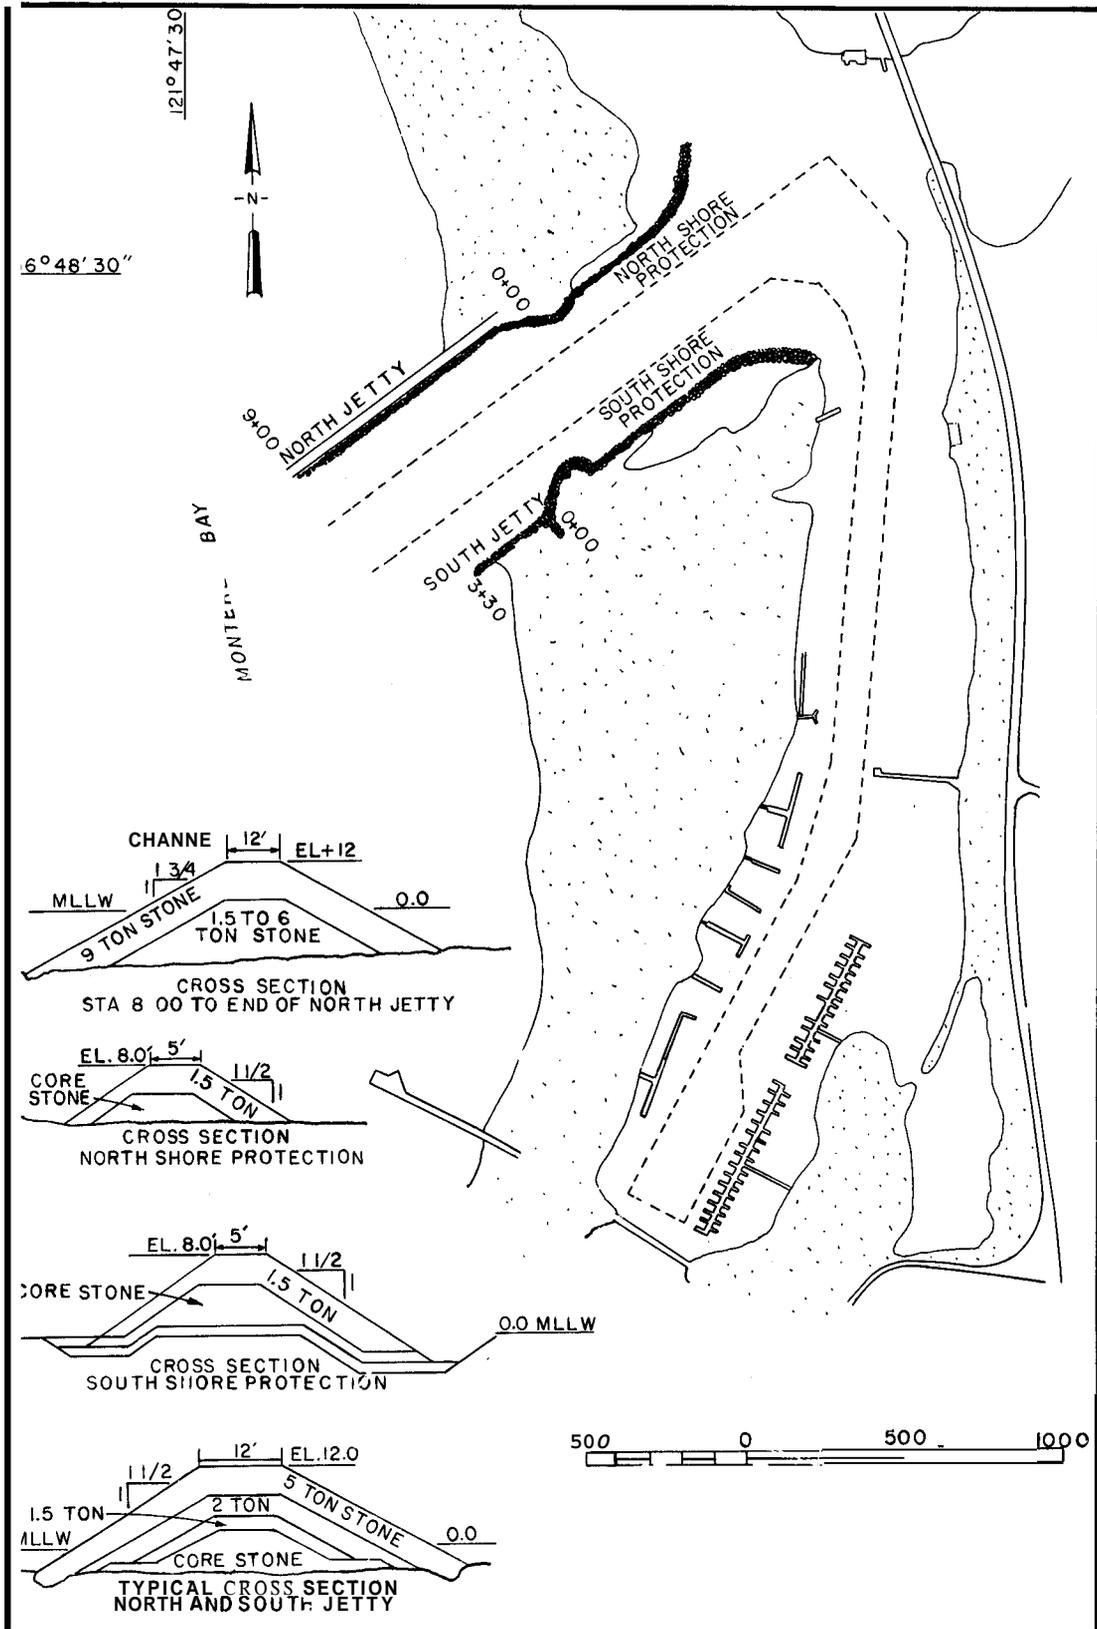
Figure 19. Moss Landing Harbor, California

1949- 1965	Severe erosion around the jetties and the unprotected shorelines adjacent to them was experienced during this time frame.
1966- 1967	Approximately 285 ft of the north jetty and the entire length of the south jetty were repaired. Also about 280 ft of curved revetment work was added to the north jetty and about 380 ft added to the south jetty. This work required the placement of 77,560 tons of stone. The north jetty head was not repaired because of the movement of the canyon head and the possibility that damage may occur to any repairs in that vicinity.
1975	A field inspection revealed the jetties in satisfactory condition except for damage on the seaward ends due to erosion and subsequent stone displacement. The deep submarine canyon head at the seaward end of the north jetty appeared to have stabilized.
1976	A basis for design of repairs to the jetties and revetment was prepared. Estimated cost of these repairs was \$290,000, and approximately 7,400 tons of stone would be required.

1986	Work is still required at the jetty heads. Except for the erosion at these locations, the jetties historically have performed satisfactorily and suffered relatively minor damages.

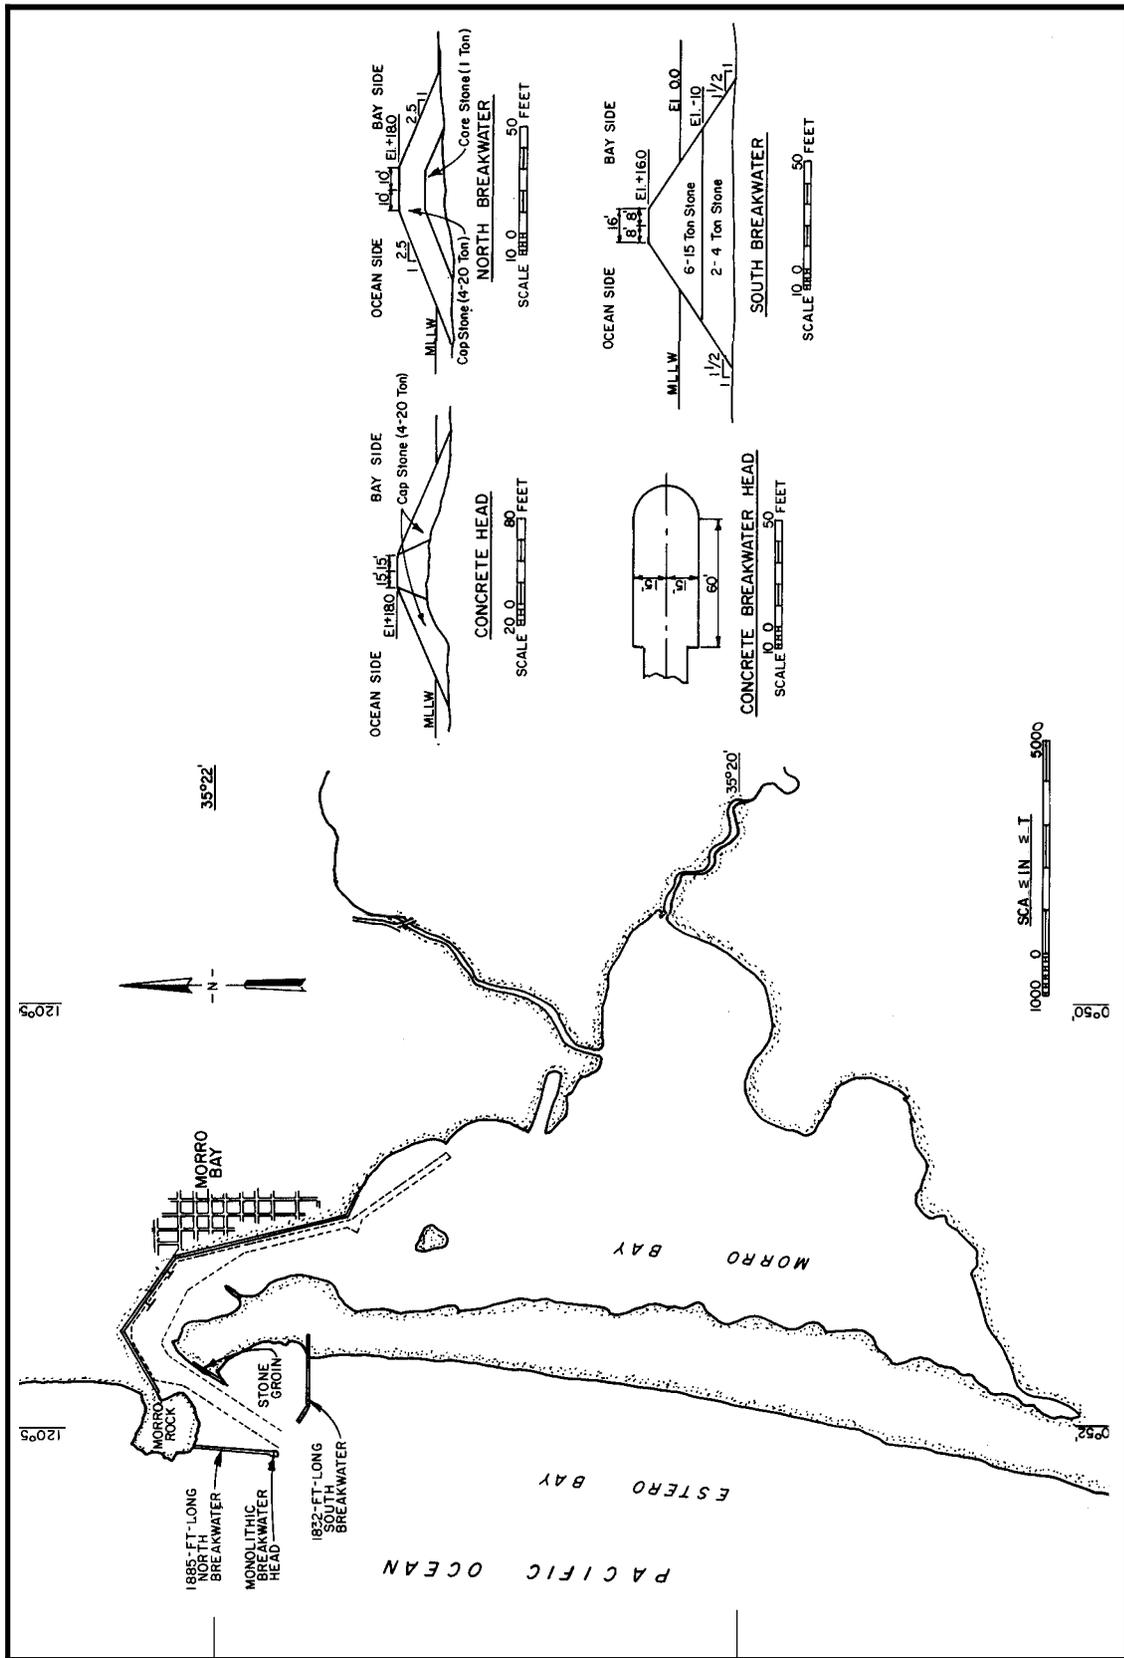
Figure 21. Morro Bay Harbor, California

1949- 1960	The north breakwater continued to deteriorate, and shoaling occurred in the channels. The south breakwater still had suffered no observable damage since its construction in 1943.
1964	The north breakwater was reconstructed at a cost of \$1,561,882. The new rubble-mound structure was built at an el of +18 ft mllw, with a 20-ft-wide crest and 1V:2.5H side slopes. The structure was rebuilt about 100 ft bayward of the original north breakwater location and extended to 1,885 ft in length (Figure 21). The breakwater included larger armor stone than the original structure. Also included was a concrete monolithic breakwater head. Model tests were conducted (Jackson 1961).
1983	Major storms resulted in approximately \$1,430,000 in damages to the breakwaters.
1985	Maintenance repair of the north and south breakwaters was completed which included the placement of approximately 18,000 tons of capstone. Capstones ranged in weight from 6-21 tons each.
