Table 46
Holland Harbor Structures
Holland, Michigan

Table 47
Grand Haven Harbor Piers
Grand Haven, Michigan

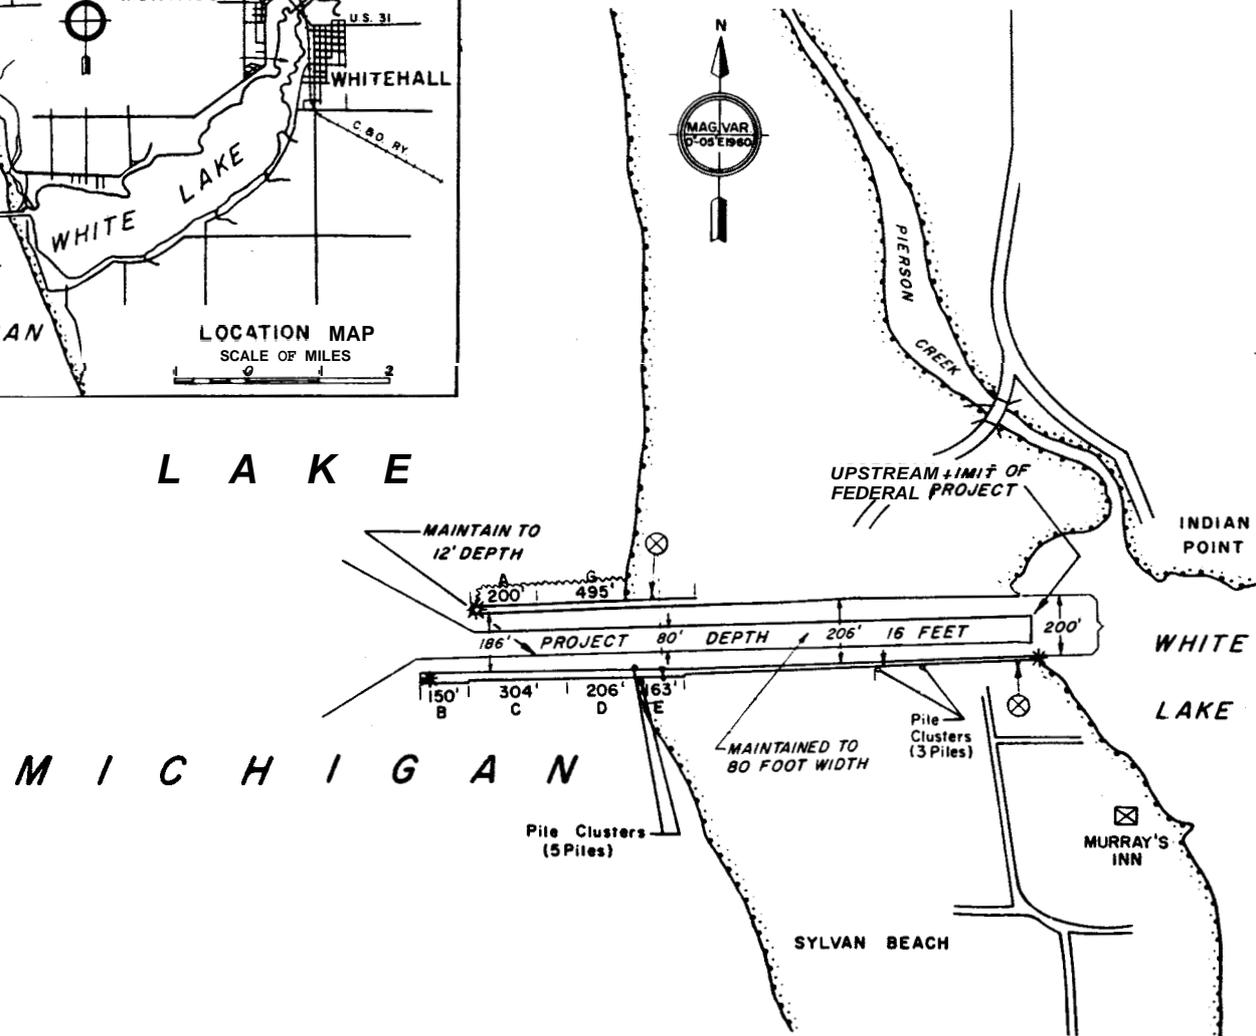
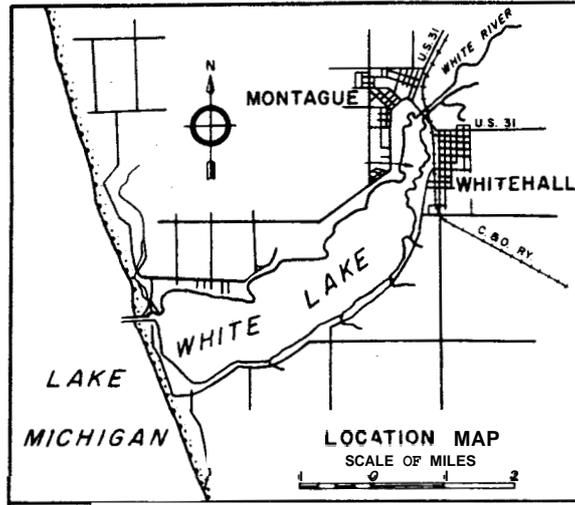
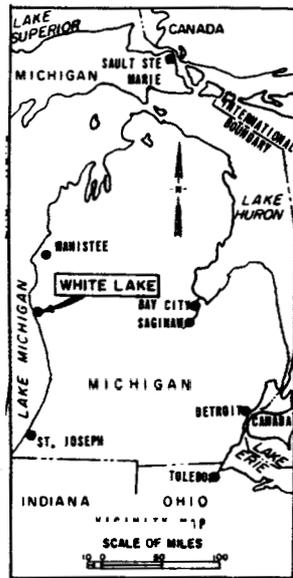
Figure 134. White Lake Harbor, Michigan

1985	An inspection of the structures indicated that the substructures of both piers are deteriorating, resulting in superstructure settlement and cracking, considerable misalignment and tilt, and loss of fill stone. Both structures are considered to be in poor condition, Reconstruction and/or rehabilitation has been recommended within the next 2 to 3 years.

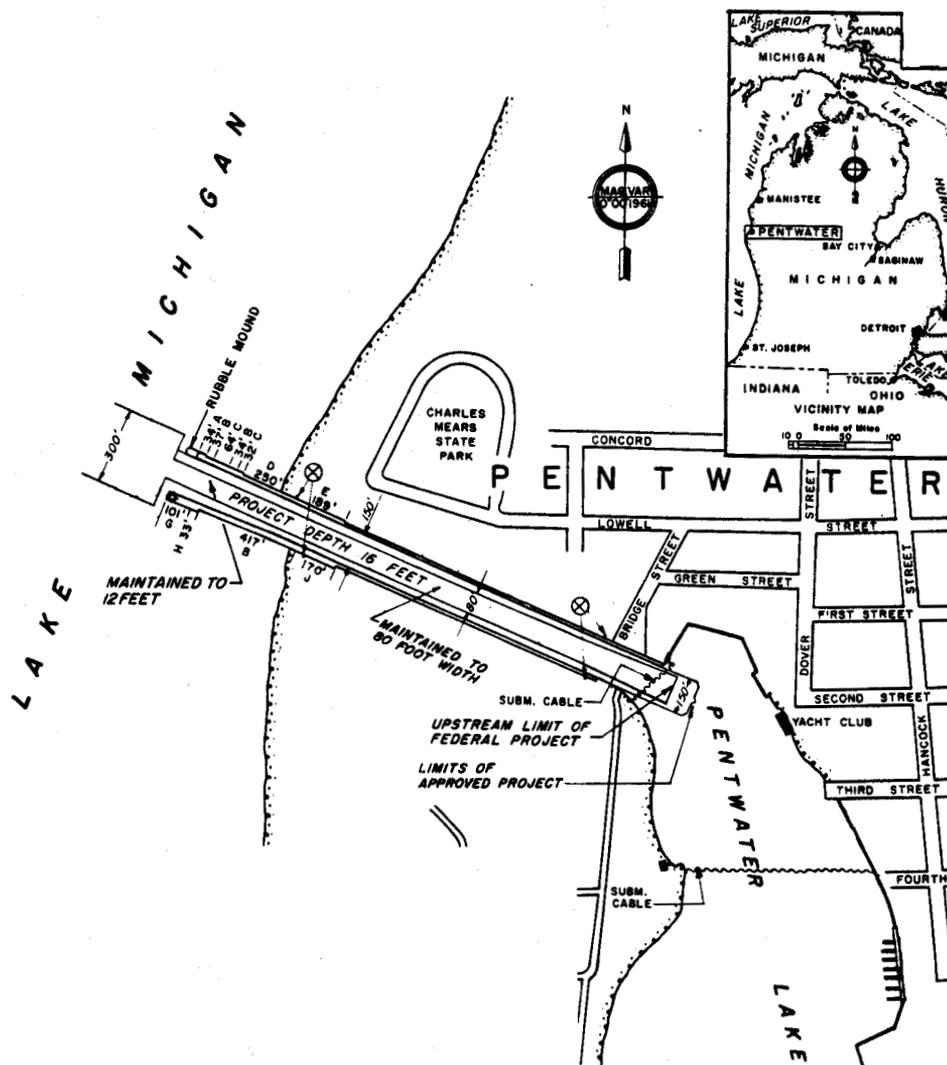
Figure 136. Pentwater Harbor, Michigan

1985 A site inspection of the structures indicated that the rubble-mound extension of the north pier (Figure 136) has settled up to 1 ft throughout. The remaining portions of the north pier (Sections A, B, C, D, and E) and the south pier (Sections G, H, B, and J) are bulging, tilting, leaning, cracked and misaligned. These factors, along with loss of fill stone, indicate substructure deterioration. The structures are considered in poor condition; however, major rehabilitation has been recommended and is scheduled for 1987. An aerial view of the Pentwater Harbor piers is shown in Figure 138.

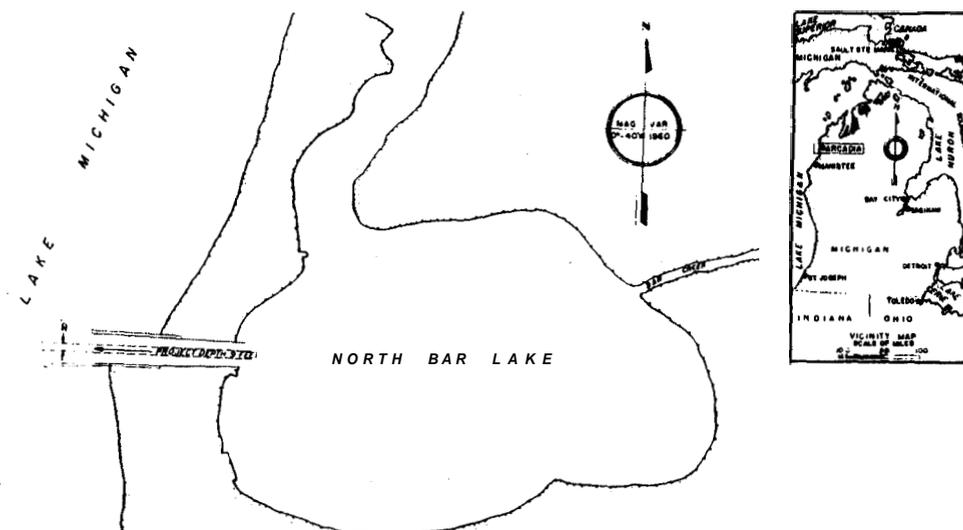
Figure 152. Arcadia Harbor, Michigan

1985	An inspection of the site indicated settled and/or washed out stone in numerous areas of the north pier. Water is washing through the voids of the structure, and three areas are nearly breached. The steel sheet-pile cell at the head of the south pier is completely broken out, and most of the grout cap along the entire length of the pier is missing with stone being washed out. The condition of the piers is very poor, and immediate reconstruction/rehabilitation has been recommended.

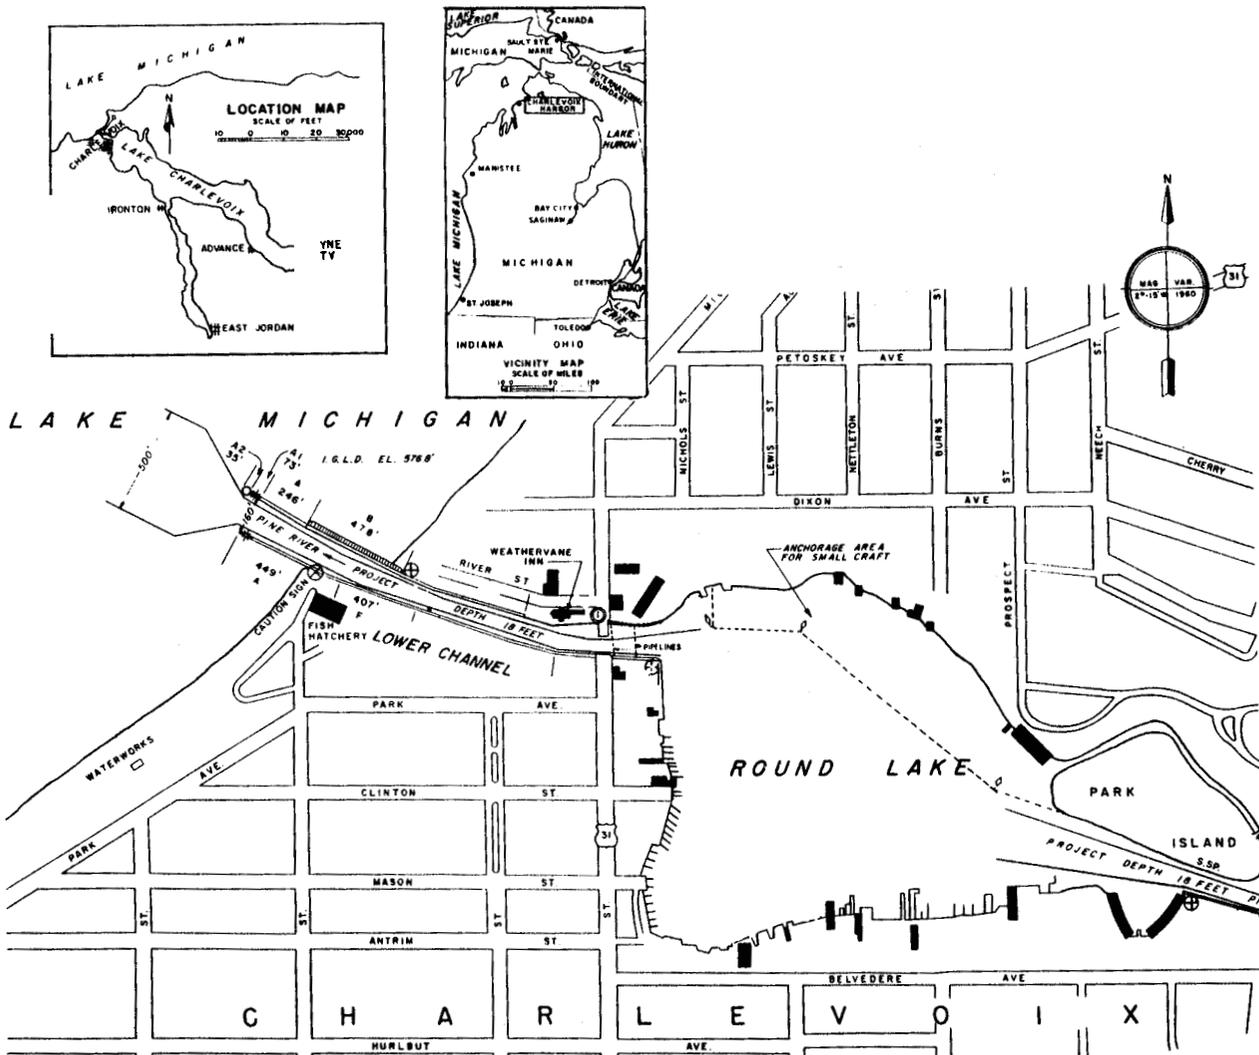
Figure 163. Charlevoix Harbor, Michigan

1985 An inspection of the piers revealed them to be in fair condition. Settlement and loss of fill stone are evidenced in the piers, and some of the structures are cracked and tilting. Replenishment of fill with larger stone, and placement of riprap along the piers have been recommended. An aerial view of the Charlevoix Harbor piers is shown in Figure 165.
