TECHNICAL REPORT REMR-CO-3

CASE HISTORIES OF CORPS BREAKWATER  
AND JETTY STRUCTURES

Report 5

NORTH ATLANTIC DIVISION

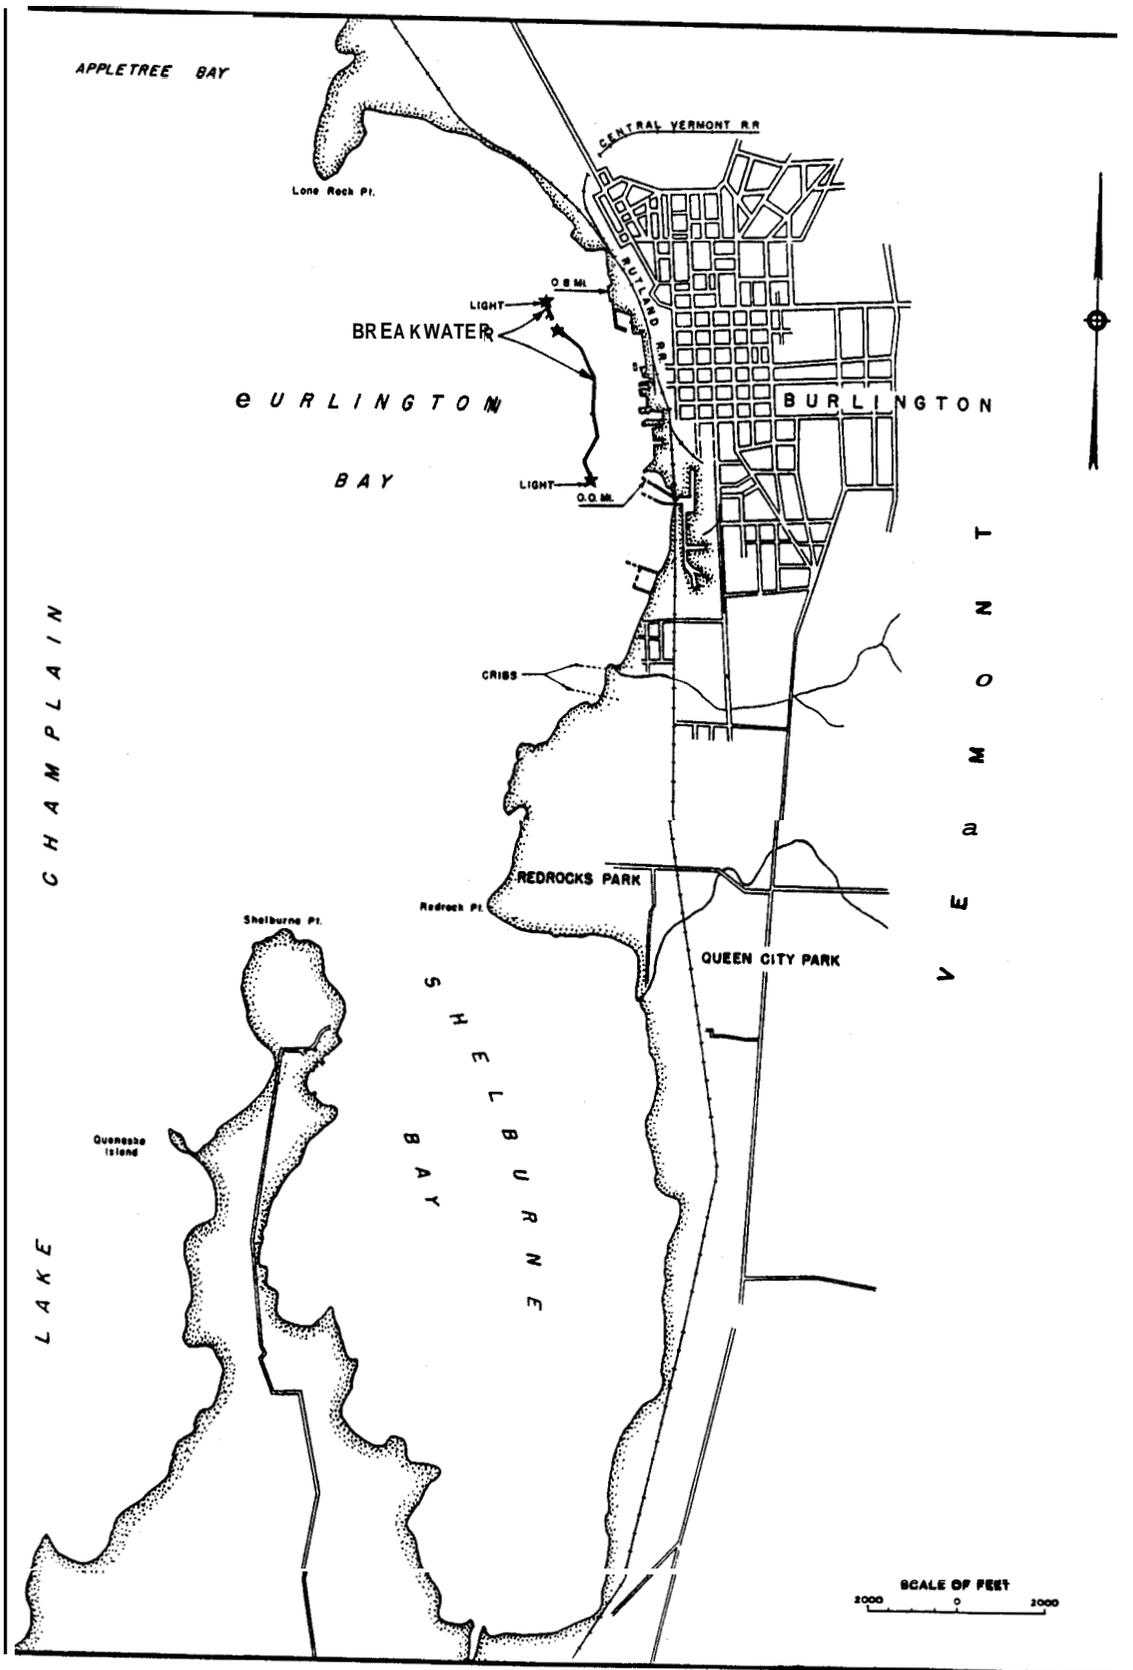
Figure 8. Burlington Harbor, Vermont

Date(s)	Construction and Rehabilitation History
1890	A 4,157-ft breakwater was completed after 54 years of construction (Figure 8). The breakwater consisted of two segments at lengths of 364 ft (north) and 3,793 ft (south) which were separated by 250 ft. Construction was of rubble mound resting on rock-filled timber cribs capped by either concrete (2,457 ft), or rock (1,700 ft). The cribs rested on a sand and gravel bed and were fastened with dowels and tenons. Crest elevation was +8.0 ft low lake level (lll), and crib width ranged from 24 to 34 ft.
1948	The breakwater was repaired. Stone was placed on the lakeside at weakened sections.
1960	A survey indicated the existing structure had settled 1.0 to 3.0 ft along the entire length. Deterioration of sections of the timber fasteners left unconnected sections and caused timber displacement and leaning of the structure lakeward. Deterioration was believed to be caused by wave action and ice conditions over long periods of time. Approximately 550 lin ft of the stone superstructure was undetermined. Eighty feet of the structure was breached.

1962- 1965	The breakwater was rehabilitated using 16,573 tons of stone at a cost of \$381,000.
1986	No further repair or maintenance information has been found.

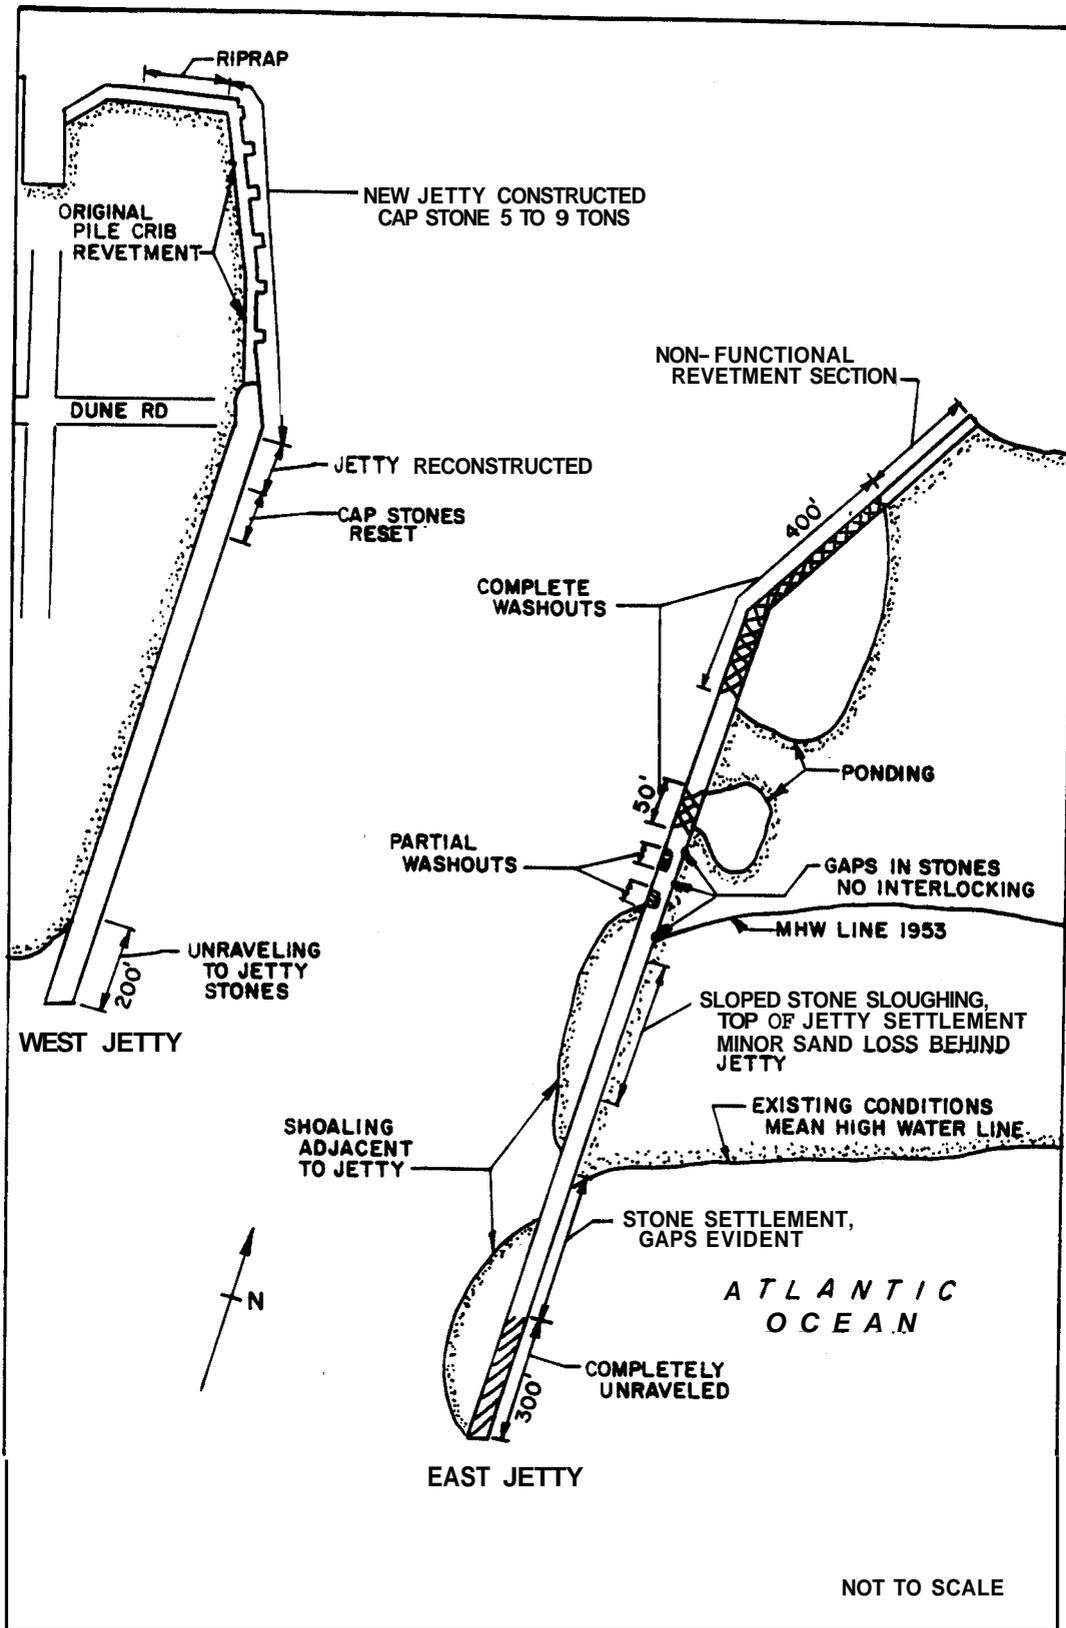
1956	A survey revealed that the east jetty had suffered severe damage. Capstones and slope stones had slipped and were disarranged in numerous spots. Core stones were washed out in several places. Capstones and core stones were washed out in four locations totaling 150 ft. The outer 250 ft of the jetty was partly washed out. Beach and dunes adjacent to the jetty eroded, and waves rode over the dunes and flanked the jetty. The west jetty was in fair condition with minor slips and disarrangement in five spots. The inlet was in a shoal condition. Most of the damage was due to a hurricane in 1954.
1982	The west jetty was reconstructed by resetting cap stones to original design geometry over 170 ft. A 1,470-ft-long pile crib revetment on the north end of the west jetty was replaced by a rubble-mound jetty. (Figure 18).
1985	A survey revealed that the reconstructed portion of the west jetty was in good condition. The seaward 200 ft of the west jetty had unraveled and capstones were scattered. The west jetty head had not maintained design configuration. Stones on the inlet side of the east jetty had sloughed in some sections, but stones on the beach side had retained their original position. Two areas on the northern end were completely deteriorated. Erosion of sand caused undermining of the east jetty with continual loss of sand undermining it further.

Figure 18. 1982 reconstruction of west jetty and 1985 existing conditions of east jetty, Shinnecock Inlet

Date(s)	Construction and Rehabilitation History
1985 (Cont.)	There were areas of partial washouts of stone, settlement, and non-interlocking capstones. The seaward 300 ft was completely unraveled, with all stones scattered (Figure 18). It was determined that the jetties had served their function of inlet stabilization and they were not leaking significant amounts of sand.
1986	Plans call for rehabilitation of the jetties. The east jetty will need new capstones and core stones where there are complete washouts, approximately 450 ft. Original stones will be removed and reset where settlement and sloughing has occurred, approximately 700 ft. The 300-ft east jetty head section will be completely rebuilt with new and original stone. A blanket will be placed for scour protection. A 5.0-ft-thick blanket using 1,000-lb stone will be laid on the existing bottom to prevent additional scouring of the west jetty toe. New capstone and core stone are needed to supplement the displaced stones of the west jetty head. The section will be rebuilt using existing stone but will consist of two layers of armor stone.

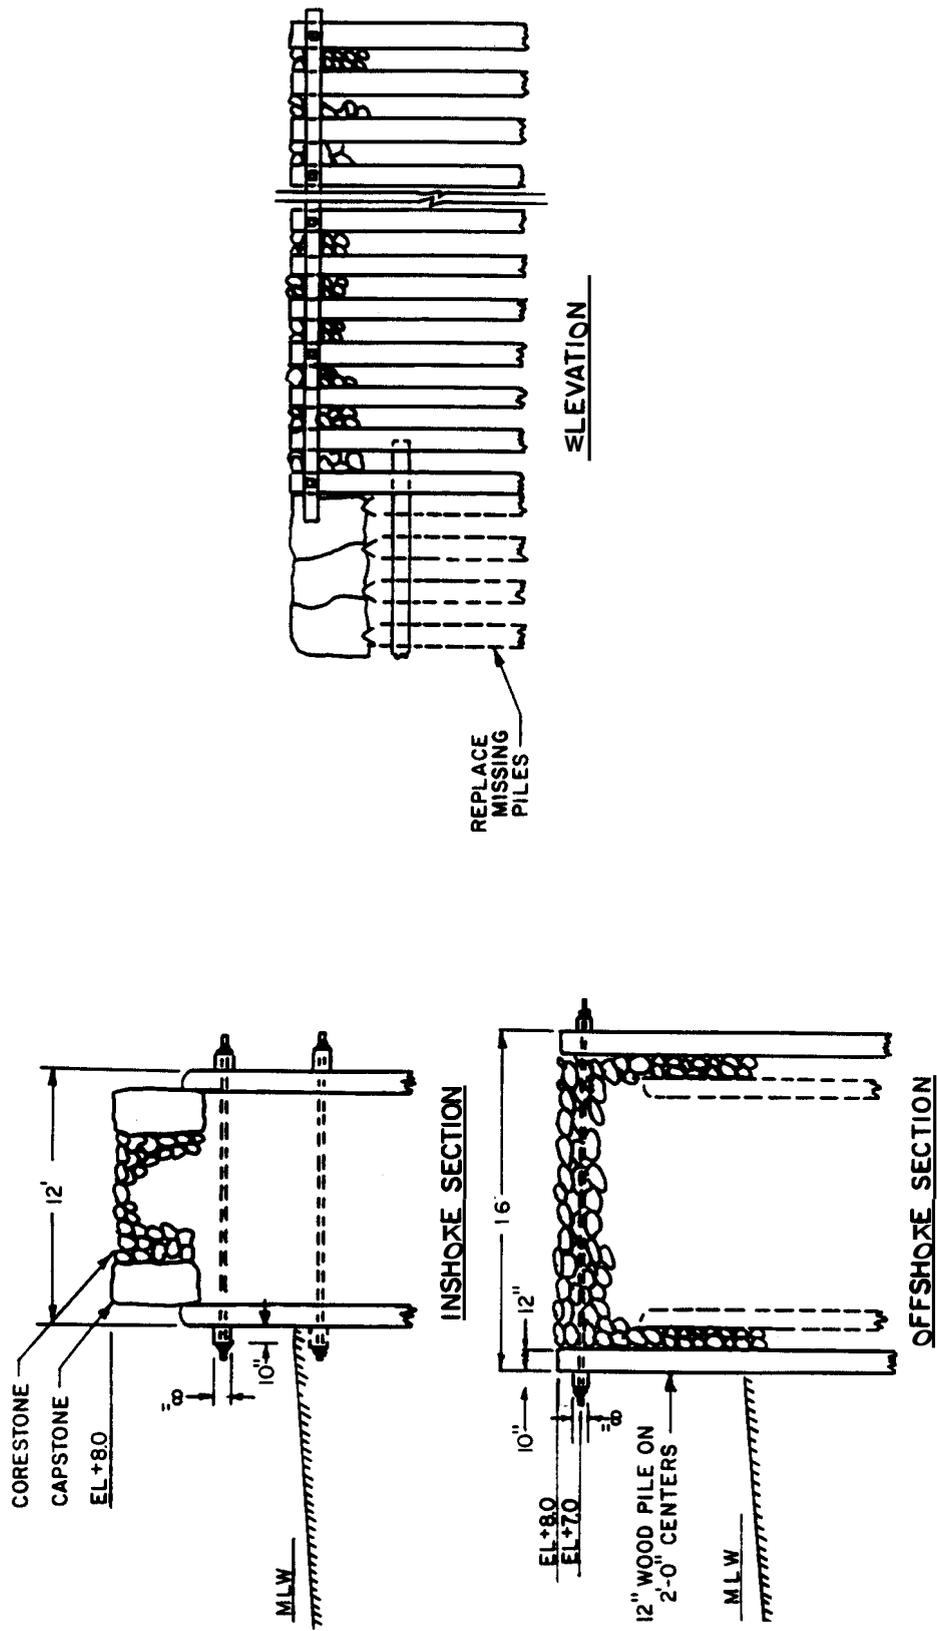
Figure 29 Rehabilitation of Mantua Creek Jetties, 1963

1963	The jetties were rehabilitated at a cost of \$136,895. A new row of piles was placed over approximately 100 ft at the offshore ends. Piles were placed 7.5 ft on either side of the center line of the jetties. Corestone was dumped between the piles to an elevation of +8.0 ft mlw (Figure 29). Missing piles were replaced, and new wales were provided along the remainder of the jetties. One row of capstone was placed on the inner sides of both cribs on top of the existing stone to +8.0 ft mlw. Core stone was filled between the capstones in the center of the jetties to +8.0 ft mlw (Figure 29). Crown width was 16.0 ft at the offshore ends and 12.0 ft on the remainder of the jetty. Design wave height was 4.2 ft.
1964	Repairs were made to the seaward end of the east jetty at a cost of \$4,864. The Corps was reimbursed later for this work.
1986	No further repair or maintenance information has been found.

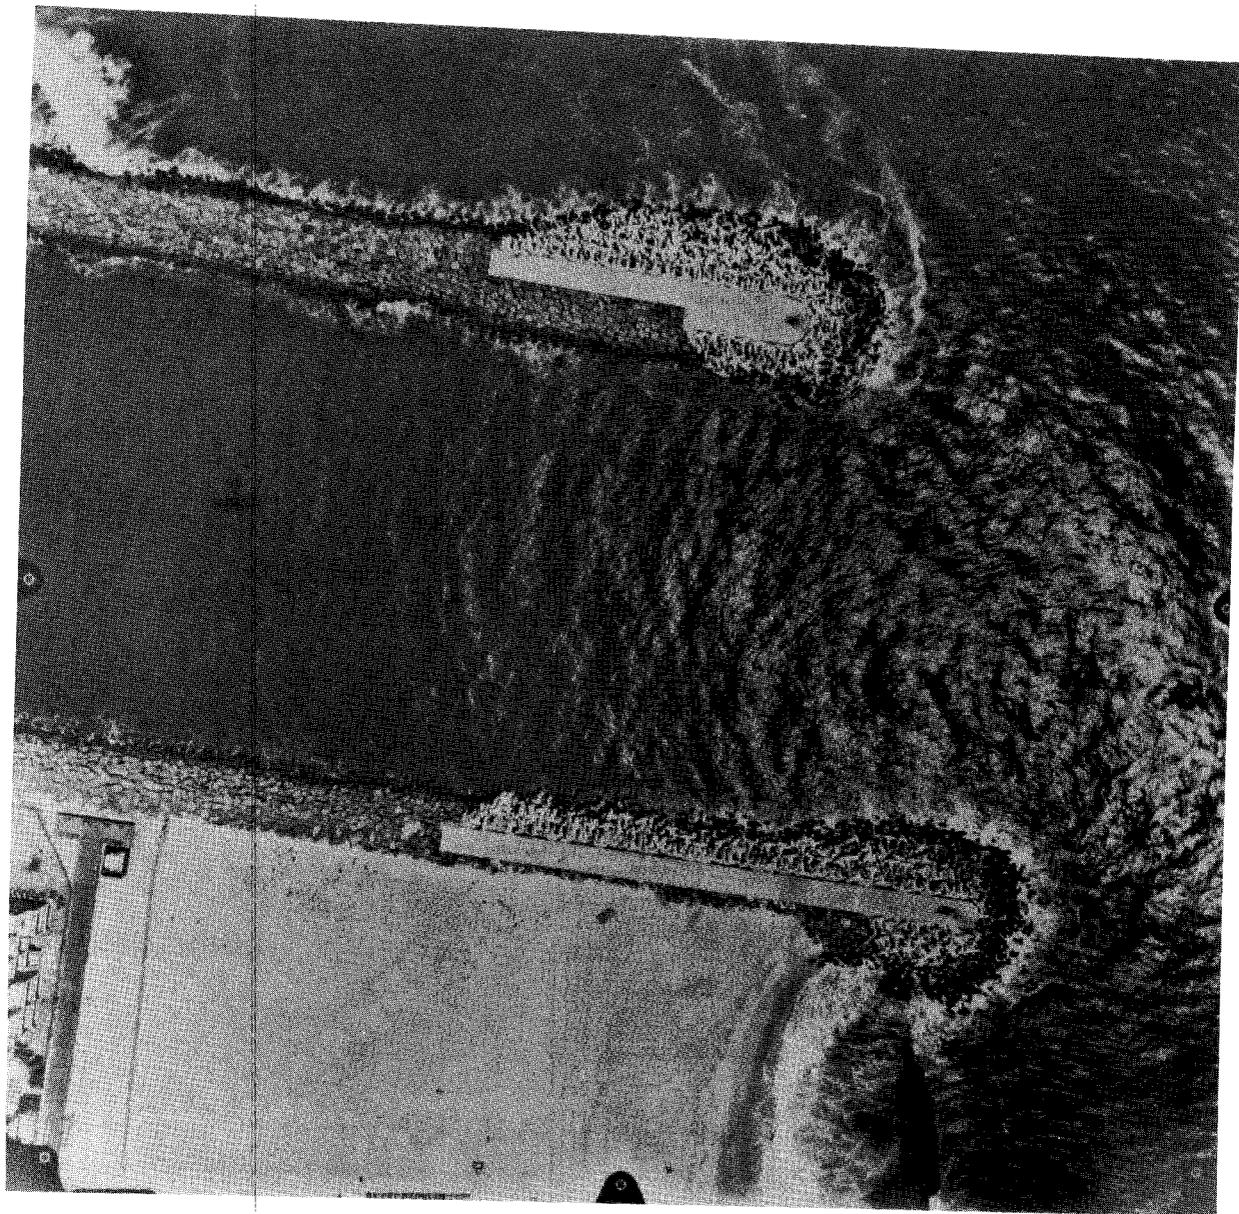
Figure 39. Photograph of Manasquan Inlet jetties after 1982 rehabilitation

Date(s)	Construction and Rehabilitation History
1979- 1982 (Cont.)	the south side. The seaward 240 ft was concrete capped, 35 ft wide at the seaward end and 20 ft wide elsewhere. Capstone was placed shoreward of the dolosse section, 375 ft on the north side and crest, and 90 ft on the south side. Capstone size decreased in the shoreward direction from 12.0 to 3.0 to 5.0 tons. Design wave height was 25.0 ft. An aerial photograph of the rehabilitation is shown in Figure 39.
1985	The jetties were subjected to several storms after the 1982 rehabilitation, including a design level storm in March 1984. Photogrammetric monitoring of the structures under the Monitoring of Completed Coastal Projects (MCCP) Program indicated the last rehabilitation of the jetties has been fully successful to date.

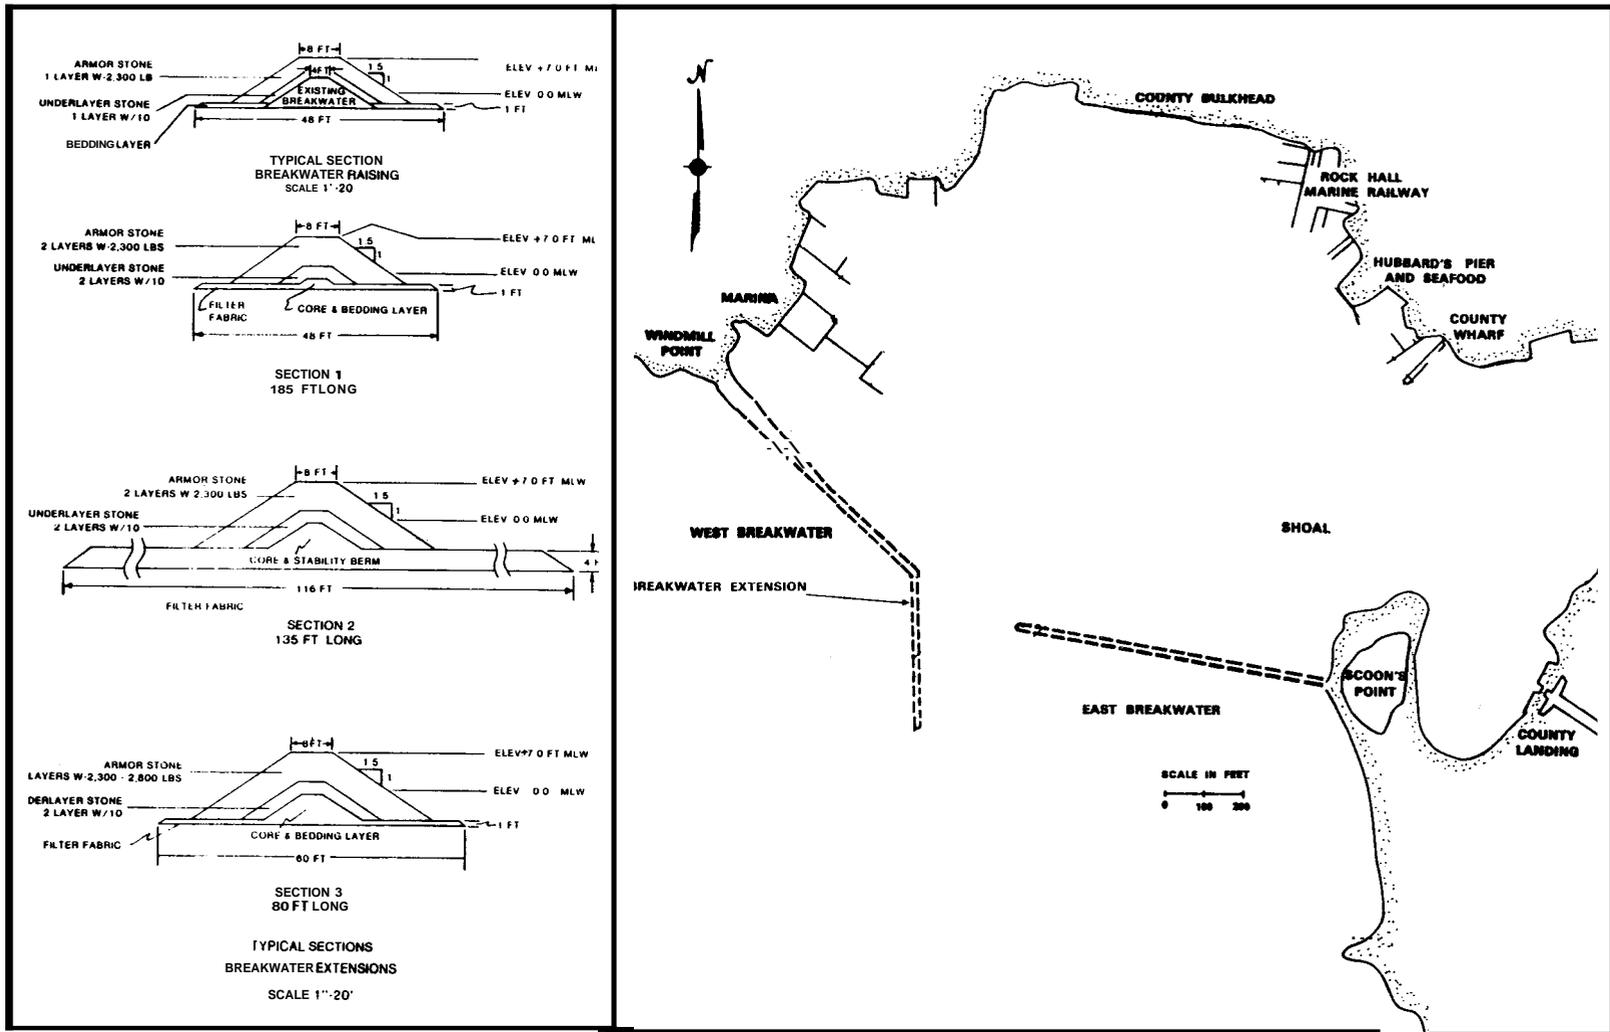
Figure 52. Plan view and cross sections of 1982 rehabilitation, Rock Hall Harbor

1982	Extensive rehabilitation was done to both breakwaters due to wave transmission and overtopping causing excessive wave heights (greater than 4.0 ft) in the inner harbor. Estimated cost of the rehabilitation was \$1,800,000 and required over 27,000 tons of stone. Crown elevation was raised to +7.0 ft mlw, crown width was widened to 8.0 ft with three capstones, and side slopes remained <b>1V:1.5H</b> requiring 12,400 tons of stone. The west breakwater was extended to 1,100 ft requiring 14,800 tons of stone. Cover stone used for rehabilitation ranged from 2,300 lb at the trunk to 2,800 lb at the head. Cross sections and location of the rehabilitation are shown in Figure 52.
1986	No further repair or maintenance information has been found.
