TECHNICAL REPORT REMR-CO-3

CASE HISTORIES OF CORPS BREAKWATER  
AND JETTY STRUCTURES

Report 7

NEW ENGLAND DIVISION

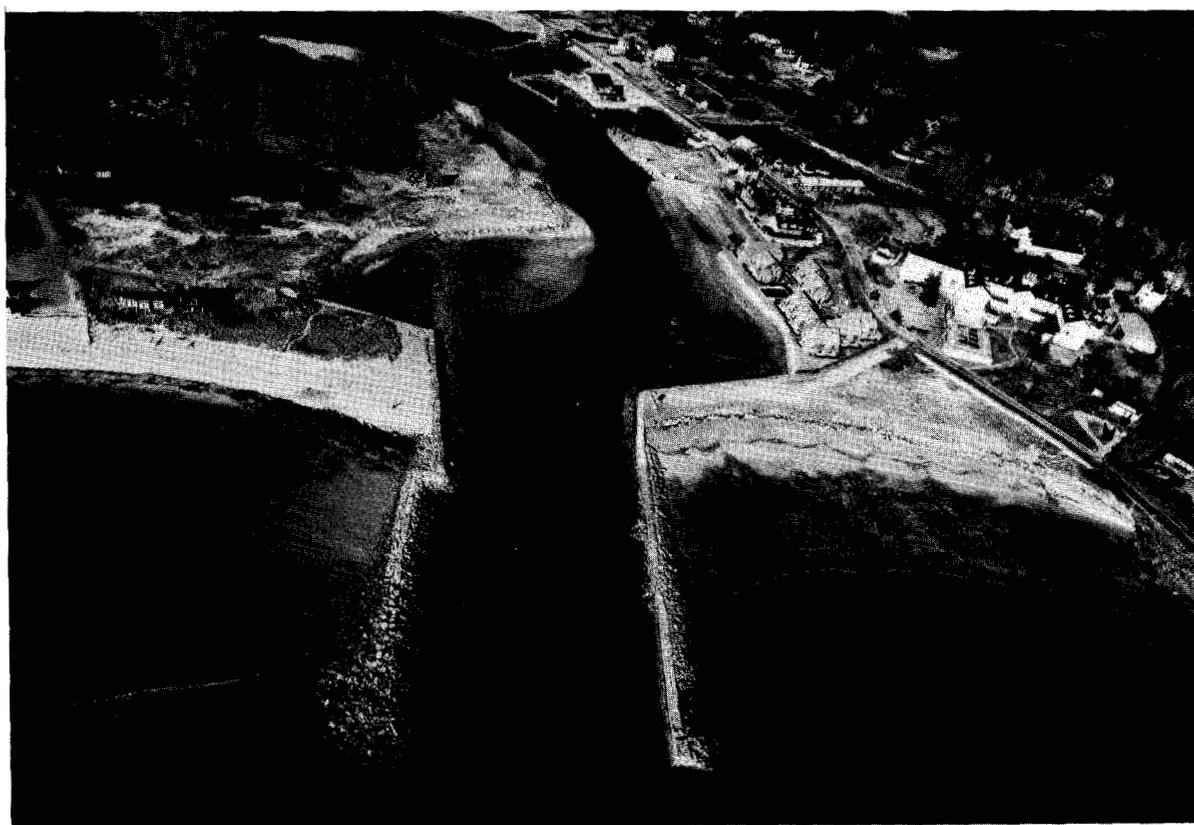
Figure 14. March, 1981 photograph of jetties at the mouth of the Kennebec River, Maine

1977- 1978	Visual inspections indicated the jetties were in poor condition. On the east jetty the seaward side of the head (stone pier) was severely damaged, void spaces in the seaward slope armor stone were evident, and the channel side toe was in a deteriorated state due to undermining. On the west jetty extension the outer 150 ft had large amounts of displaced cover stone with typical elevations from +6 to +13 ft mlw. The remainder of the extension was in considerably better shape with only minor displacement and settlement of the armor stone.
1981	The jetties were repaired with armor stone along the damaged sections observed on previous inspections and a topographic survey. The channel side of the east jetty, from 1+66 to 3+80, was repaired with 5- to 8-ton stone placed to an elevation of +12 ft mlw, a 1V:1H side slope, and a top width varying from 0 to 4 ft. The east jetty's seaside was repaired between 4+20 and 5+24 using 5- to 8-ton stone

Date(s)	Construction and Rehabilitation History
1981 (cont,)	placed to a +16 ft mllw crown elevation. The crown width and side slope were 6 ft and 1V:1.5H, respectively, except seaward of 5+00 where they were 30 ft and 2V:1H, respectively. The seaward 200 ft of the west jetty was brought up to the original design geometry with 3- to 5-ton and 3- to 7-ton stone on the trunk and head sections, respectively. Total cost for placing 2,100 tons of stone was \$99,000. Figure 14 is a photograph of the jetties taken prior to the repairs.
1986	Present conditions of the jetties are not known.

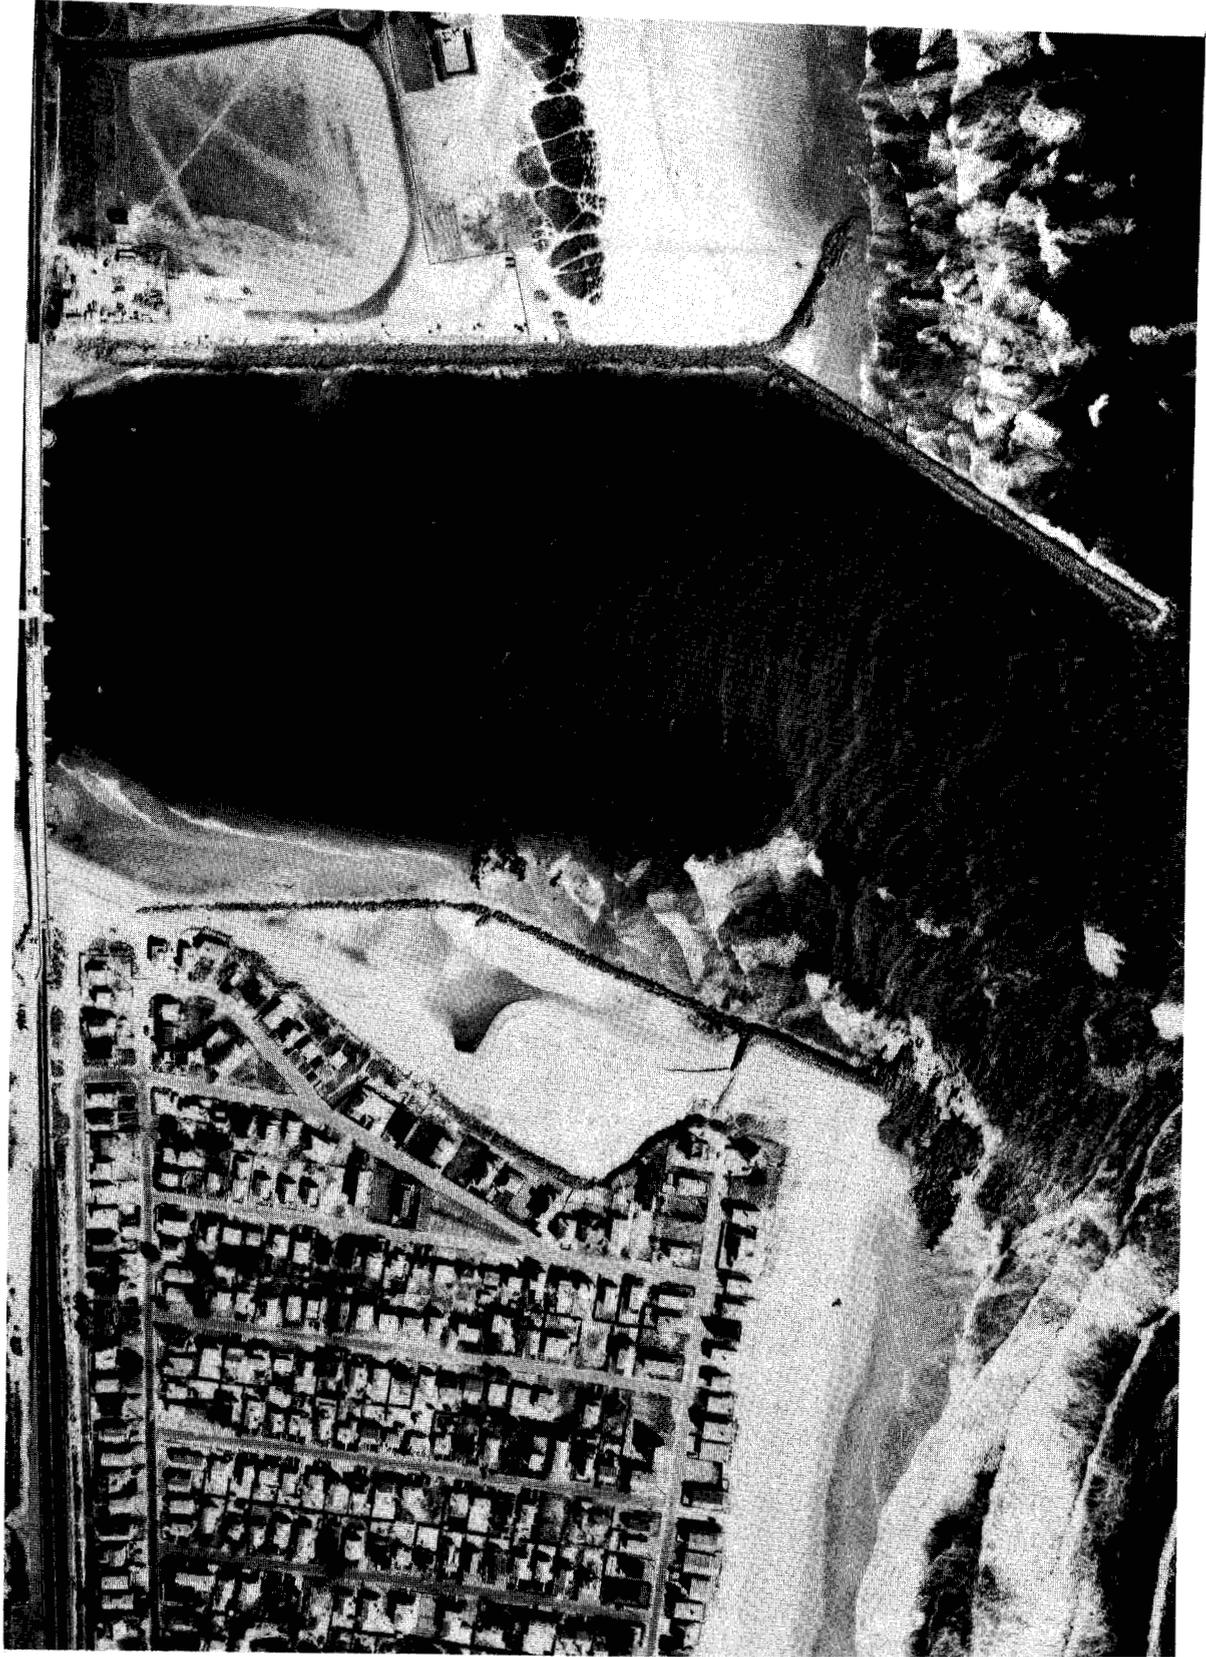
Figure 19. October 1984 photograph of jetties at Hampton Harbor, N.X

1984	The jetties were inspected and found to be in excellent condition. Figure 19 is an aerial photograph of the jetties taken on 16 October 1984.
