**REPAIR, EVALUATION, MAINTENANCE, AND
REHABILITATION RESEARCH PROGRAM**

TECHNICAL REPORT REMR-CO-3

**CASE HISTORIES OF CORPS BREAKWATER
AND JETTY STRUCTURES**

Report 1
SOUTH PACIFIC DIVISION

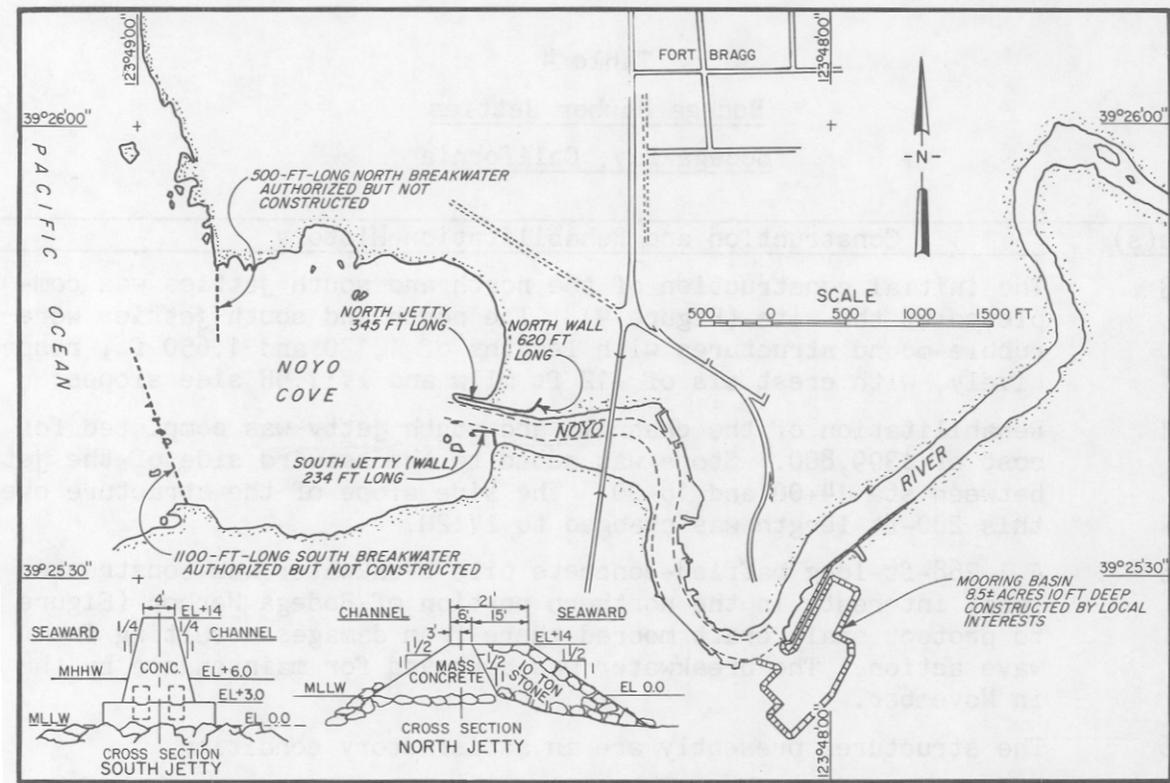
Figure 7. Noyo River and Harbor, California

<u>Date(s)</u>	<u>Construction and Rehabilitation History</u>
1924	Construction of two jetties across a sand bar was completed at the mouth of Noyo River. These were rubble-mound structures spaced approximately 125 ft apart. The initial lengths of the north and south jetties were 648 and 110 ft, respectively.
1931	Work at the Noyo River entrance, which included dredging, rock removal, and reconstruction of the jetties, was completed. The jetties were constructed to their present lengths (Figure 7). The north jetty was constructed of mass concrete. It was 345 ft long and connected to a 620-ft-long concrete wall. The south jetty was constructed 234 ft long with concrete. Both structures had crest els of +14 ft mllw.
1945	A 1,100-ft-long outer rubble-mound south breakwater was authorized (Figure 7). This structure has not been constructed.
1954	Stone (10-ton) was added to the seaward side of the north breakwater (Figures 7 and 8).

1961	Minor rehabilitation of the jetties and north wall was completed.
1962	A 500-ft-long outer rubble-mound north breakwater was authorized (Figure 7). This structure has not been constructed.
1970	The two outer breakwaters authorized by the Acts of 1945 and 1962 were reclassified from an active to inactive category. They were not economically feasible because of the high cost of construction and maintenance. Model testing of the structures was conducted (Wilson 1967).
1983	Restoration of the north jetty head was completed. Materials used consisted of approximately 2,500 tons of capstone, 10 cu yd of concrete, 1,500 cu yd of sandfill, and 4,100 tons of quarystone fill.
1986	The jetties are presently in good condition. Model testing currently is being conducted to optimize the location of a structure in the immediate area of the River entrance (Bottin, in preparation).

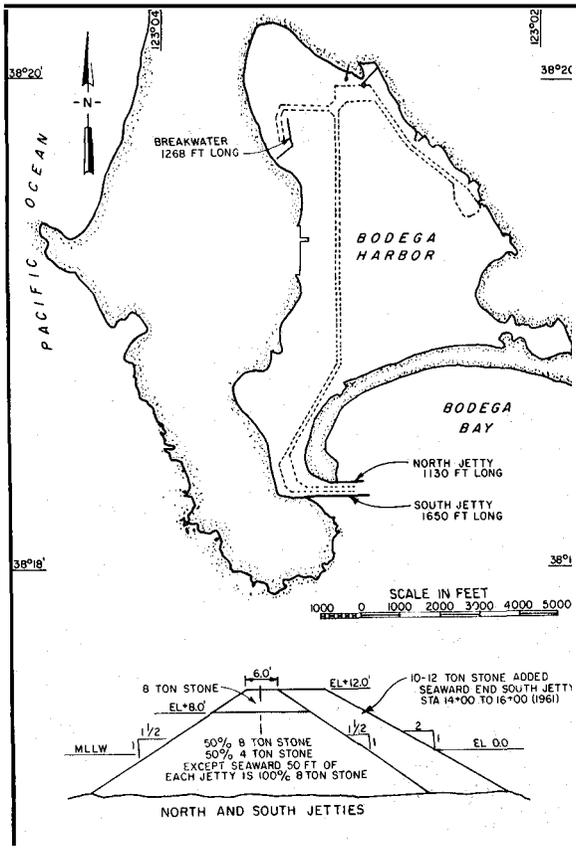
Figure 9. Bodega Harbor, California

Date(s)	Construction and Rehabilitation History
1943	The initial construction of the north and south jetties was completed at the site (Figure 9). The north and south jetties were rubble-mound structures with lengths of 1,130 and 1,650 ft, respectively, with crest els of +12 ft mllw and 1V:1.5H side slopes.
1961	Rehabilitation of the channels and south jetty was completed for a cost of \$399,800. Stone was added to the seaward side of the jetty between sta 14+00 and 16+00. The side slope of the structure over this 200-ft length was changed to 1V:2H.
1985	A 1,268-ft-long baffled-concrete pile breakwater was constructed by local interests in the northern portion of Bodega Harbor (Figure 9) to protect small craft moored there from damages resulting from wave action. The breakwater was approved for maintenance by the CE in November.
1986	The structures presently are in satisfactory condition.

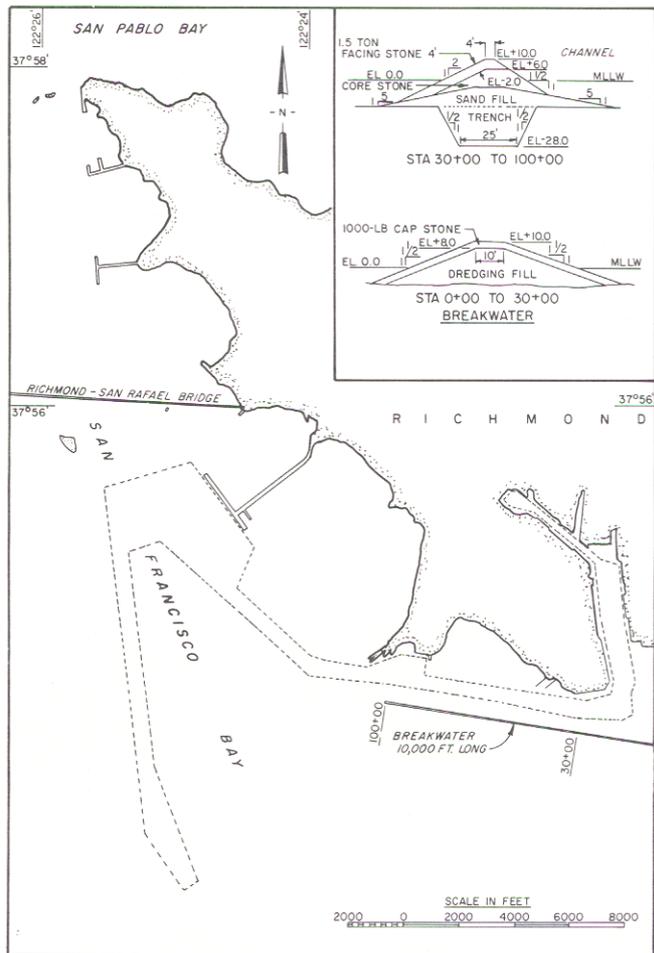
Figure 10. Richmond Harbor, San Francisco Bay, California

Date(s)	Construction and Rehabilitation History
1923-1931	Construction of a 10,000-ft-long breakwater (also referred to as a training wall) was completed (Figure 10) during this time frame. The seaward 3,000-ft-long portion of the breakwater had a 10-ft crest width and a 10-ft mllw crest el. Side slopes were 1V:1.5H. The remaining portion of the breakwater entailed a 10-ft mllw crest el and a 4-ft crest width. Side slopes were 1V:2H on the bay side and 1V:1.5H on the channel side.
1967	Rehabilitation of the breakwater was performed. The extent of the work is not known, however.
1985	The breakwater again underwent repairs and is considered to be in good condition.

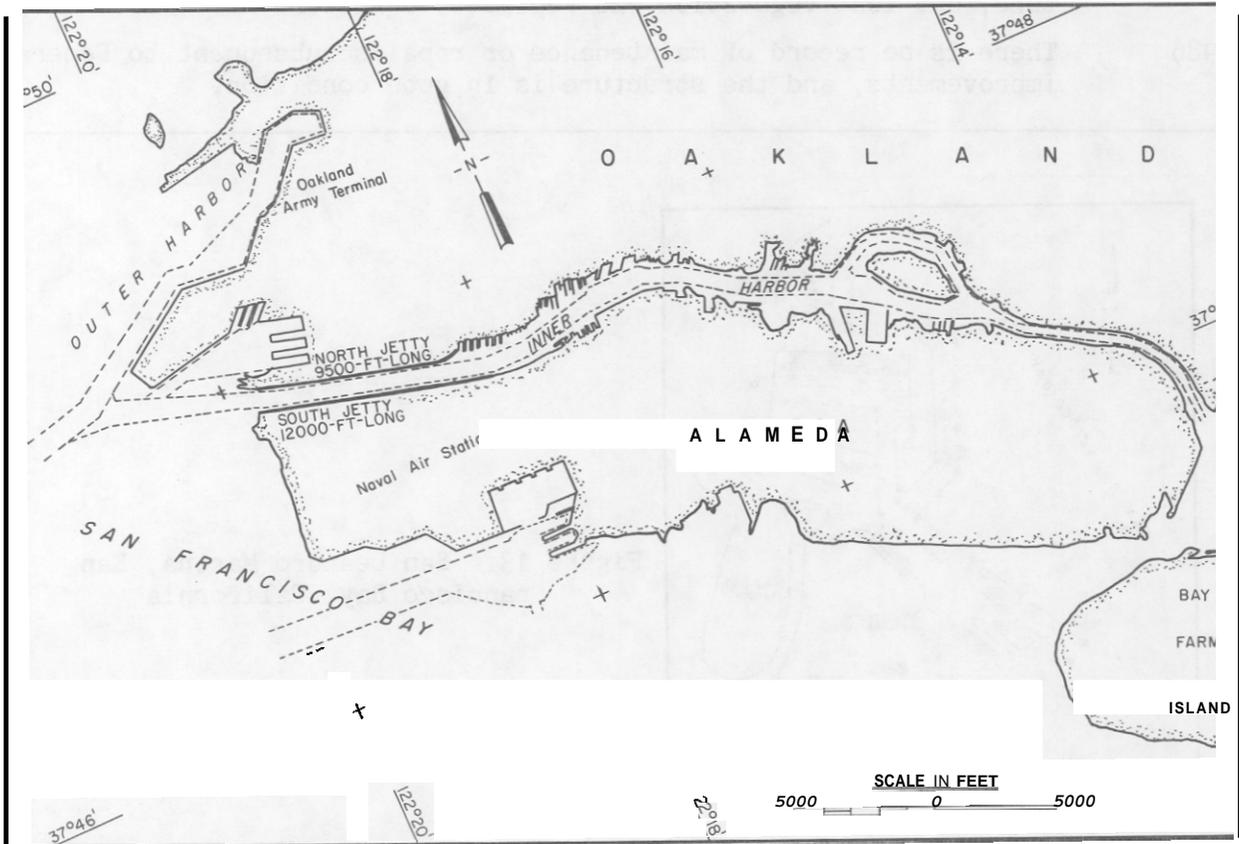
Figure 12. Oakland Harbor, San Francisco Bay, California

<u>Date(s)</u>	<u>Construction and Rehabilitation History</u>
1921-1927	Construction of a 9,500-ft-long north jetty and a 12,000-ft-long south jetty was completed (Figure 12) during this period of time. The jetties were constructed of stone.
1962	Maintenance of the structures along with maintenance dredging was adopted by the Corps of Engineers as authorized by the River and Harbor Act of 1962.
1986	Over the years the shore has been extended bayward on the outside of both jetties, and they function similar to revetments or absorbers. There are no records of maintenance to the jetties, and they are assumed to be in fair condition.

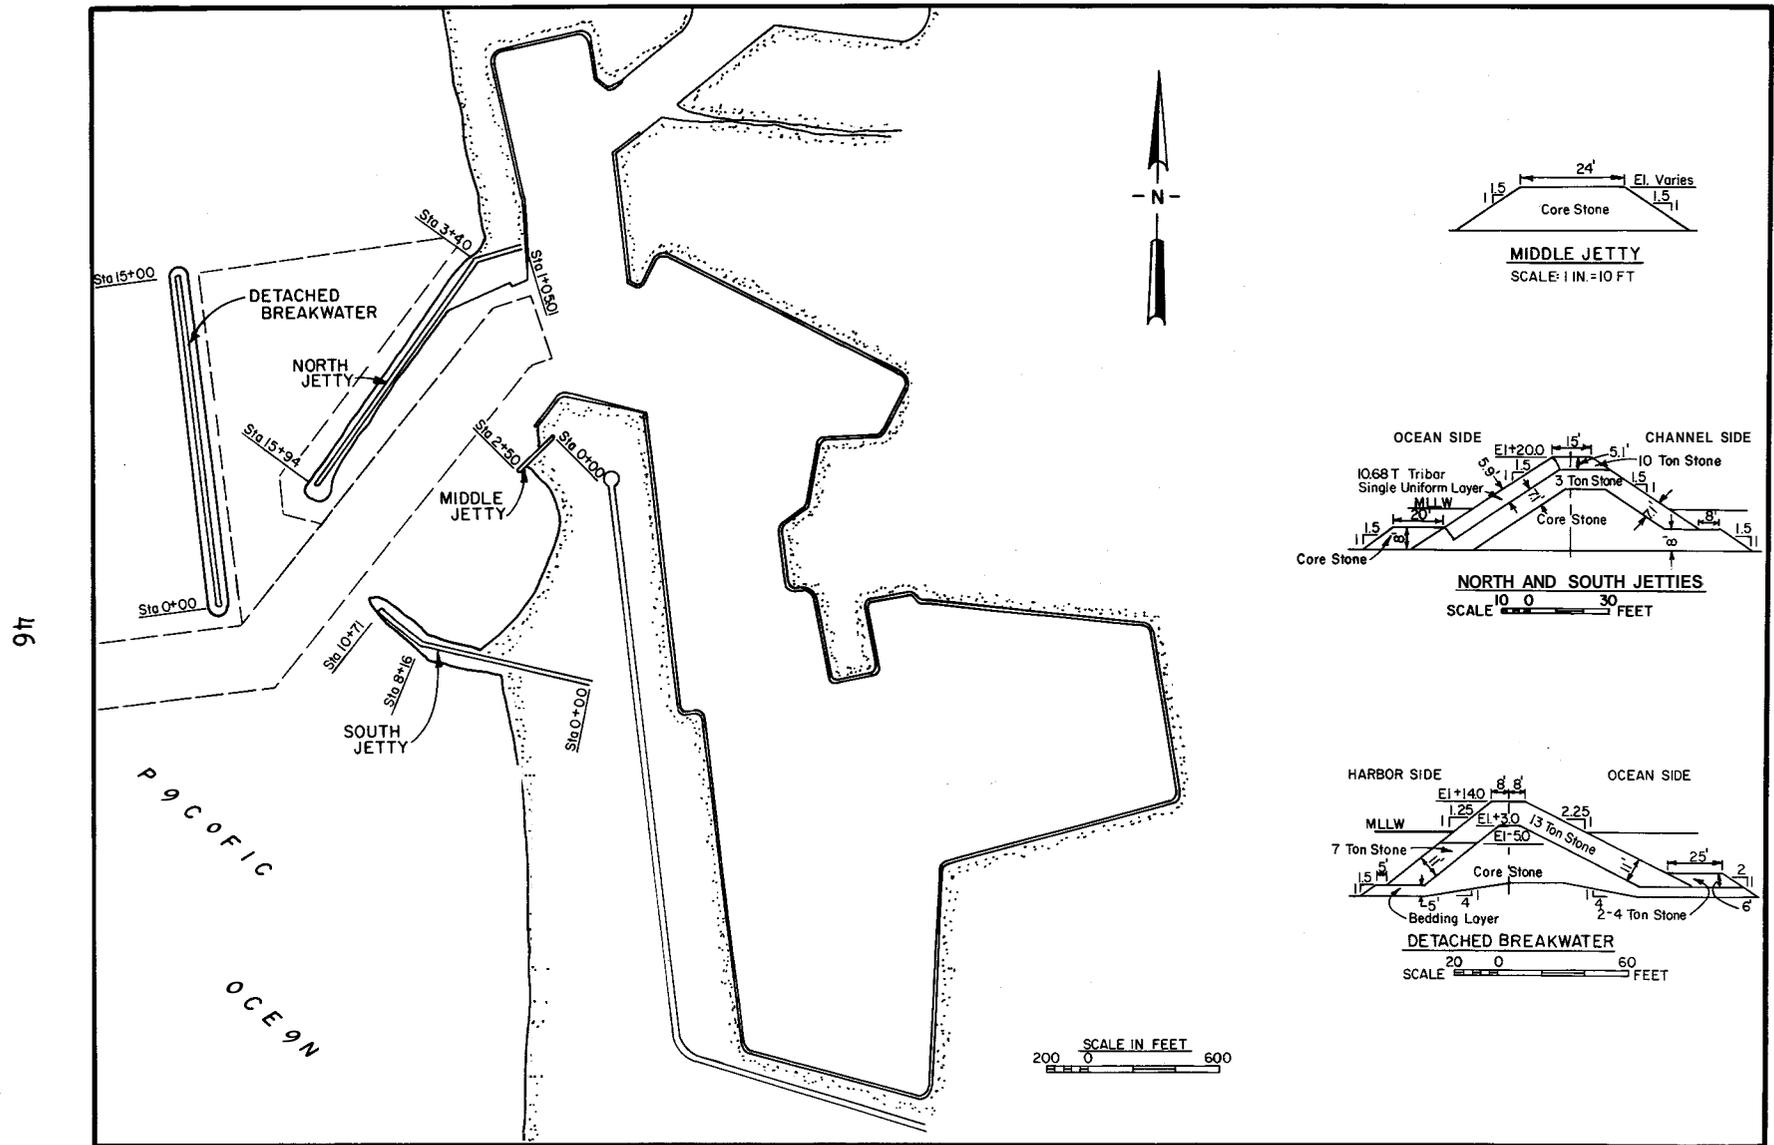
Figure 24. Ventura Marina, California

<u>Date(s)</u>	<u>Construction and Rehabilitation History</u>
1963	Construction of the marina was completed by local interests. Structures included a 1,254-ft-long north jetty, a 1,071-ft-long south jetty, and a 250-ft-long middle jetty (Figure 24). The north and south jetties were constructed with a crest el of +20 ft mllw and a crest width of 15 ft with 1V:1.5H side slopes. The ocean side of these jetties was armored with a single, uniform layer of 10.68-ton tribars. The middle jetty had a crest width of 24 ft with varying els and 1V:1.5H side slopes.
1968	A 1,500-ft-long detached rubble-mound breakwater and dredging of a sand trap were authorized. Also , the authorization plan provided for the US to maintain the existing jetties and channels previously constructed by local interests.
1971	Minor repairs were completed at the head of the north jetty. The repairs consisted of resetting displaced and broken tribars on the seaward end of the jetty and reshaping the jetty head with 3-ton stone.

1972	Construction of the 1,500-ft-long offshore rubble-mound breakwater authorized in 1968 was completed (Figure 24). The structure had a 16-ft-wide crest with an el of +20 ft mllw. Side slopes were 1V:1.25H on the harbor side and 1V:2.25H on the ocean side.
1986	The structures currently are in good condition.

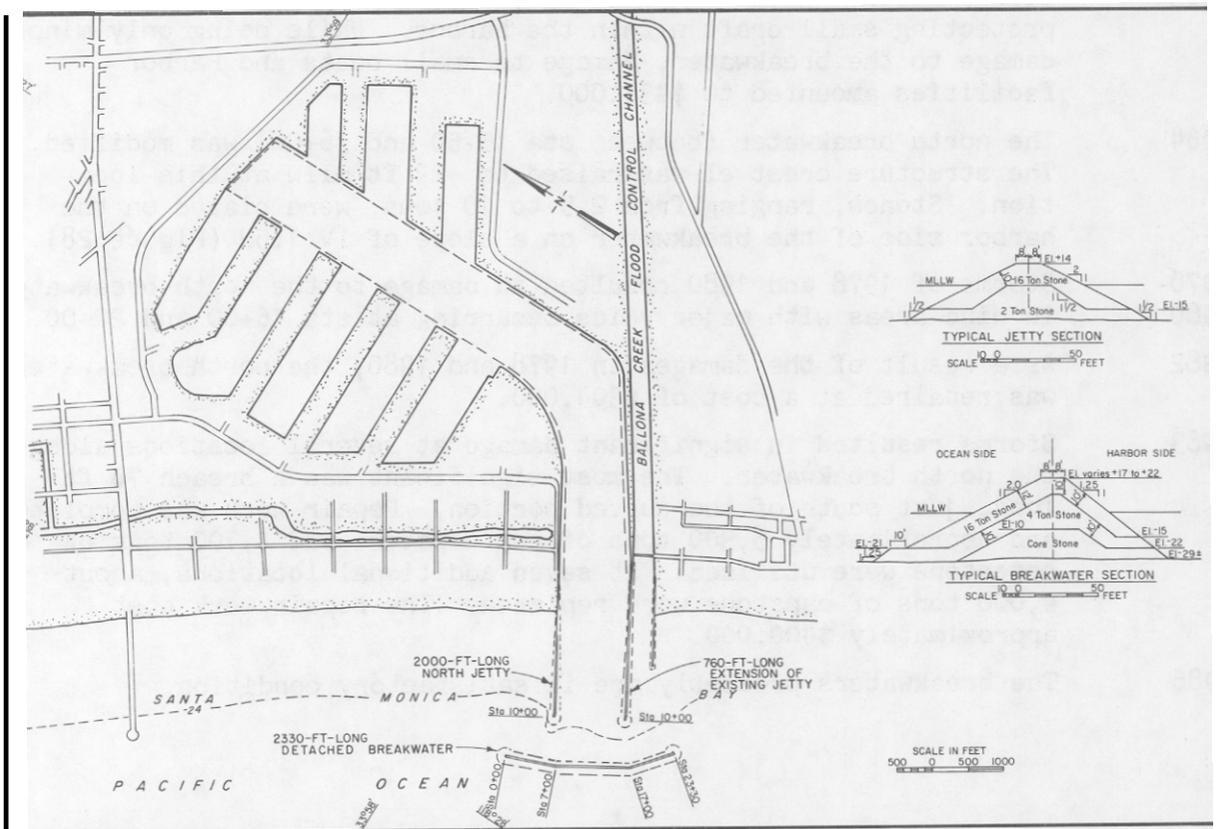
Figure 27. Marina Del Rey, California

<u>Date(s)</u>	<u>Construction and Rehabilitation History</u>
1965	Construction of a rubble-mound breakwater and two rubble-mound jetties was completed at the site (Figure 27). The breakwater was 2,330 ft long with a crest el varying from +17 to +22 ft mllw. The crest was 16 ft wide, and side slopes were 1V:2H on the ocean side and 1V:1.25H on the harbor side. The existing Ballona Creek north jetty was extended 760 ft in length and became the marina south jetty, and a 2,000-ft-long north jetty was constructed. The crest els of the jetties were +14 ft mllw with a width of 16 ft. Side slopes were constructed 1V:2H. The breakwater was model tested (Brasfeild 1965) and was necessary to reduce waves entering the wide entrance channel and reflecting off the vertical concrete perimeter walls to an acceptable level.
1986	The structures presently are in satisfactory condition.

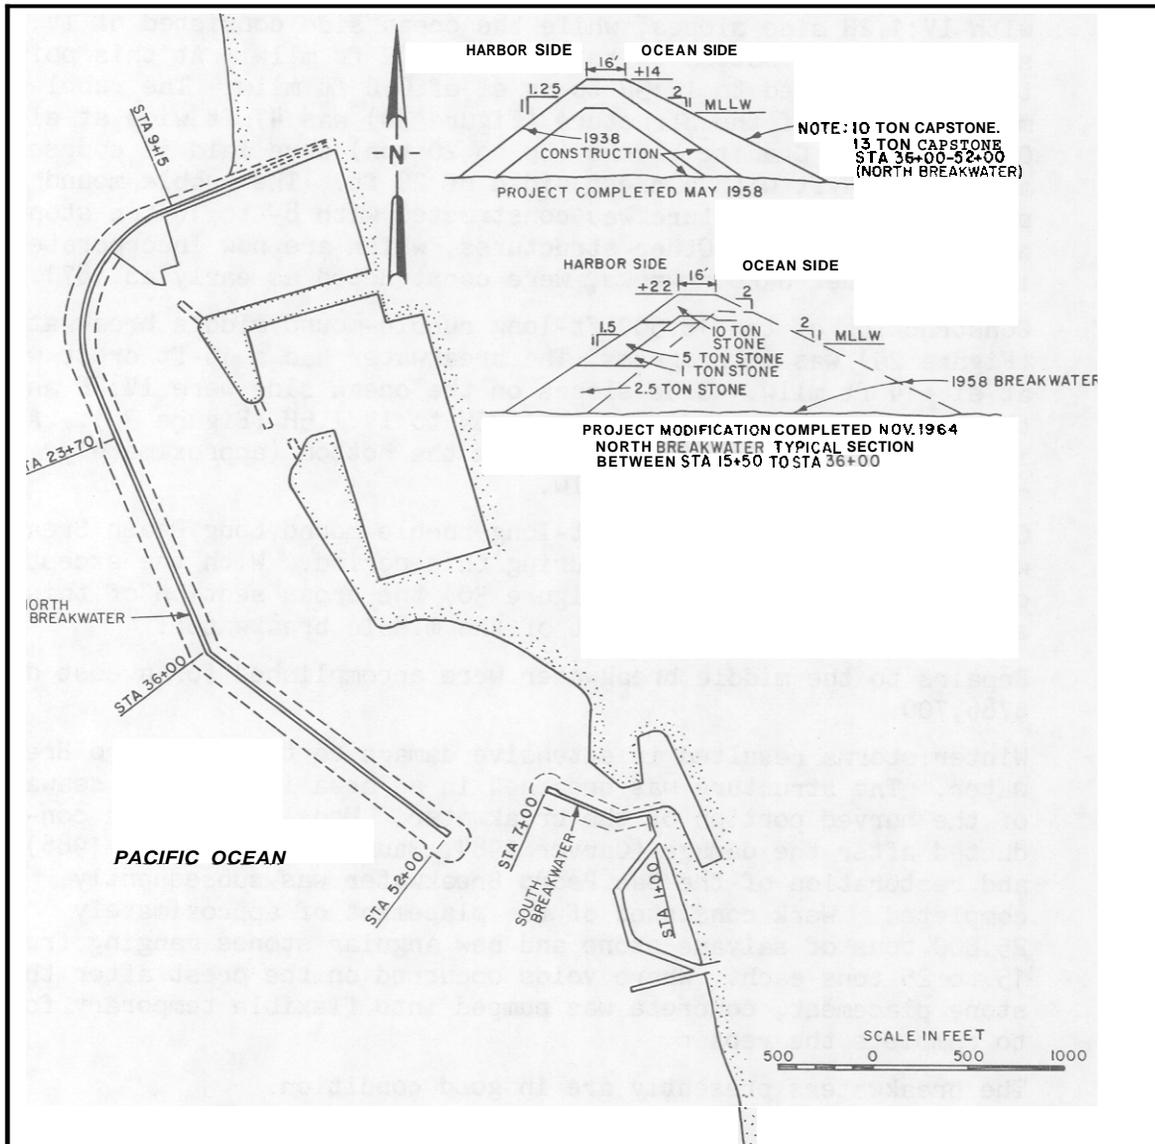
Figure 28. Redondo Beach King Harbor, California

<u>Date(s)</u>	<u>Construction and Rehabilitation History</u>
1938	Construction of a 4,285-ft-long permeable, rubble-mound breakwater (Figure 28) was completed.
1950	The breakwater became a Federal project, and improvements were authorized.
1958	Ten-ton capstones were placed on the ocean side of the breakwater on a 1V:2H slope, and the crest was raised to +14 ft mllw and increased to 16 ft in width. Thirteen-ton capstones were used on the breakwater between sta 36+00 and 52+00. A 600-ft-long south breakwater with a crest el of +14 ft was constructed. The structure has a 16-ft crest width, and side slopes were 1V:2H on the sea side and 1V:1.5H on the harbor side.
1960	Minor repairs to the north breakwater (from a storm in 1959) were completed.
1963	Storms demonstrated the inadequacy of the north breakwater for protecting small craft within the Harbor. While doing only minor damage to the breakwater, damage to small boats and Harbor facilities amounted to \$431,000.

1964	The north breakwater (between sta 15+50 and 36+00) was modified. The structure crest el was raised to +22 ft mllw at this location. Stones, ranging from 2.5 to 10 tons, were placed on the harbor side of the breakwater on a slope of 1V:1.5H (Figure 28).
1978- 1980	Storms of 1978 and 1980 resulted in damage to the north breakwater in nine areas with major voids occurring at sta 16+00 and 22+00.
1982	As a result of the damages in 1978 and 1980, the north breakwater was repaired at a cost of \$304,000.
1983	Storms resulted in significant damage at several locations along the north breakwater. The most significant was a breach 70 ft long, just south of the curved portion. Repair work was completed, and approximately 5,300 tons of new capstone and 1,700 tons of corestone were utilized. At seven additional locations, about 4,000 tons of capstone were replaced. The repair work cost approximately \$400,000.

1986	The breakwaters presently are in satisfactory condition.

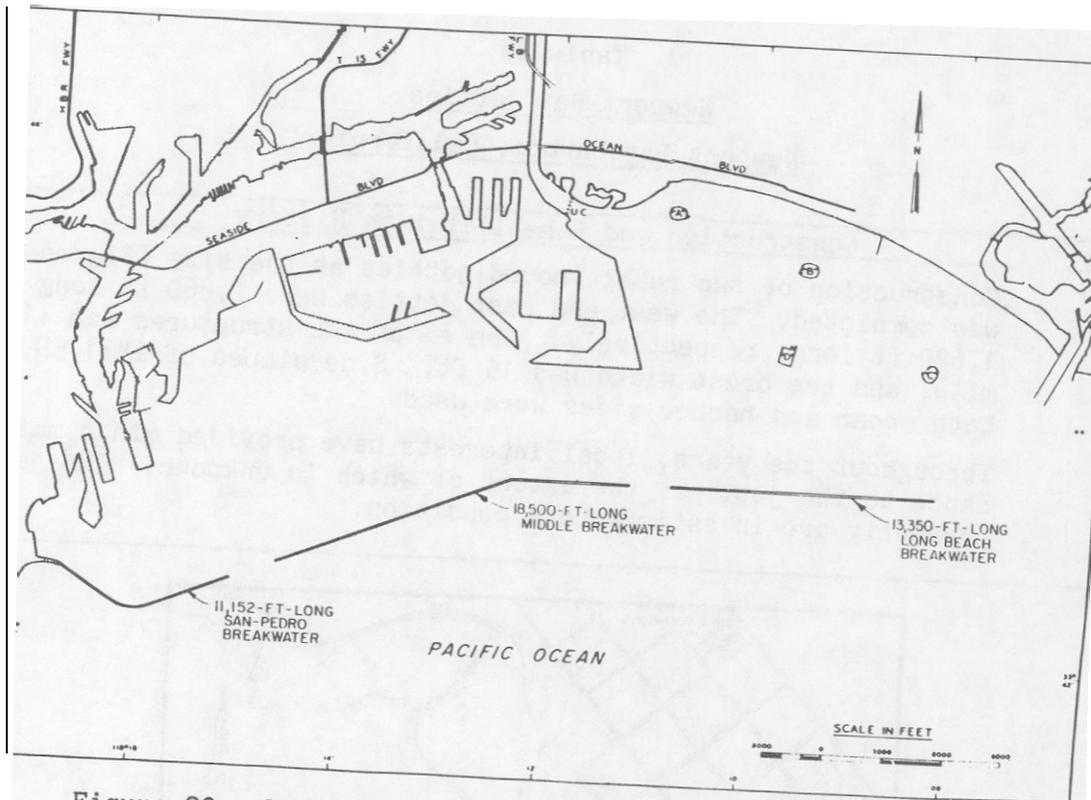
Figure 29. Los Angeles and Long Beach Harbors, California

<u>Date(s)</u>	<u>Construction and Rehabilitation History</u>
1898- 1910	Construction of the 11,152-ft-long San Pedro Breakwater occurred at the site (Figure 29). The harbor side of the structure was built with 1V:1.2H side slopes, while the ocean side consisted of 1V:1.2H slopes from the bottom up to an el of -12 ft mllw. At this point the slope changed to 1V:3H to an el of 0.0 ft mllw. The rubble-mound portion of the structure (Figure 30) was 47 ft wide at el 0.0 ft mllw. Granite blocks (up to 20 ton) were laid in courses to an el of +14 ft with a crest width of 20 ft. The rubble-mound portion of the structure was constructed with 8- to 10-ton stone and was permeable. Other structures, which are now incorporated into the inner harbor works, were constructed as early as 1871.
1930- 1938	Construction of the 18,500-ft-long rubble-mound middle breakwater (Figure 29) was in progress. The breakwater had a 16-ft crest width at el +14 ft mllw. Side slopes on the ocean side were 1V:2H and on the harbor side ranged from 1V:1.25H to 1V:1.5H (Figure 30). An impermeable core was installed from the bottom (approximately -50 ft mllw) to el -26 ft mllw.

1942- 1960	Construction of the 13,350-ft-long rubble-mound Long Beach Breakwater (Figure 29) occurred during this period. With the exception of the breakwater core el (Figure 30) the cross section of this structure was similar to that of the middle breakwater.
1947	Repairs to the middle breakwater were accomplished for a cost of \$786,700.
1983	Winter storms resulted in extensive damage to the San Pedro Breakwater. The structure was breached in an area immediately seaward of the curved portion of the breakwater. Model tests were conducted after the damage (Carver 1984, Baumgartner, et al. 1986), and restoration of the San Pedro Breakwater was subsequently completed. Work consisted of the placement of approximately 25,000 tons of salvage stone and new angular stones ranging from 15 to 25 tons each. Where voids occurred on the crest after this stone placement, concrete was pumped into flexible temporary forms to complete the repair.

1986	The breakwaters presently are in good condition.

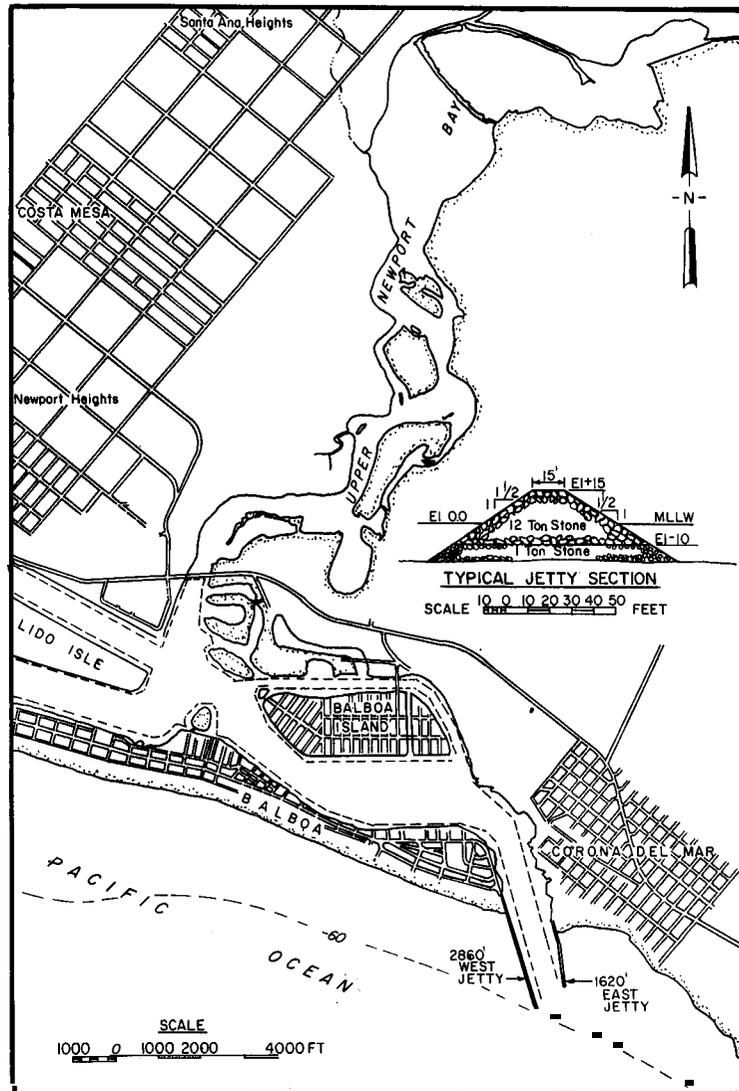
Figure 31. Newport Bay Harbor, California

Date(s)	Construction and Rehabilitation History
1934	Construction of two rubble-mound jetties at the site (Figure 31) was completed. The west and east jetties were 2,860 ft long and 1,620 ft long, respectively. The el of the structures was +15 ft mllw, and the crest width was 15 ft. Side slopes of 1V:1.5H on both ocean and harbor sides were used.
1986	Throughout the years, local interests have provided minor maintenance to the jetties, the extent of which is unknown. The jetties presently are in satisfactory condition.

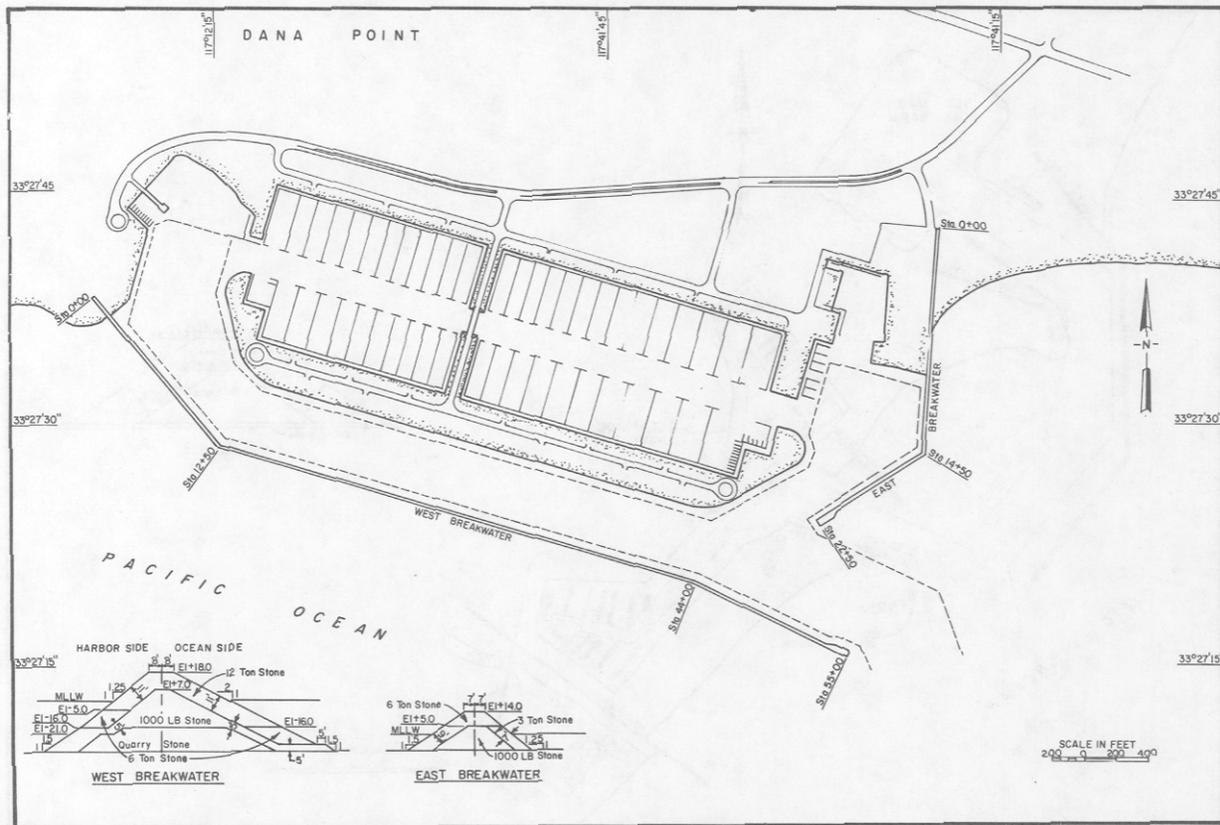
Figure 32. Dana Point Harbor, California

Date(s)	Construction and Rehabilitation History
1968	Construction of two rubble-mound breakwaters at the site (Figure 32) was completed. The west breakwater was 5,500 ft long with a 16-ft-wide crest at el of +18 ft mllw. The ocean side slope of the structure was 1V:2H, and the harbor side was 1V:1.25H. The east breakwater was 2,250 ft long with a 14-ft-wide crest width and a +14-ft el mllw. The ocean-side slope was 1V:1.5H, and the harbor-side slope was 1V:1.25H. Model tests were conducted for the project (Dai and Jackson 1966, Wilson 1966).
1983	Major storms resulted in approximately \$610,000 in damages to the breakwater.
1984	Restoration of the west breakwater in nine locations was completed. About 5,800 tons of capstone were used for this maintenance repair.
1986	The breakwaters are in satisfactory condition.

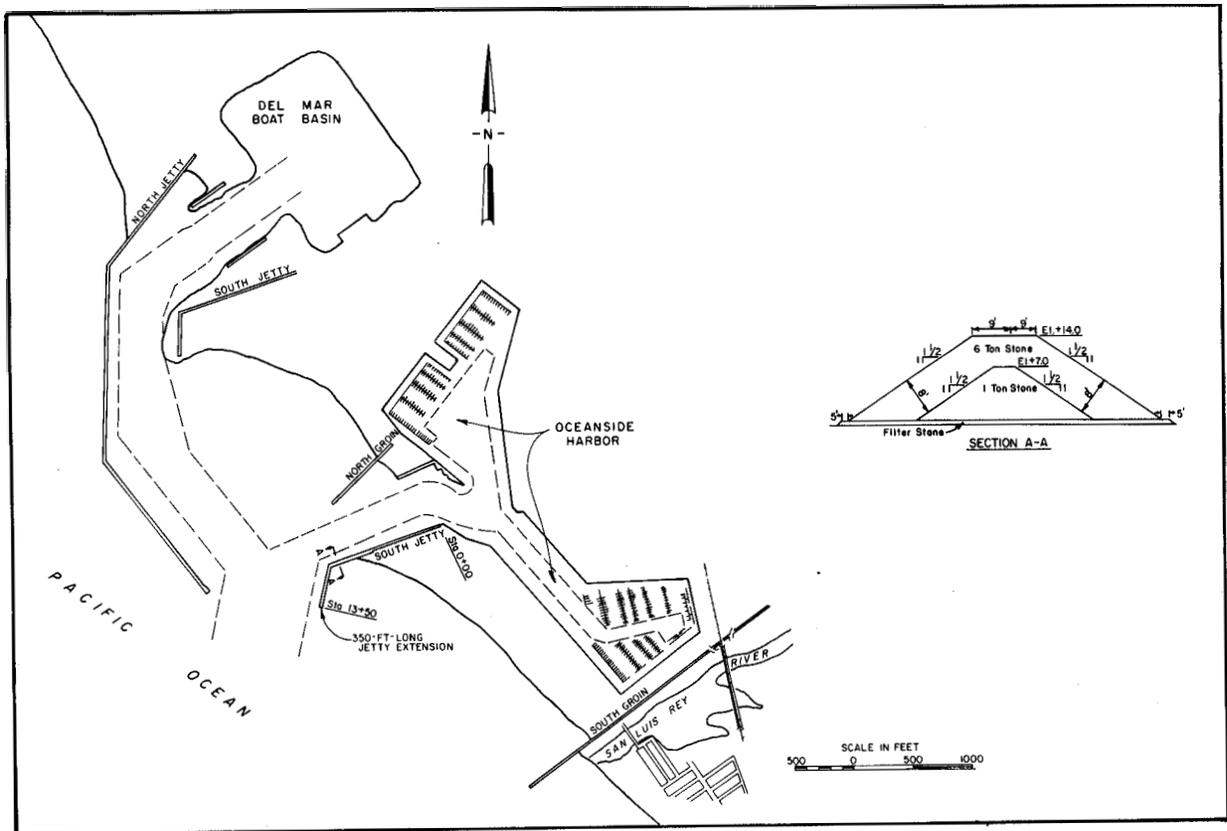
Figure 33. Oceanside Harbor, California

Date(s)	Construction and Rehabilitation History
1958	Construction of the Del Mar Boat Basin (formerly Camp Pendleton Harbor) was completed by the US Navy. The north and south jetties at the basin entrance also were constructed and are maintained by the Navy.
1961	The construction of a 1,000-ft-long rubble-mound south jetty at the entrance to Oceanside Harbor (south of Del Mar Boat Basin) was completed (Figure 33). The jetty had a crest el of +14 ft mllw and a width of 18 ft. Side slopes were 1V:1.5H.
1968	Construction of a 350-ft-long rubble-mound extension to the south jetty was completed. In addition, the existing jetty was sealed from sta 3+70 to 12+10 in an effort to minimize shoaling of the entrance channel. Grout holes were drilled through the armor stone and penetrated the core by 1 to 2 ft. Grout then was pumped in the holes under pressure to seal the structure.
1986	The jetty is in satisfactory condition.

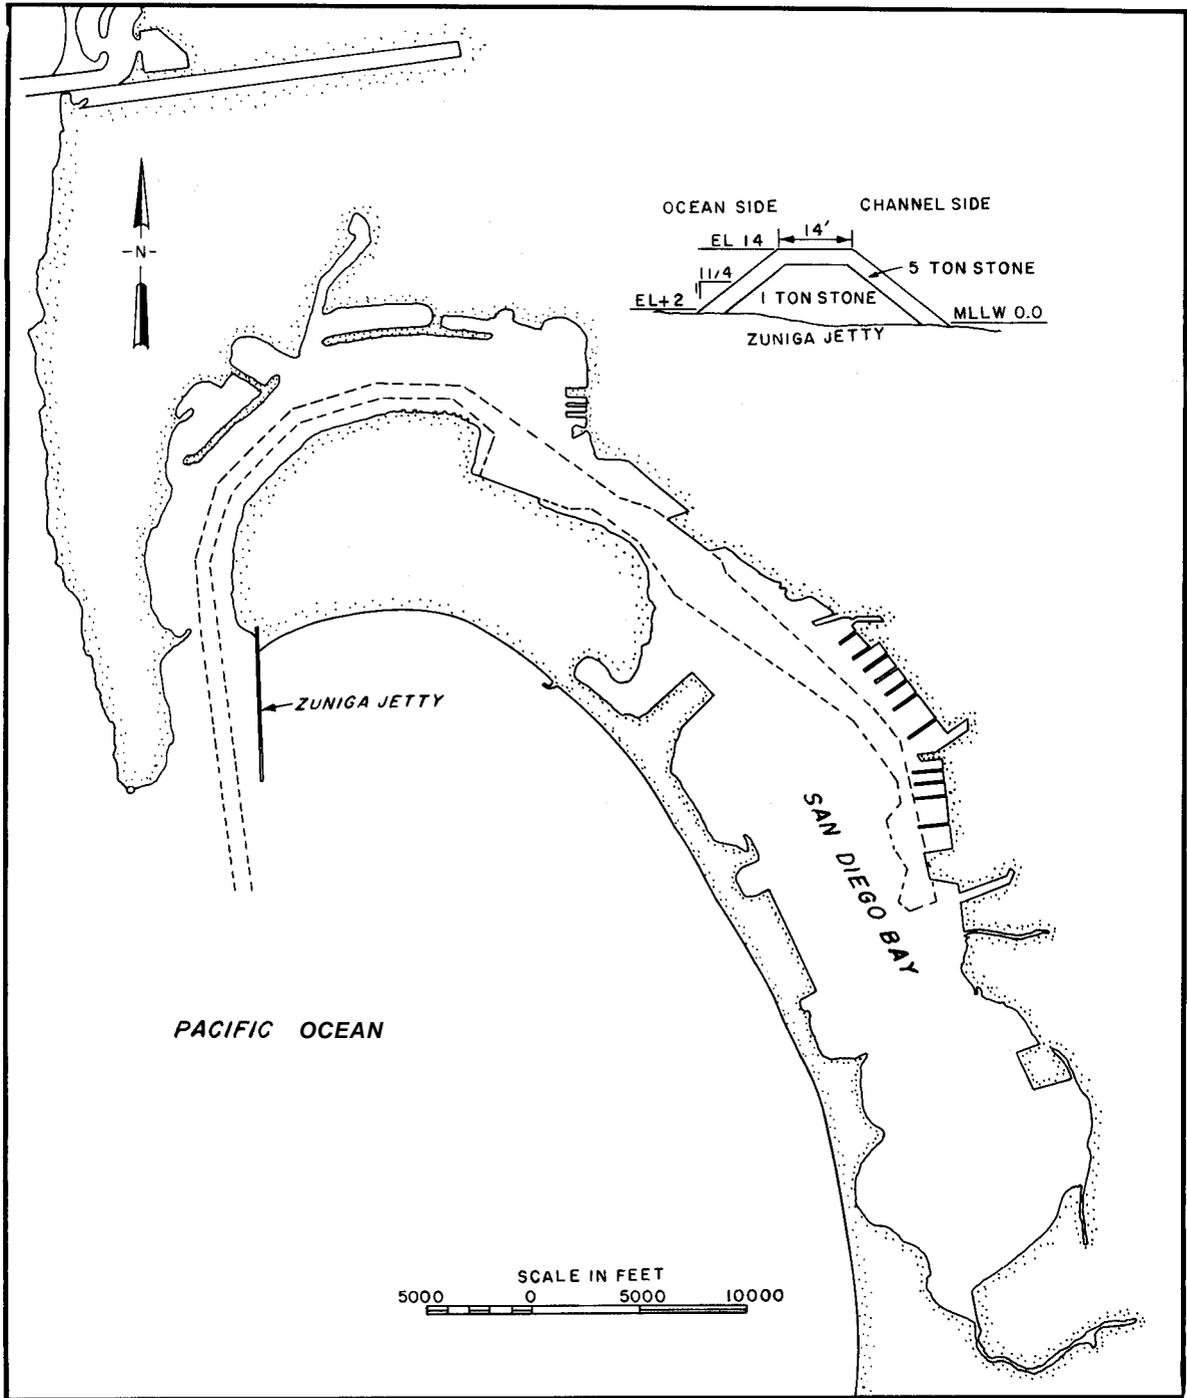
Figure 35. San Diego Harbor, California

<u>Date(s)</u>	<u>Construction and Rehabilitation History</u>
1894-1902	Construction of a 7,500-ft-long rubble-mound jetty (Zuniga Jetty) was completed (Figure 35) during this time frame. The design height of the jetty was +14 ft mllw with a 14-ft-wide crest. Side slopes were 1V:1.25H. It is indicated, however, that the jetty was not constructed to the full design height.
1942	Rehabilitation work was performed by the US Navy from the shoreward end to a point about 1,400 ft seaward.
1943-1969	Settlement and flattening of the slopes occurred, particularly in the outermost third of the jetty. As a result, parts of the jetty were awash or submerged at most tide stages, creating hazards to navigation.
1970	Maintenance repair of the jetty was accomplished for a cost of approximately \$127,000. This work consisted of the construction of platforms on the jetty for navigation lights which were installed by the US Coast Guard to alleviate hazards to navigation.

1984	Maintenance repair of the jetty was completed, the extent of which is unknown.
1986	Even though the jetty was not constructed to full design height, it functions satisfactorily as a training wall which concentrates tidal flows and keeps the entrance channel scoured to project depth.
