Table 46
Holland Harbor Structures
Holland, Michigan

Table 47
Grand Haven Harbor Piers
Grand Haven, Michigan

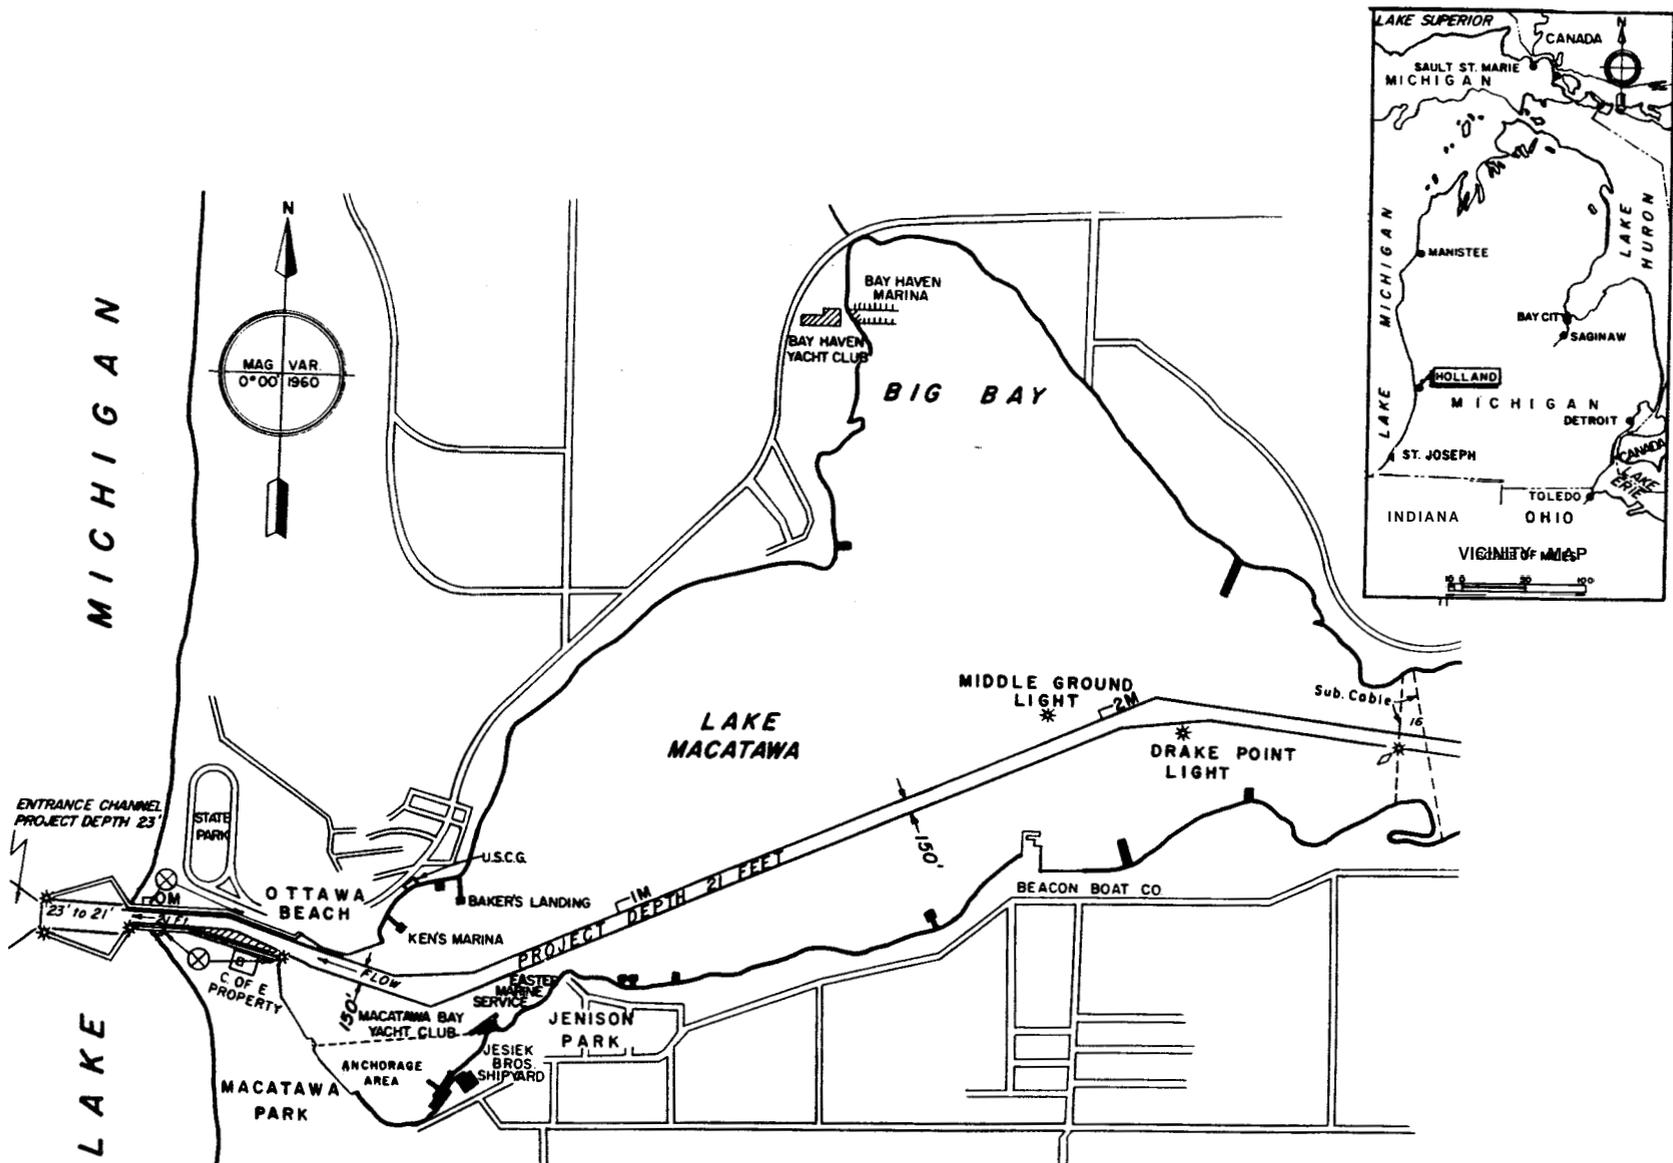
Figure 122. Holland Harbor, Michigan

Date(s)	Construction and Rehabilitation History
	Steel sheetpiling was driven on each side of the breakwater heads (Section Al) forming a structure 40.3 ft in width. The voids were stone filled and capped with concrete. The pier connections (Section Q) were capped with an 8-ft-wide precast concrete slab at an el of +4.5 ft lwd. Stone was added to the channel side and the lake-side of the structure with slopes of 1V:2H and 1V:1.5H, respectively. Steel sheetpiling also was added along the sides of the south pier (Figures I and J). The voids were filled with stone, and a concrete cap was added.
1979	An inspection of the structures indicated that the breakwaters and north pier were in good condition, while the south pier revealed cracks, settlement, and erosion of concrete and was considered in fair condition. It was noted that replenishment of riprap stone was required in some areas along the breakwater.

1980	Riprap stone was placed around the lakeward end of the north breakwater (Section Al) on the lakeside. The north and south pier connections underwent replenishment of stone in areas that had settled. The lakeward 55 ft of the south pier (Section I) and a 55-ft-long portion of Section J were rehabilitated. Precast concrete caps were installed.
1983- 1984	A 142-ft-long portion of the north breakwater (Figure 123, Section B) and a 124-ft-long portion of the south breakwater (Section A) were encased with steel sheetpiling, filled with stone, and capped with concrete. The remaining portions of Section B (north breakwater) and Section A (south breakwater) were encased with protection stone. Approximately 80,000 tons of stone was used, and the cost was approximately \$3,000,000.
1985	An inspection of the structures revealed them to be generally in good condition. Fill stone replenishment was recommended, however, at the lakeward heads of the breakwaters (Figure 123, Section Al). An aerial view of Holland Harbor Structures is shown in Figure 125.

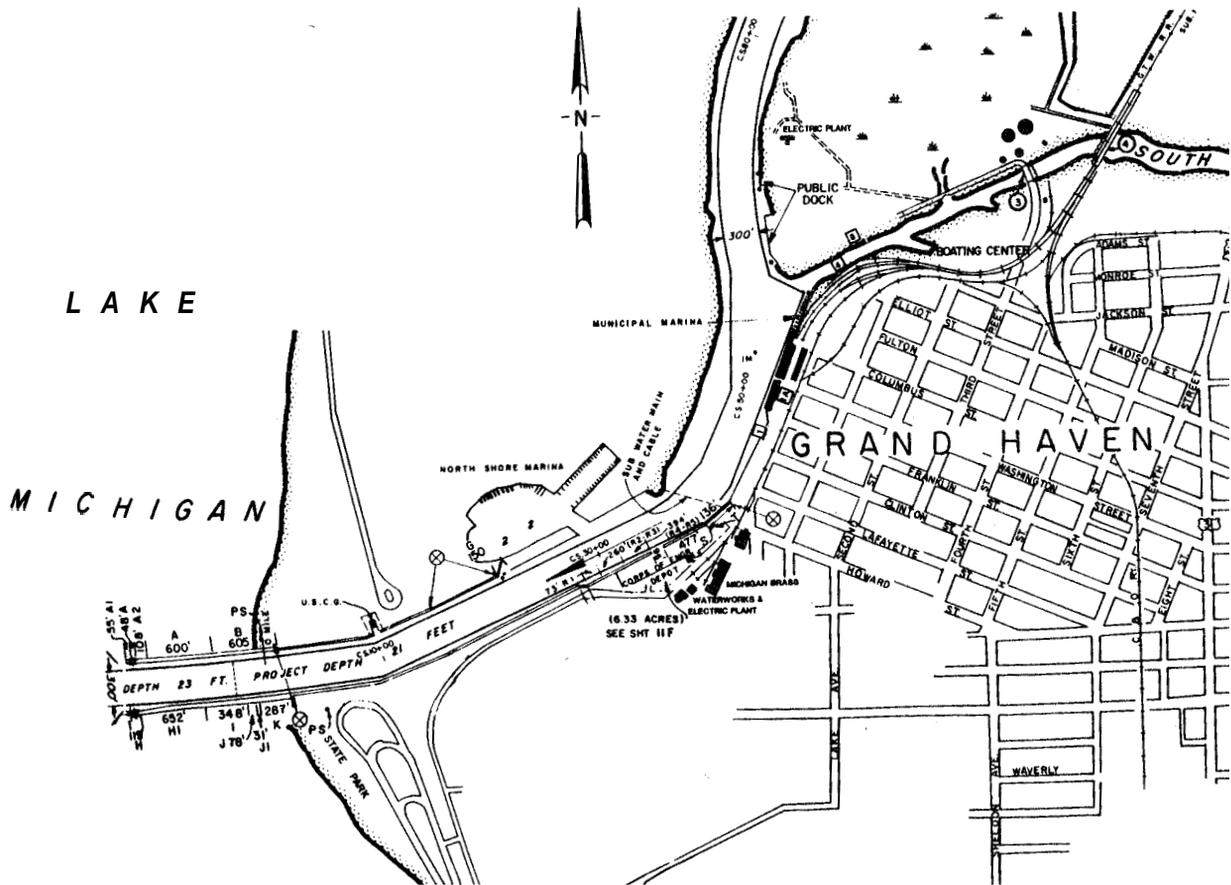
Figure 126. Grand Haven Harbor, Michigan

Date(s)	Construction and Rehabilitation History
1983	Additional riprap stone was placed along the north (Figure 126, Sections A and AI) and south (Section H) piers.
1985	A site inspection indicated the structures were generally in very good condition. An aerial photo of the Grand Haven Harbor Piers is shown in Figure 129.

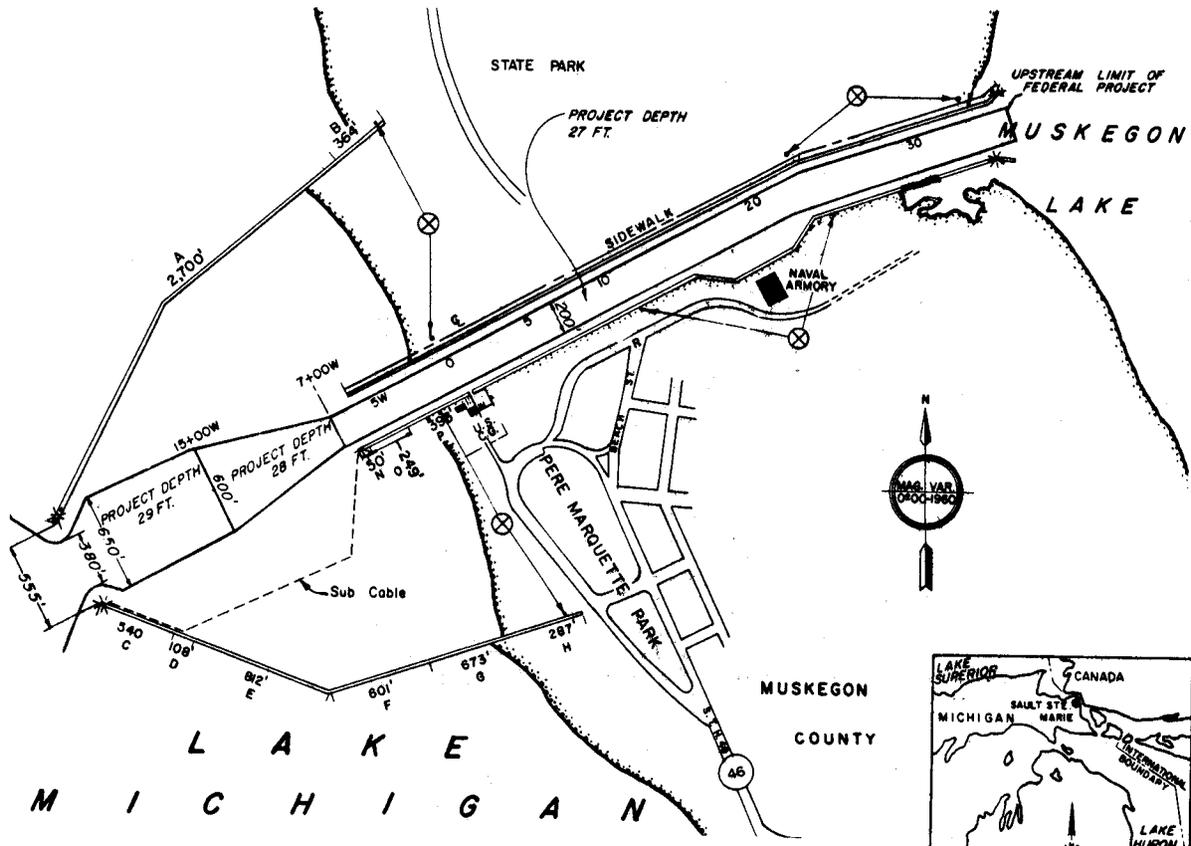
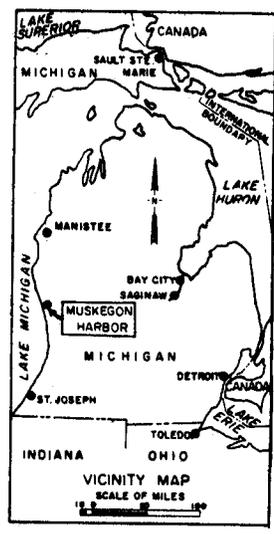
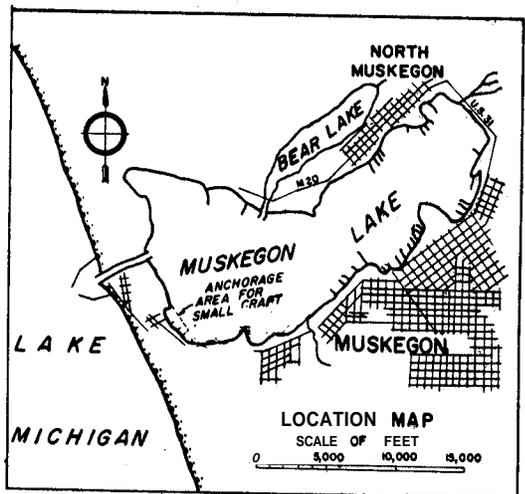
Figure 130. Muskegon Harbor, Michigan

1982	The stone at the head of the west breakwater (Figure 130) again was washed out, and approximately 1020 tons of 8- to 16-ton riprap stone was placed around the navigation light. Also added were 50 tons of 3- to 10-in. fill stone, 247 tons of 50- to 300-lb core stone, and 312 tons of 500-lb to 3-ton riprap to the north breakwater (Figure 130, Section A). Repairs to the head of the south breakwater (Section C) included the addition of 324 tons of 500-lb to 3-ton riprap as core stone along the lakeside face and 1,038 tons of 3- to 16-ton riprap around the breakwater head. In addition, 800 tons of 500-lb to 3-ton riprap stone was placed as toe protection along the channel side of the south pier.
1983	The north pier (Figures 130 and 131) was repaired with the placement of larger cover stone, and 8- to 12-ton riprap stone was placed around the navigation light at the head of the west breakwater (Figure 130).

1984	Major riprap placement at the south breakwater (Figure 130, Sections C, D, and E) for protection against waves and ice action was completed which involved approximately 86,770 tons of 10- to 26-ton cover stone (with stones as large as 49 tons in some areas). This placement encompassed the south breakwater head and both the lake and harbor sides. The stone was placed to an el of +8.0 ft lwd.
1986	Reconstruction of the head of the north breakwater was initiated and involved (Figure 130) removal of the existing cover and core stone and the placement of a steel sheetpiling with a concrete cap breakwater head structure. Also initiated was rehabilitation of the south breakwater concrete caps which are extensively spalled with large pieces cracked and broken off causing a hazard to the public. After these repairs, the structures will be in good condition. An aerial view of Muskegon Harbor structures is shown in Figure 133.

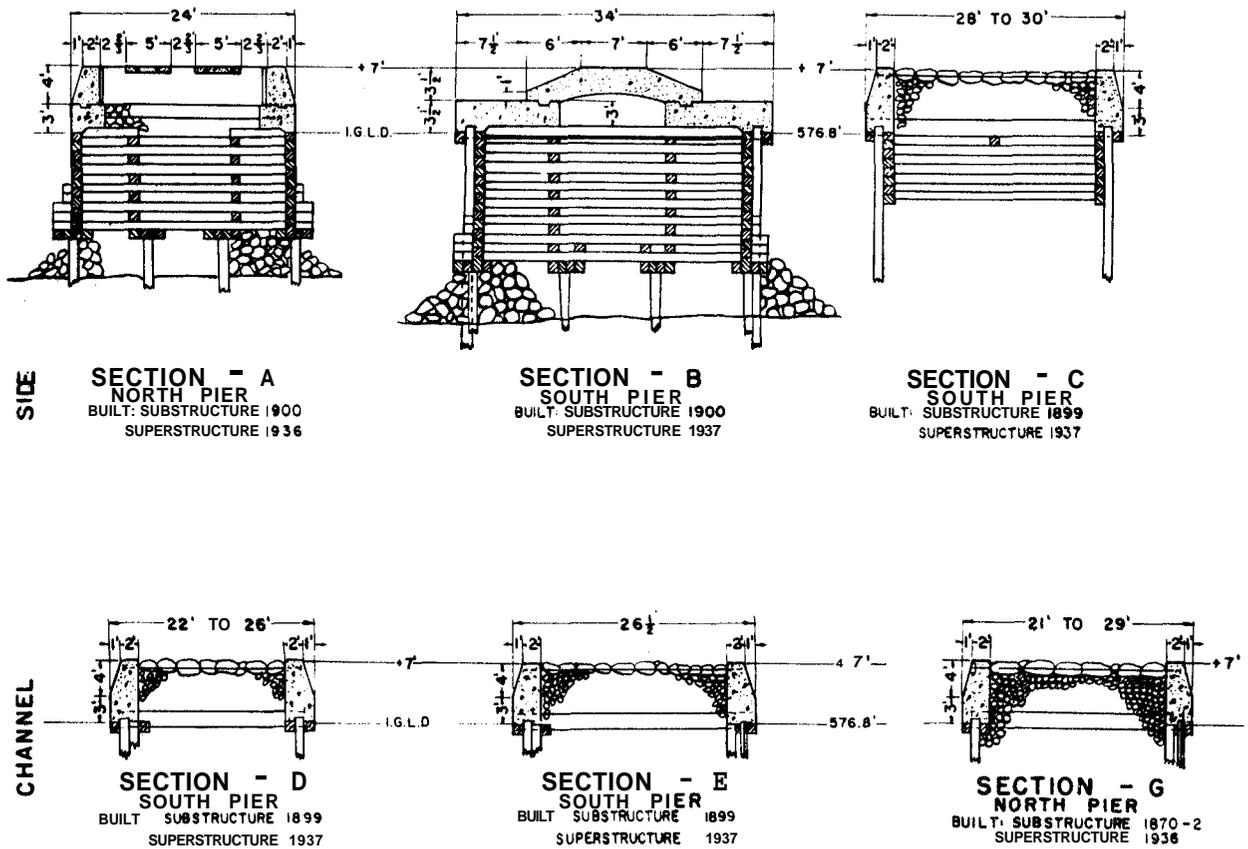
Figure 135. Typical pier cross sections, White Lake Harbor, Michigan

1936-1937	The north and south piers were capped with concrete and stone superstructures (Figure 135, Sections A-E and G). The crest elevations of the pier were +7.0 ft lwd.
1971	Fill stone was replenished in the shoreward portion of the north pier (Figure 134, Section G). An underwater examination of the lakeside of the south pier revealed signs of deterioration of the timber piling along Sections C and D (Figure 134) and fill stone being washed out between these pilings.
1982	Fill stone was replenished in the lakeward portion (Figure 134, Section A) of the north pier and the south pier (Figure 134, Section B). Riprap stone around the head of the south pier (Section B) also was placed.
1983	Riprap stone around the heads and along the lake and channel sides of Section A (Figure 134) was placed. In addition, stone fill was again placed in open pockets of the superstructures of this portion of the pier and grouted over.

1985	An inspection of the structures indicated that the substructures of both piers are deteriorating, resulting in superstructure settlement and cracking, considerable misalignment and tilt, and loss of fill stone. Both structures are considered to be in poor condition, Reconstruction and/or rehabilitation has been recommended within the next 2 to 3 years.

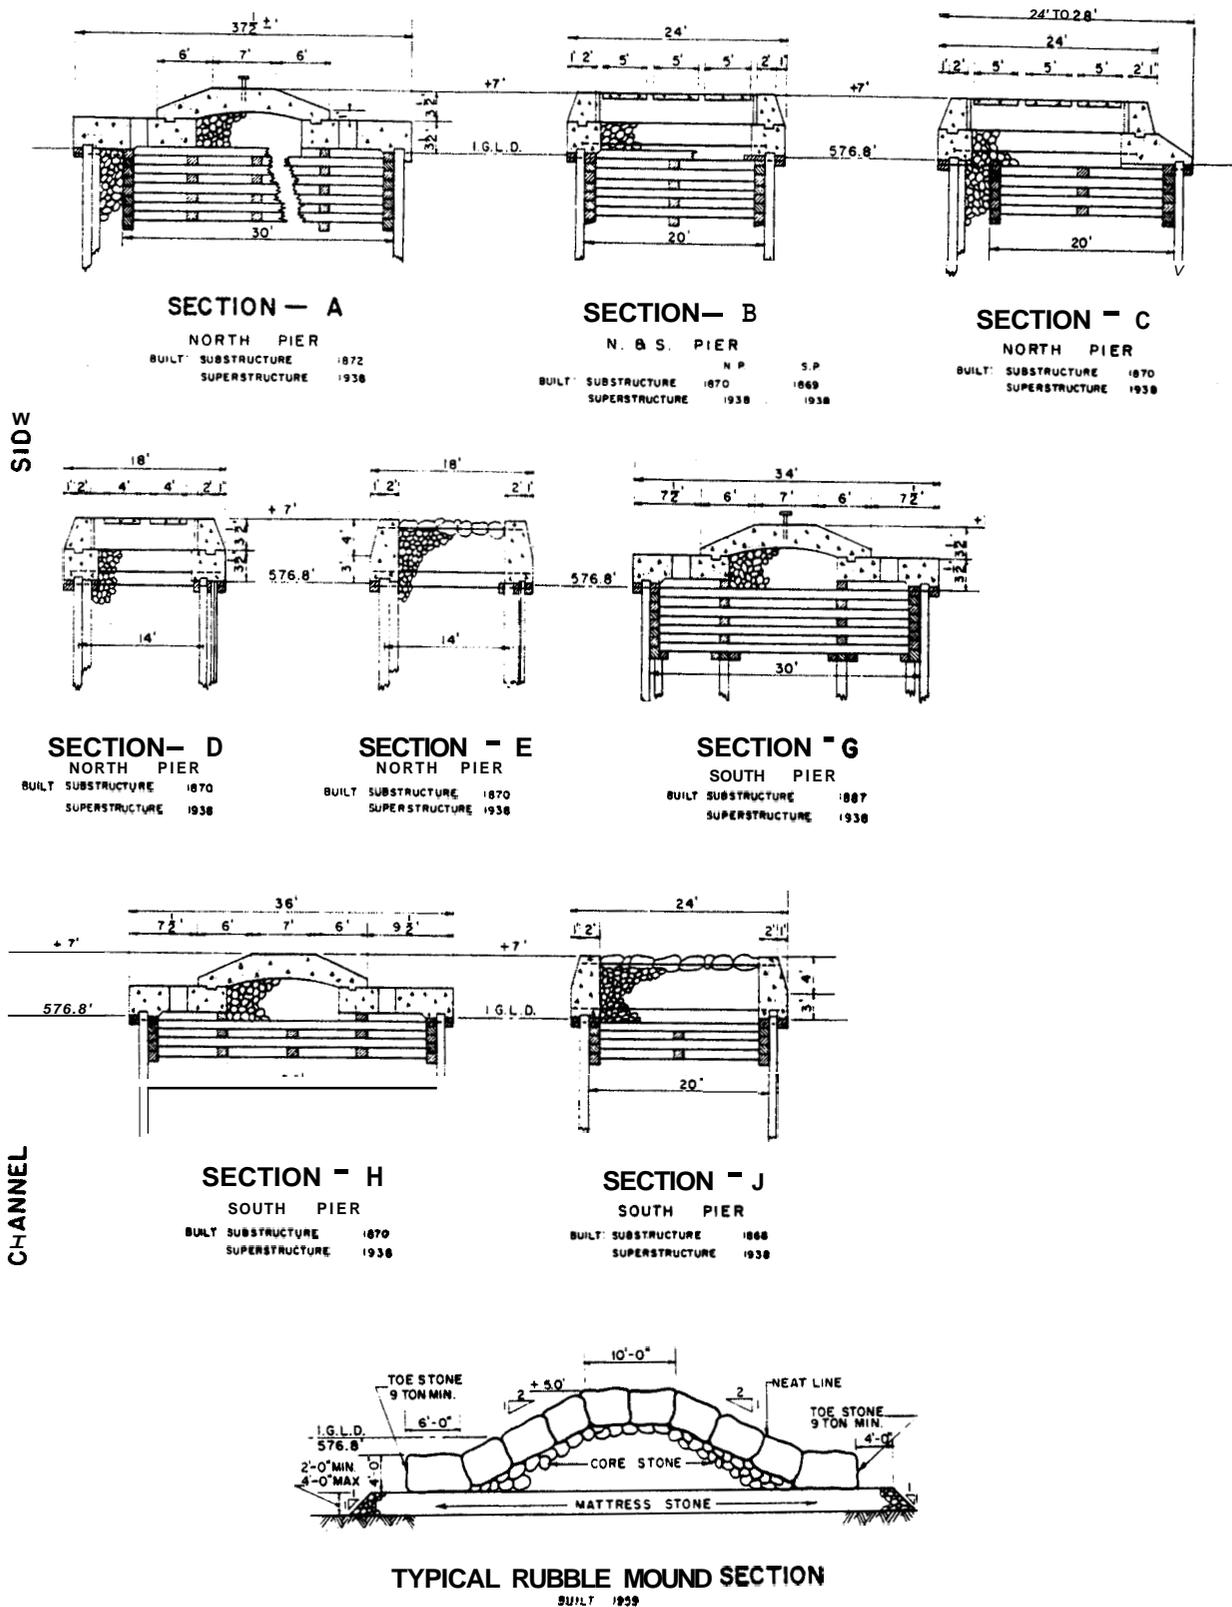
Figure 137. Typical structure cross sections, Pentwater Harbor, Michigan

1985 A site inspection of the structures indicated that the rubble-mound extension of the north pier (Figure 136) has settled up to 1 ft throughout. The remaining portions of the north pier (Sections A, B, C, D, and E) and the south pier (Sections G, H, B, and J) are bulging, tilting, leaning, cracked and misaligned. These factors, along with loss of fill stone, indicate substructure deterioration. The structures are considered in poor condition; however, major rehabilitation has been recommended and is scheduled for 1987. An aerial view of the Pentwater Harbor piers is shown in Figure 138.

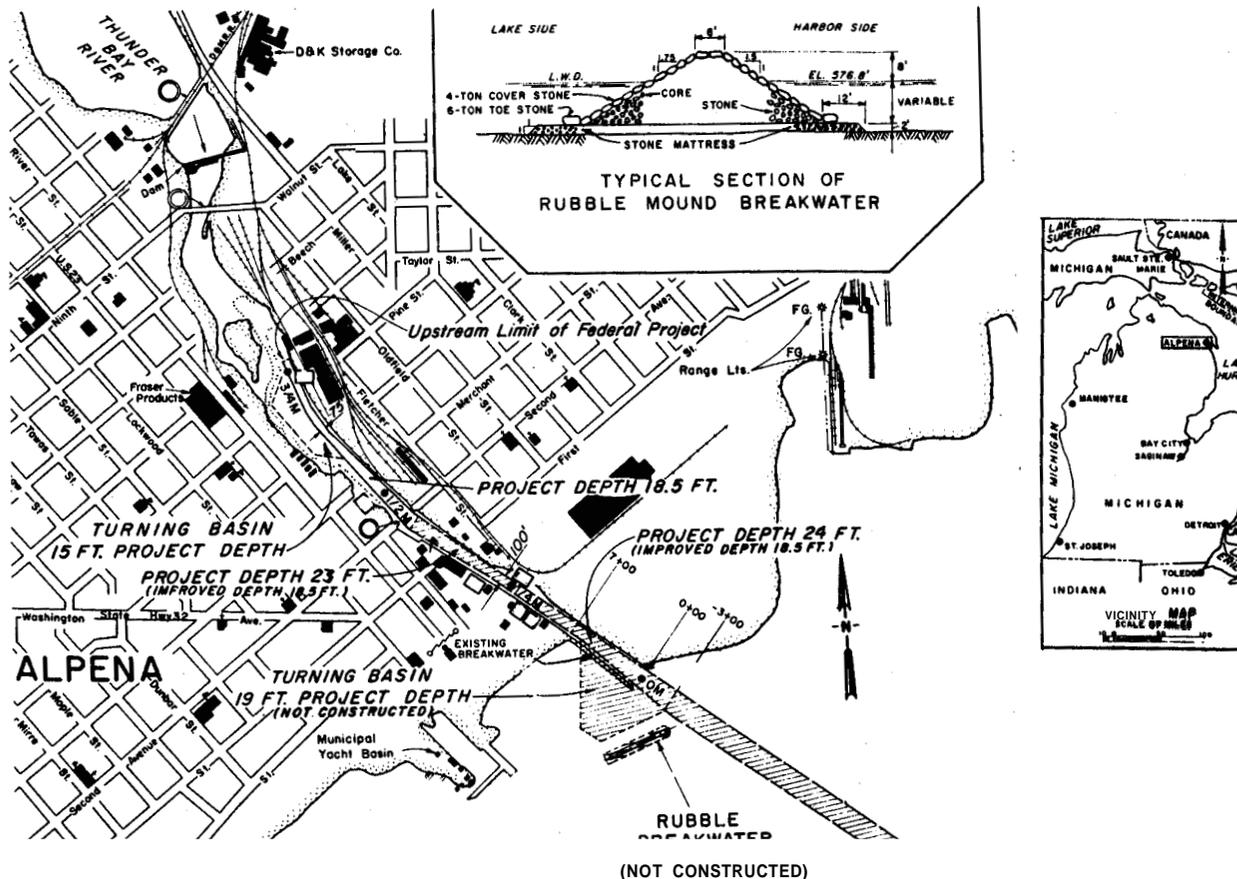
Figure 178. Alpena Harbor, Michigan

Date(s)	Construction and Rehabilitation History
1939	A 750-ft-long rubble-mound breakwater (Figure 178) was constructed from the shore extending parallel to the entrance channel.
1965	The project was modified, which entailed removal of the existing breakwater and construction of a new 550-ft-long offshore rubble breakwater. The new structure would include an 8-ft crest width, 4-ton cover stone, a crest el of +8 ft lwd, and 1-V:1.5-H side slopes on the harbor side with 1-V:1.75-H side slopes on the lakeside (Figure 178).
1969	The 1965 modification to the project was reclassified into an inactive status based on an unfavorable benefit-to-cost ratio.
1986	The existing breakwater has never undergone maintenance during its lifetime and is considered presently to be in good condition.

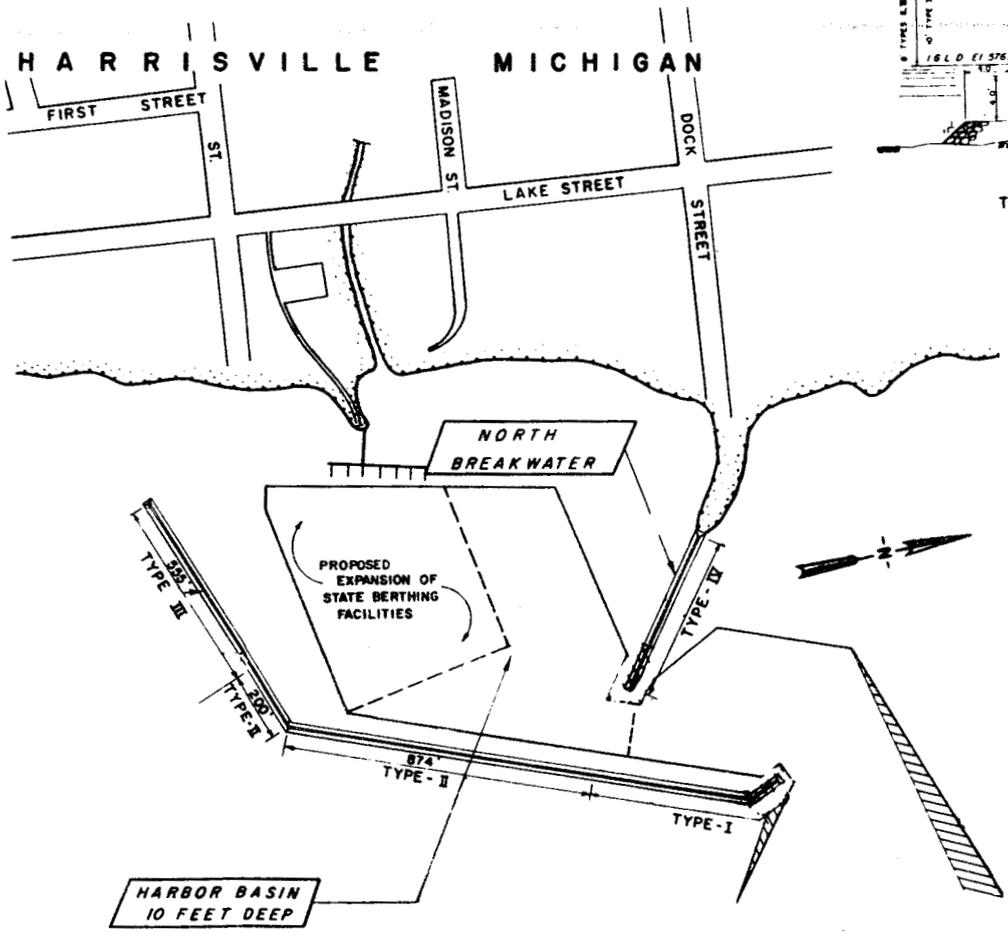
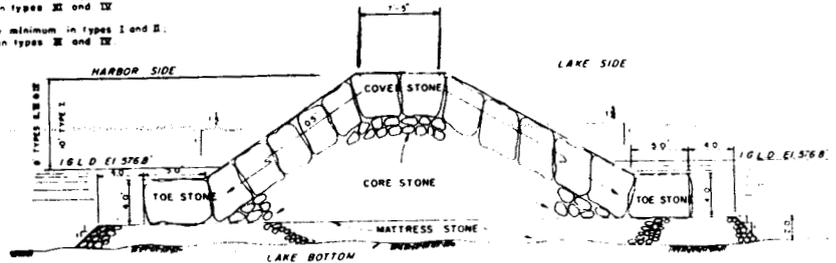
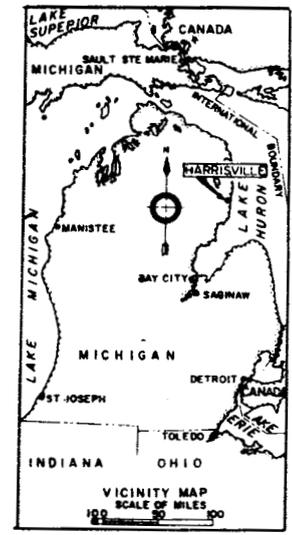
Figure 179. Harrisville Harbor, Michigan

<u>Date(s)</u>	<u>Construction and Rehabilitation History</u>
1959	Construction of a 360-ft-long north breakwater and a 2,170-ft-long south breakwater was completed (Figure 179). The breakwater was constructed of rubble-mound materials with cover stones ranging to 3 (min) and 5 tons (min) for Types III and IV and Types I and II structures, respectively (Figure 179). The lakeward end of the south breakwater (Type I) had a crest el of +10 ft lwd, and the remaining portions of the structure (Types II, III, and IV) had a crest el of +8.0 ft lwd. The crest width was about 7.5 ft; and side slopes on the lakeside of the breakwaters were 1V:1.75H, while side slopes on the harbor side were 1V:1.5H. Toe stone ranged from 5 tons (min) in Types III and IV to 7 tons (min) in Types I and II.
1971	Replenishment of cover stone on the breakwaters was accomplished.
1984	An inspection of the breakwaters revealed some winter storm damage since several cover stones were missing. An estimated 80 tons of stone would be required to repair the breakwaters.

1985	Extensions of the north and south breakwaters of approximately 140 and 110 ft, respectively, were completed (Figure 179, hatched ends) for a cost of over \$433,000. Cover stones up to 9.5 tons were used.
1986	The breakwaters, presently, are considered in fair condition. An aerial photo of the Harrisville Harbor breakwaters (prior to breakwater extensions) is shown in Figure 180.

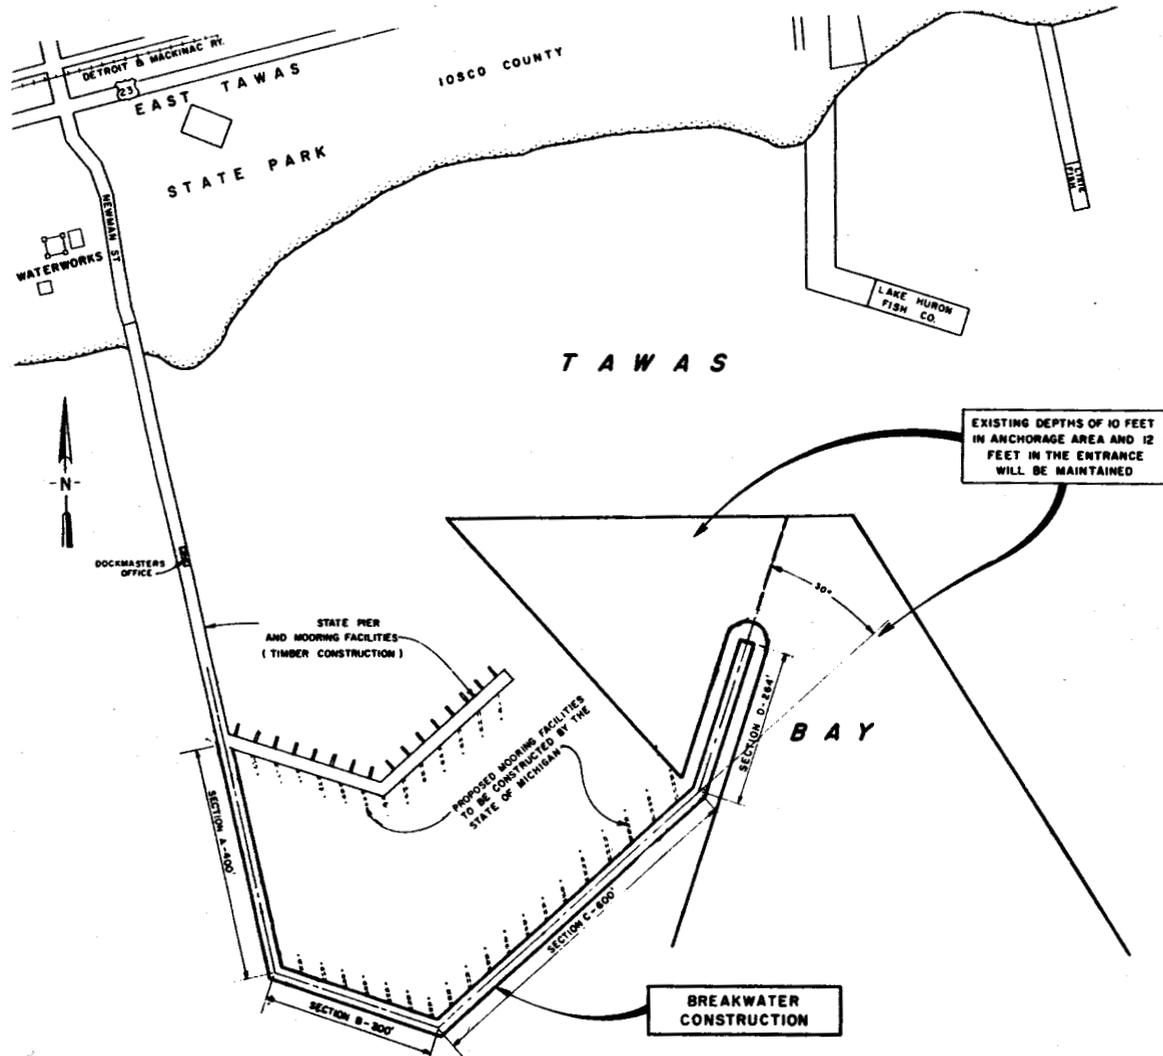
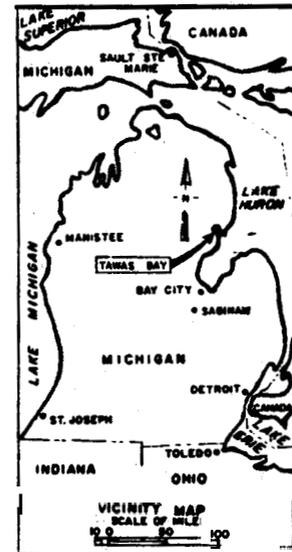
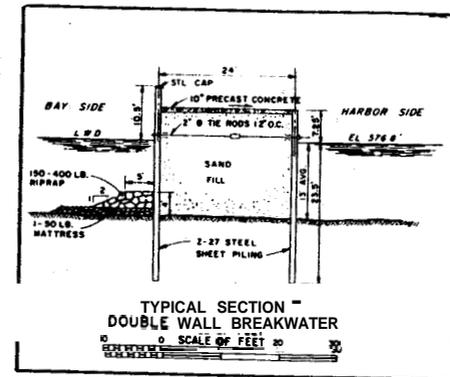
Figure 184. Tawas Bay Harbor, Michigan

t (s)	Constructi	and	itati	ry
7	Construction of four cast sections of an existing length of 4 ft (Figure 184) extending from an existing timber pile- owned breakwater. The breakwater was extended to form a structure 2 ft in width. The structure was filled and capped with precast concrete at a crest level of +7.25 ft. The sheetpiling was extended to an elevation of +10.5 ft on the bay side. Riprap from 400 lb was placed on the bay side (Figure 184).			
1985	An inspection of the site indicated the breakwater to be in very good condition. No maintenance has been performed on the breakwater since its construction. An aerial photograph of the Tawas Harbor breakwater is shown in Figure 185.

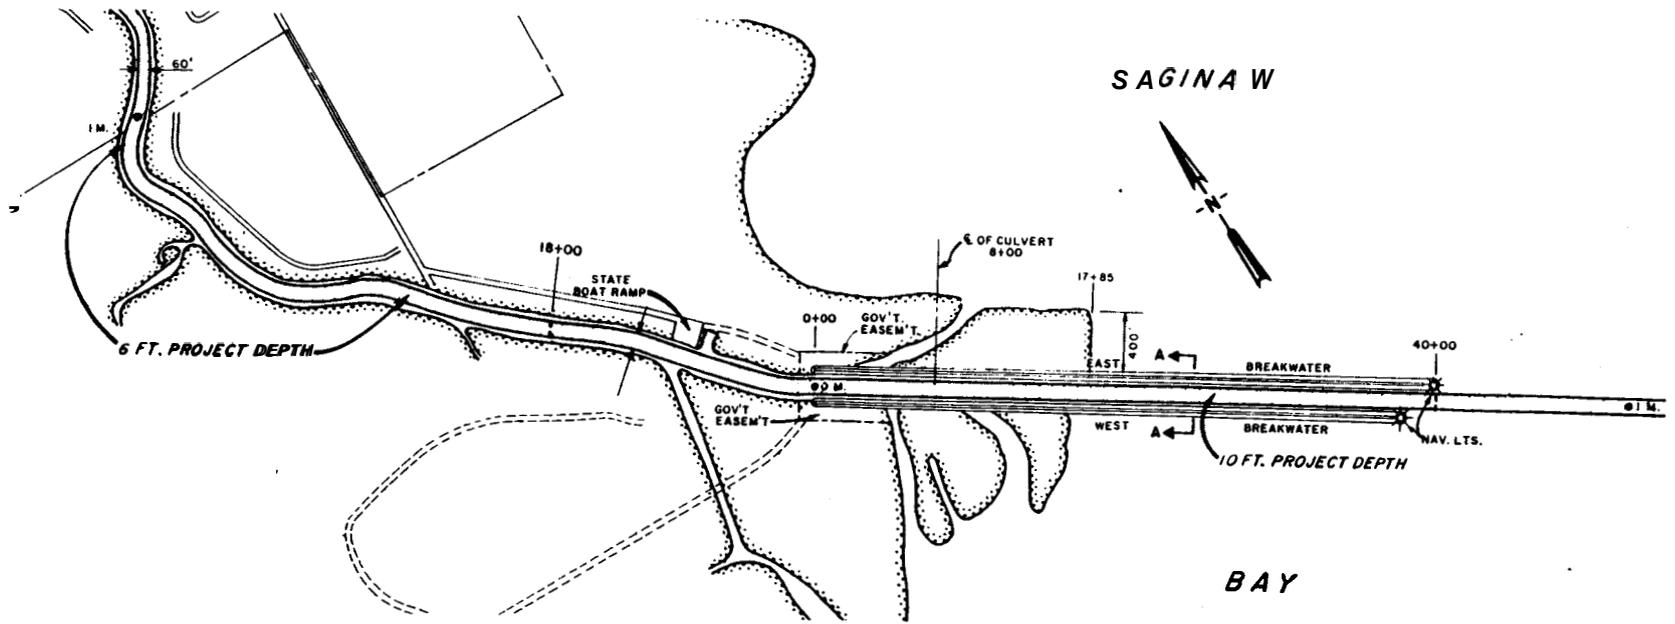
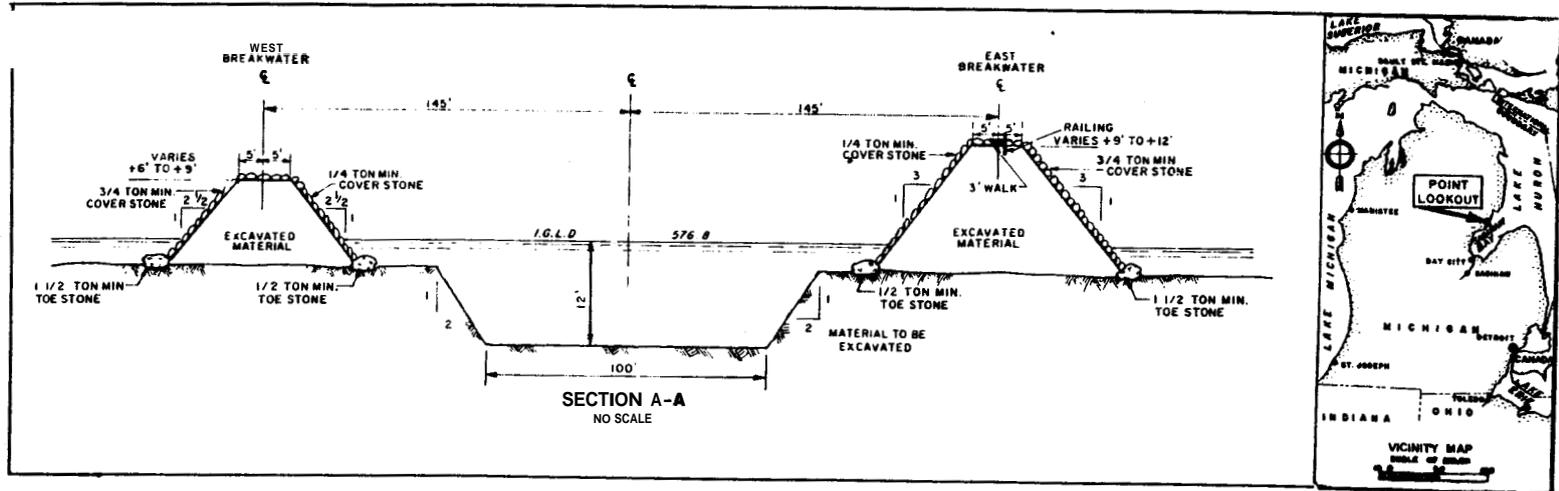
Figure 186. Point Lookout Harbor, Au Gres, Michigan

Date(s)	Construction and Rehabilitation History
1972	Construction of a 4,000-ft-long east and a 3,800-ft-long west breakwater was completed. The breakwaters were rubble-mound structures extending parallel into Saginaw Bay (Figure 186). They consisted of cover stone laid on excavated material. Cover stone on the channel sides consisted of 1/4-ton (min) material, and cover stone on the bay sides of the breakwaters consisted of 3/4-ton (min) material. The breakwaters had 10-ft crest widths and side slopes of 1V:3H for the east breakwater and 1V:2.5H for the west structure. The crest el of the east breakwater ranged from +9 to +12 ft lwd, and the west breakwater had a crest el ranging from +6 to +9 ft lwd (Figure 186).
1976	Approximately 1,300 tons of cover stone (1,500-300 lb) was placed along the bay side of the east breakwater in critical areas to prevent failure of the structure.
1978	Approximately 500 tons of cover stone (3/4 to 1 ton) was placed along the bay side of the west breakwater in areas to maintain stability and prevent failure.

1986	Stone was placed at the harbor, and the structures are currently in good condition. An aerial photograph (photo taken in 1981) of the Point Lookout Harbor breakwaters is shown in Figure 187.

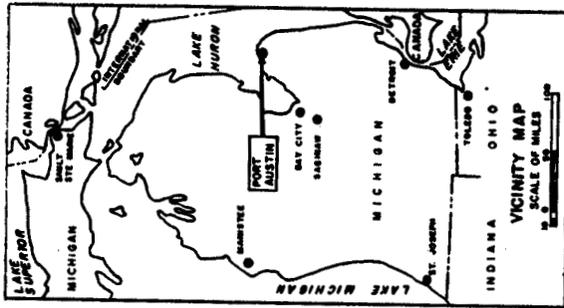
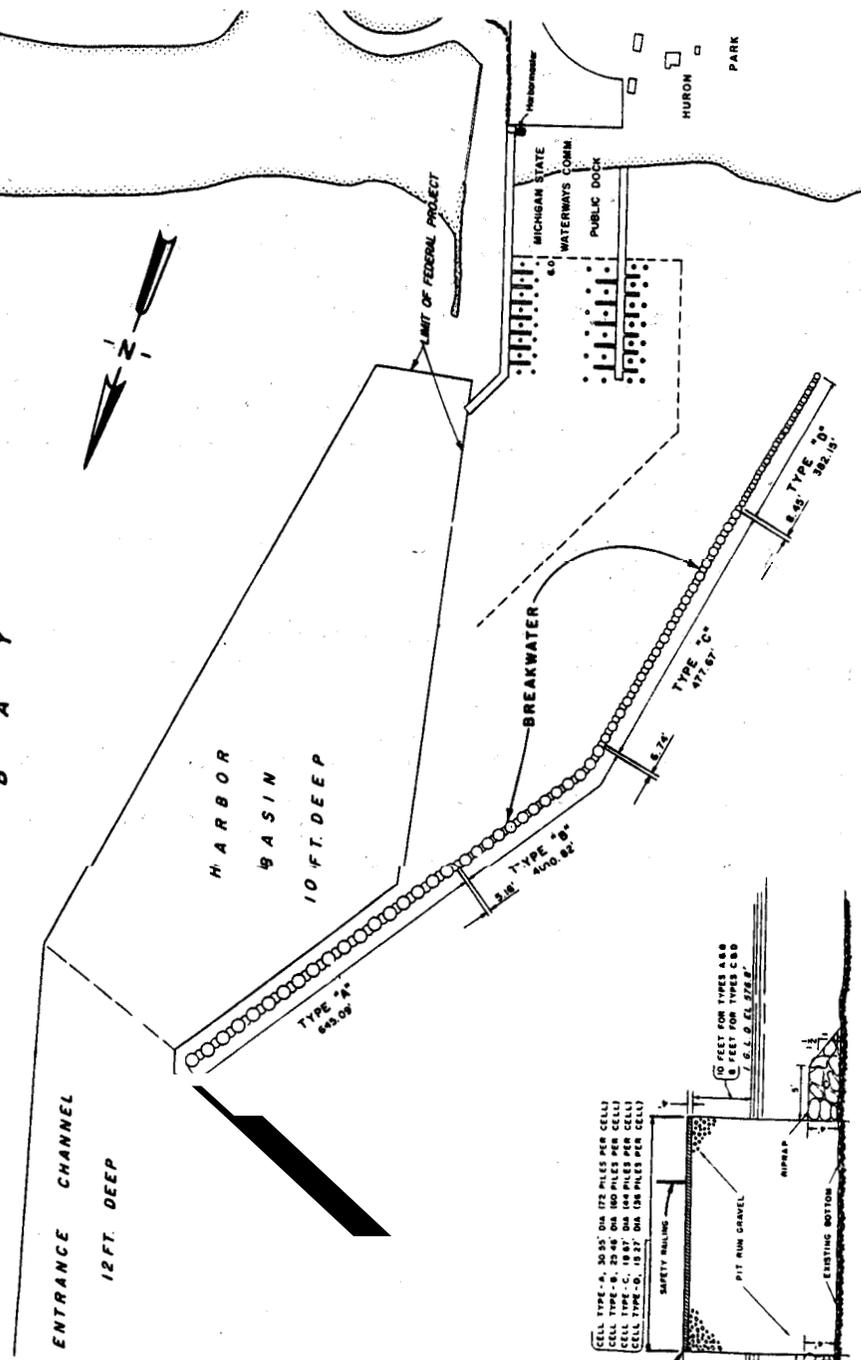
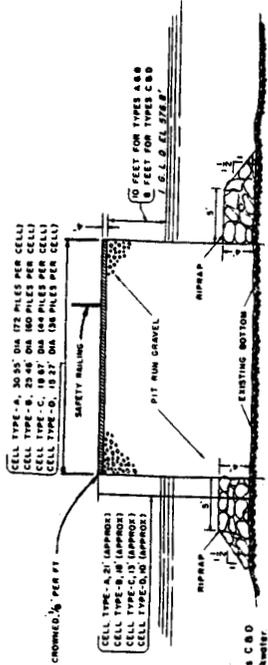
Figure 190. Port Austin Harbor, Michigan

Date(s)	Construction and Rehabilitation History
1959	Construction of a 1,926-ft-long offshore breakwater (Figure 190) was completed. The breakwater was built with cellular steel sheetpiling which ranged from 15.3 (Type D) to 30.4 ft (Type A) in diameter (Figure 190). The cells were filled with sand and gravel and crowned with a bituminous cap. The crest el of the breakwater was +10 ft lwd for Types A and B and +8 ft lwd for Types C and D. Riprap was placed along the sides of the cellular breakwater except on the harbor side of Types C and D.
1979	The lakeward cells (Types A and B) were replenished with stone and capped with concrete.
1983	The shoreward cells (Types C and D) revealed hairline cracks in the asphalt which were sealed. Caulking of construction joints in the breakwater also was performed.
1986	A safety railing was installed on the structure. The breakwater is considered to be in good condition; however, some construction joints are separating and require repairs. An aerial view of the Port Austin breakwater is shown in Figure 191.

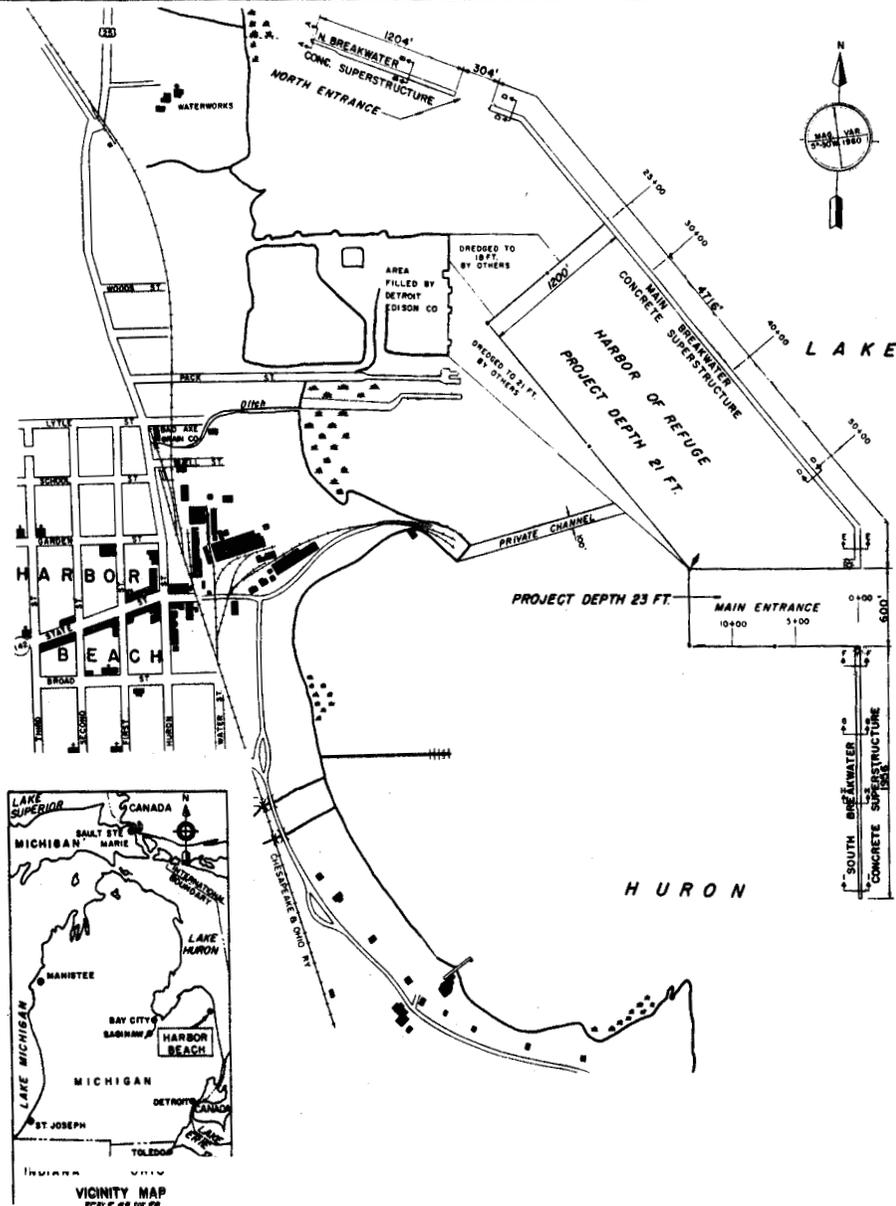
Figure 192. Harbor Beach, Michigan

Date(s)	Construction and Rehabilitation History
1874- 1885	Construction of a 1,204-ft-long north breakwater, a 4,716-ft-long main breakwater, and a 1,956-ft-long south breakwater (Figure 192) was completed during this period. The breakwaters were constructed with stone-filled timber cribs which ranged from 16 to 38 ft in width (Figure 193).
1905- 1909	The main breakwater was capped with a stone and concrete superstructure (Figure 193, Cross Sections D-D and E-E). The superstructure included a parapet that had a crest el of +16.5 ft lwd.
1911- 1912	The north breakwater was capped with a concrete superstructure (Figure 193, Cross Sections A-A and B-B). The breakwater crest el was established at +8.0 ft lwd.
1916- 1917	The south breakwater was capped with a concrete superstructure (Figure 193, Cross Sections F-F through I-I). The crest el of most of the structure was +8.0 ft lwd, but the northern end of the breakwater (Cross-Section F-F) included a parapet with an el of +14 ft lwd.

Date(s)	Construction and Rehabilitation History
1981	Riprap was replenished along portions of the north breakwater, and cracks in the superstructure were repaired.
1985	An inspection of the site indicated the structures are in need of major rehabilitation. The timber cribbing of the substructures is collapsing under the weight of the concrete superstructures resulting in shifting and cracking of the superstructure. The breakwaters are considered to be in poor condition, and major rehabilitation has been recommended for the harbor to maintain its protective status. An aerial view of the Harbor Beach breakwaters is shown in Figure 194.

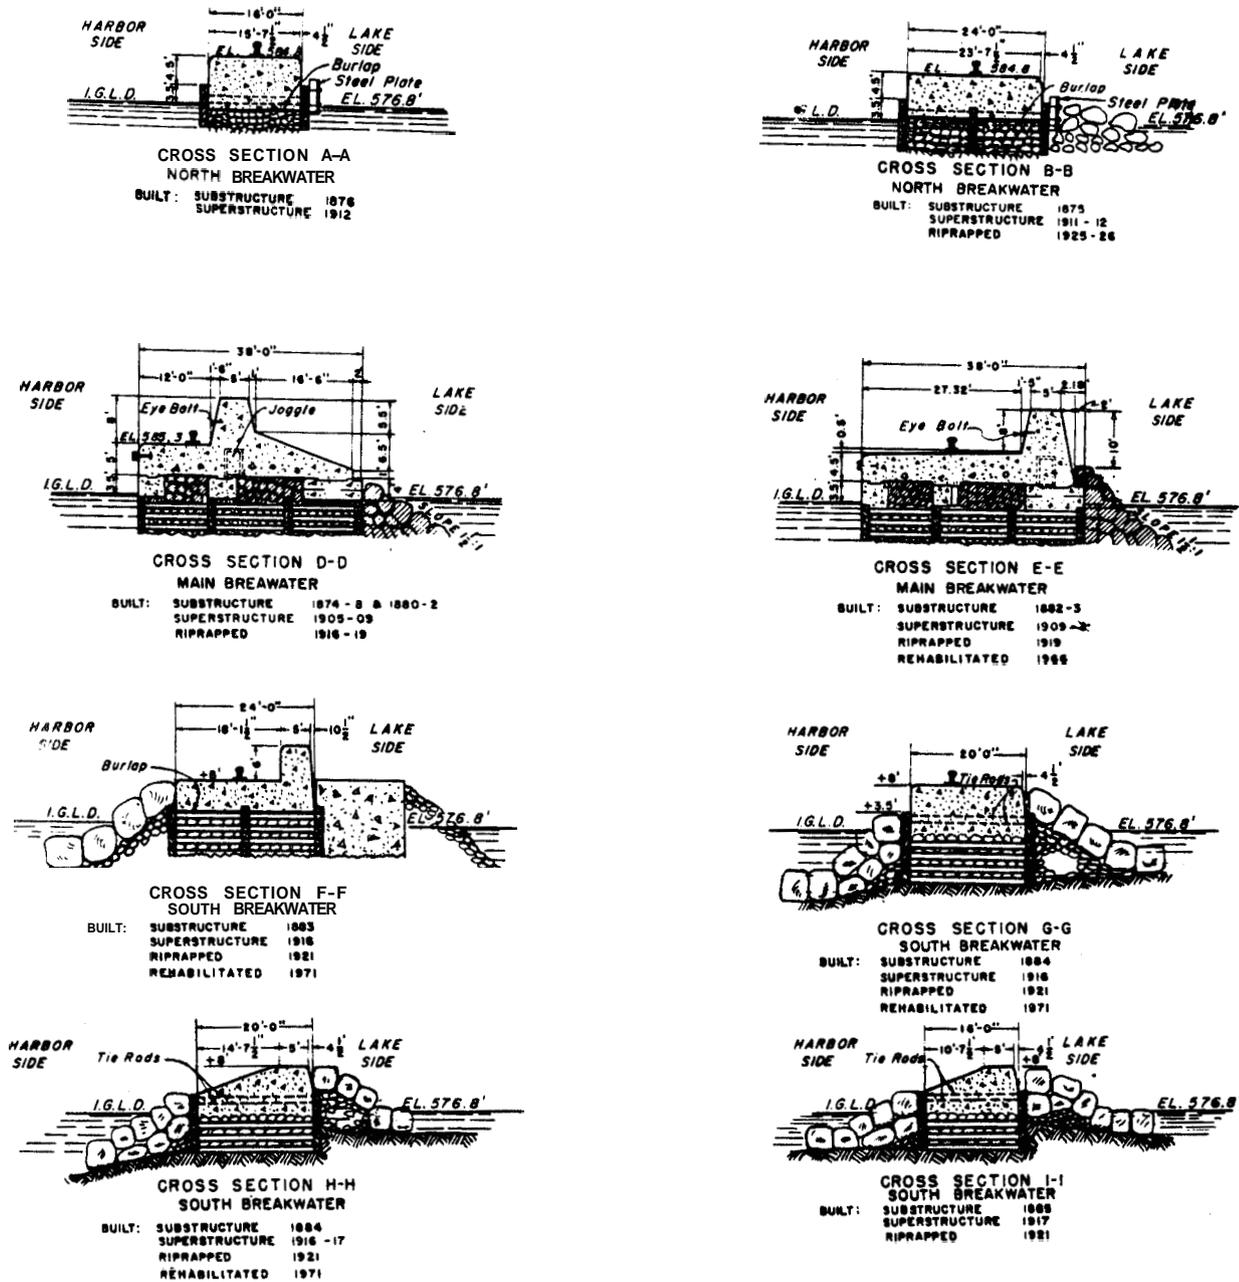
Figure 193. Typical breakwater cross sections, Harbor Beach, Michigan

1916- 1919	Riprap was placed on the lakeside of the main breakwater (Figure 193, Cross Sections D-D and E-E). It was placed on a 1-V:1.5-H slope with a crest ranging from about +3 ft lwd (Cross Section D-D) to +6.5 ft lwd (Cross Section E-E).
1921	Riprap was placed on each side of the south breakwater (Figure 193, Cross Sections F-F through I-I). The crest of the riprap on the lakeside was +8.0 ft lwd, and on the harbor side it was at an el of +3.5 ft lwd.
1925- 1926	Riprap was placed on the lakeside of a portion of the north breakwater (Figure 193, Cross Section B-B) to an el of about +3.5 ft lwd.
1966	Rehabilitation of the south end of the main breakwater (Figure 192, Cross Section E-E) was performed. Work consisted of replenishing stone fill and repairing cracks in the substructures. Cost of the repairs was about \$172,000.
1971	Rehabilitation of portions of the south breakwater (Figure 192, Cross Sections F-F through H-H) was completed. Riprap protection which included a total of approximately 38,500 tons of stone (ranging from 6 to 15 tons each) was performed for about \$676,000.
