TECHNICAL REPORT REMR-CO-3

CASE HISTORIES OF CORPS BREAKWATER  
AND JETTY STRUCTURES

Report 5

NORTH ATLANTIC DIVISION

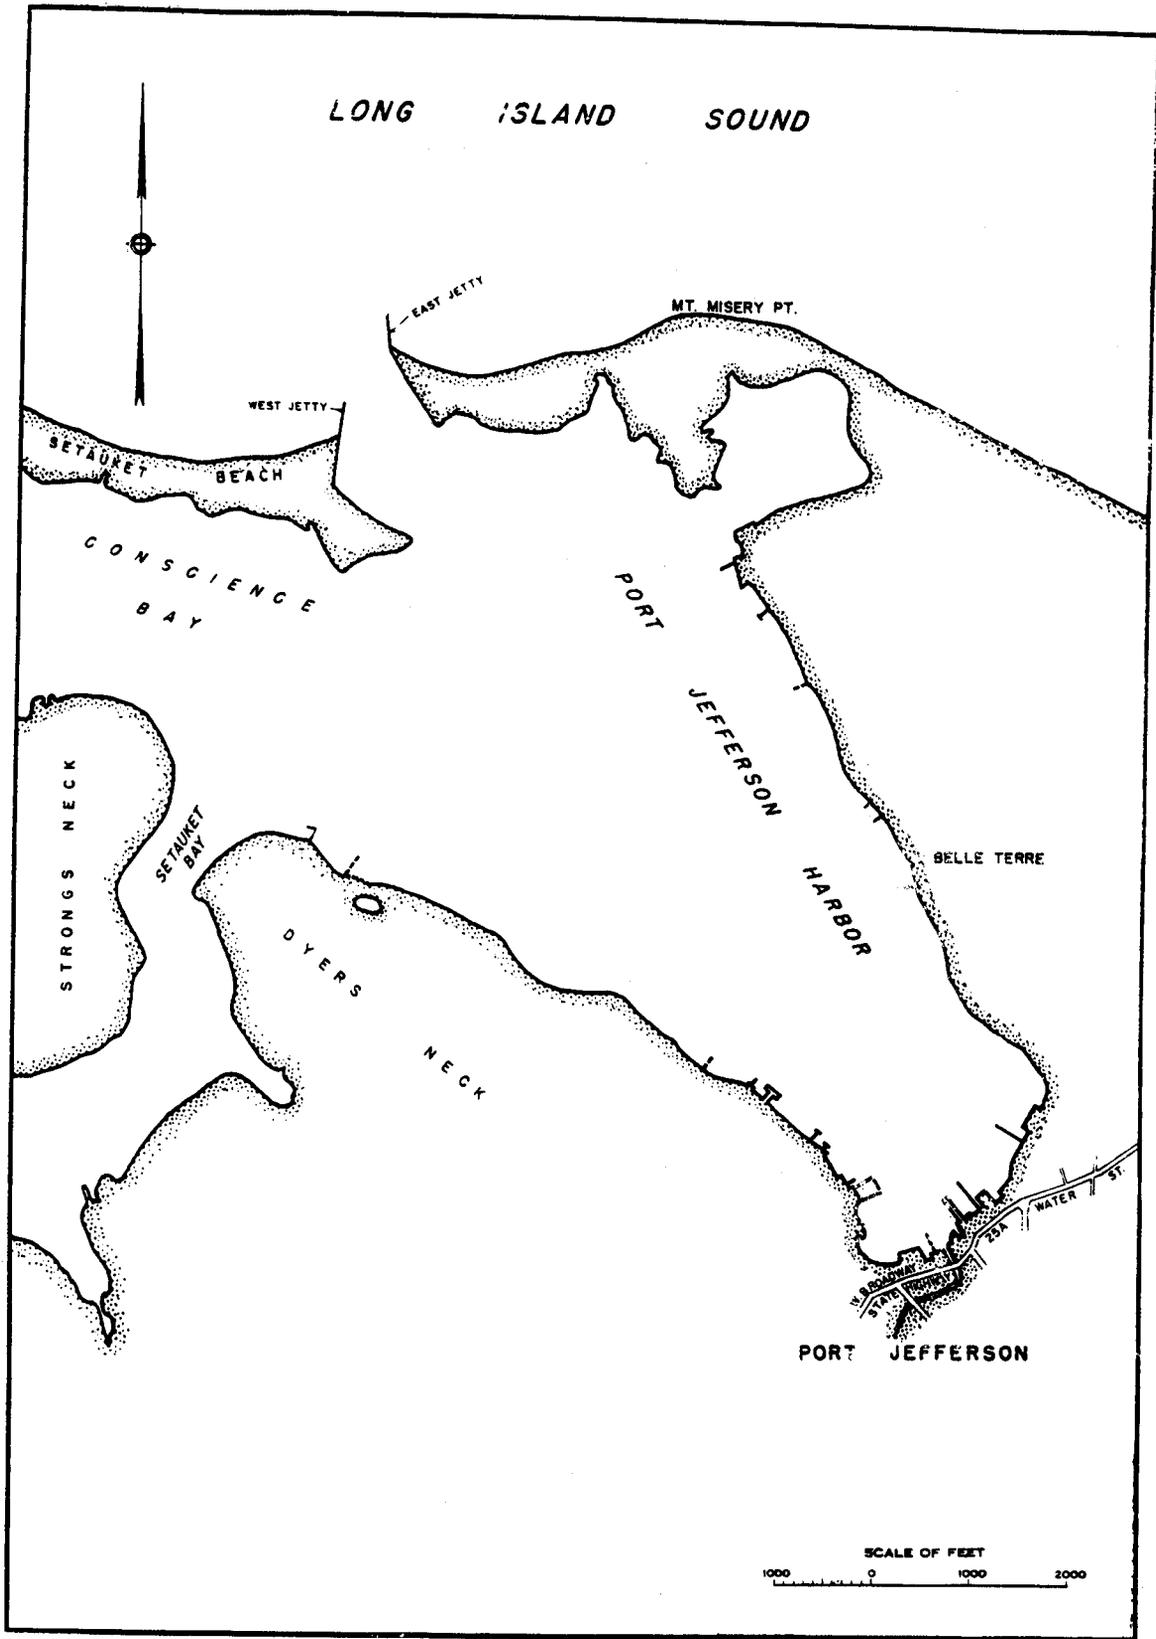
Figure 12. Port Jefferson Harbor, New York

1891	The east jetty was repaired over 600 ft with 1,464 tons of stone.
1908	The east jetty was extended to 1,550 ft (Figure 12).
1964	A survey indicated the jetties were in poor condition.
1986	No further repair or maintenance information has been found.

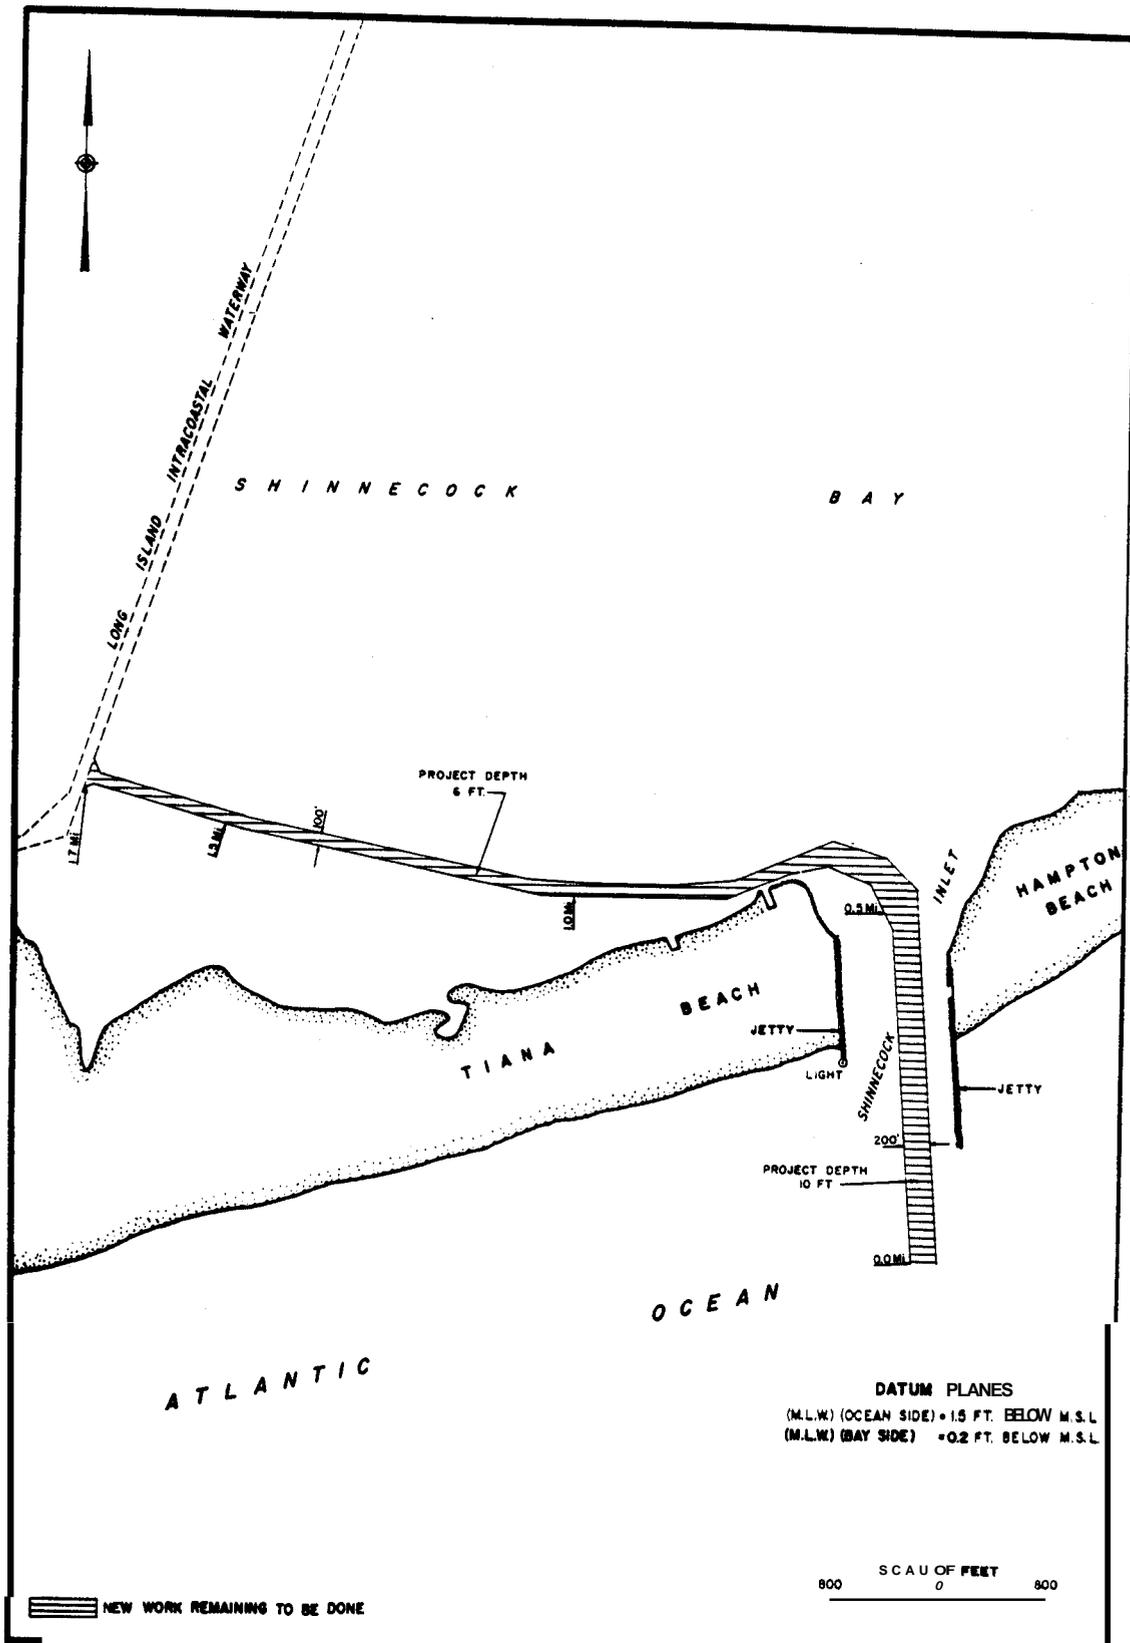
Figure 17. Shinnecock Inlet, New York

1956	A survey revealed that the east jetty had suffered severe damage. Capstones and slope stones had slipped and were disarranged in numerous spots. Core stones were washed out in several places. Capstones and core stones were washed out in four locations totaling 150 ft. The outer 250 ft of the jetty was partly washed out. Beach and dunes adjacent to the jetty eroded, and waves rode over the dunes and flanked the jetty. The west jetty was in fair condition with minor slips and disarrangement in five spots. The inlet was in a shoal condition. Most of the damage was due to a hurricane in 1954.
1982	The west jetty was reconstructed by resetting cap stones to original design geometry over 170 ft. A 1,470-ft-long pile crib revetment on the north end of the west jetty was replaced by a rubble-mound jetty. (Figure 18).
1985	A survey revealed that the reconstructed portion of the west jetty was in good condition. The seaward 200 ft of the west jetty had unraveled and capstones were scattered. The west jetty head had not maintained design configuration. Stones on the inlet side of the east jetty had sloughed in some sections, but stones on the beach side had retained their original position. Two areas on the northern end were completely deteriorated. Erosion of sand caused undermining of the east jetty with continual loss of sand undermining it further.

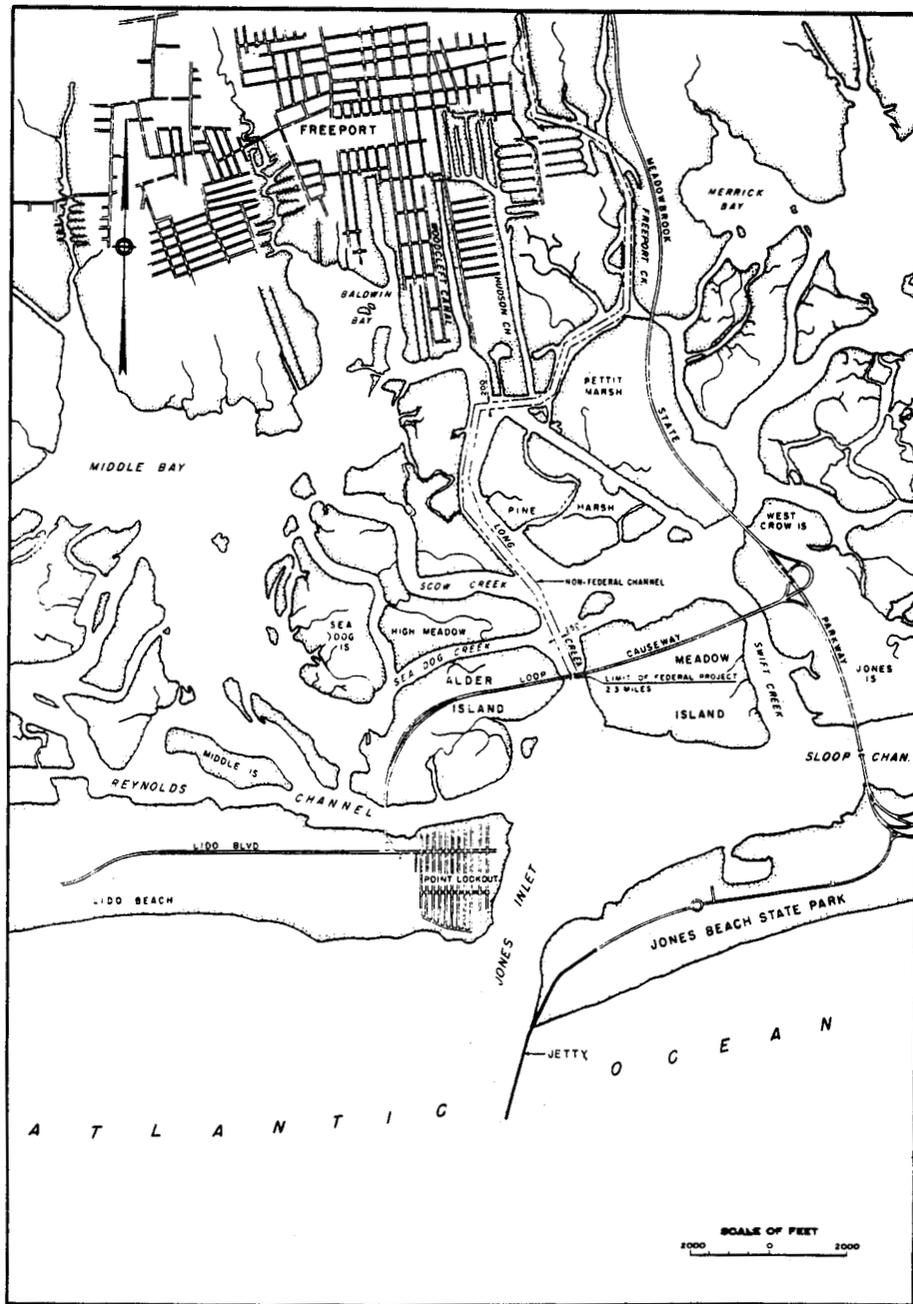
Figure 22. Jones Inlet, New York

<b>1962</b>	The Middle Atlantic coastal storm of 6-8 March 1962 damaged the jetty. The outer 200 ft was raveled and broken down to the high water level. A second layer of capstone was added to the outer 120 ft to restore the original design. The adjacent 1,080 ft shoreward was repaired by replacing armor stone and by adding stone. Armor stone was replaced on the adjacent 900 ft shoreward.
<b>1985</b>	The jetty had nearly reached impoundment. Sand was bypassing the jetty, mostly through large voids at the jetty-shoreline intersection. The apron had settled approximately 7.0 ft at the seaward end due to sand loss through voids in the apron.
<b>1986</b>	No further repair or maintenance information has been found.

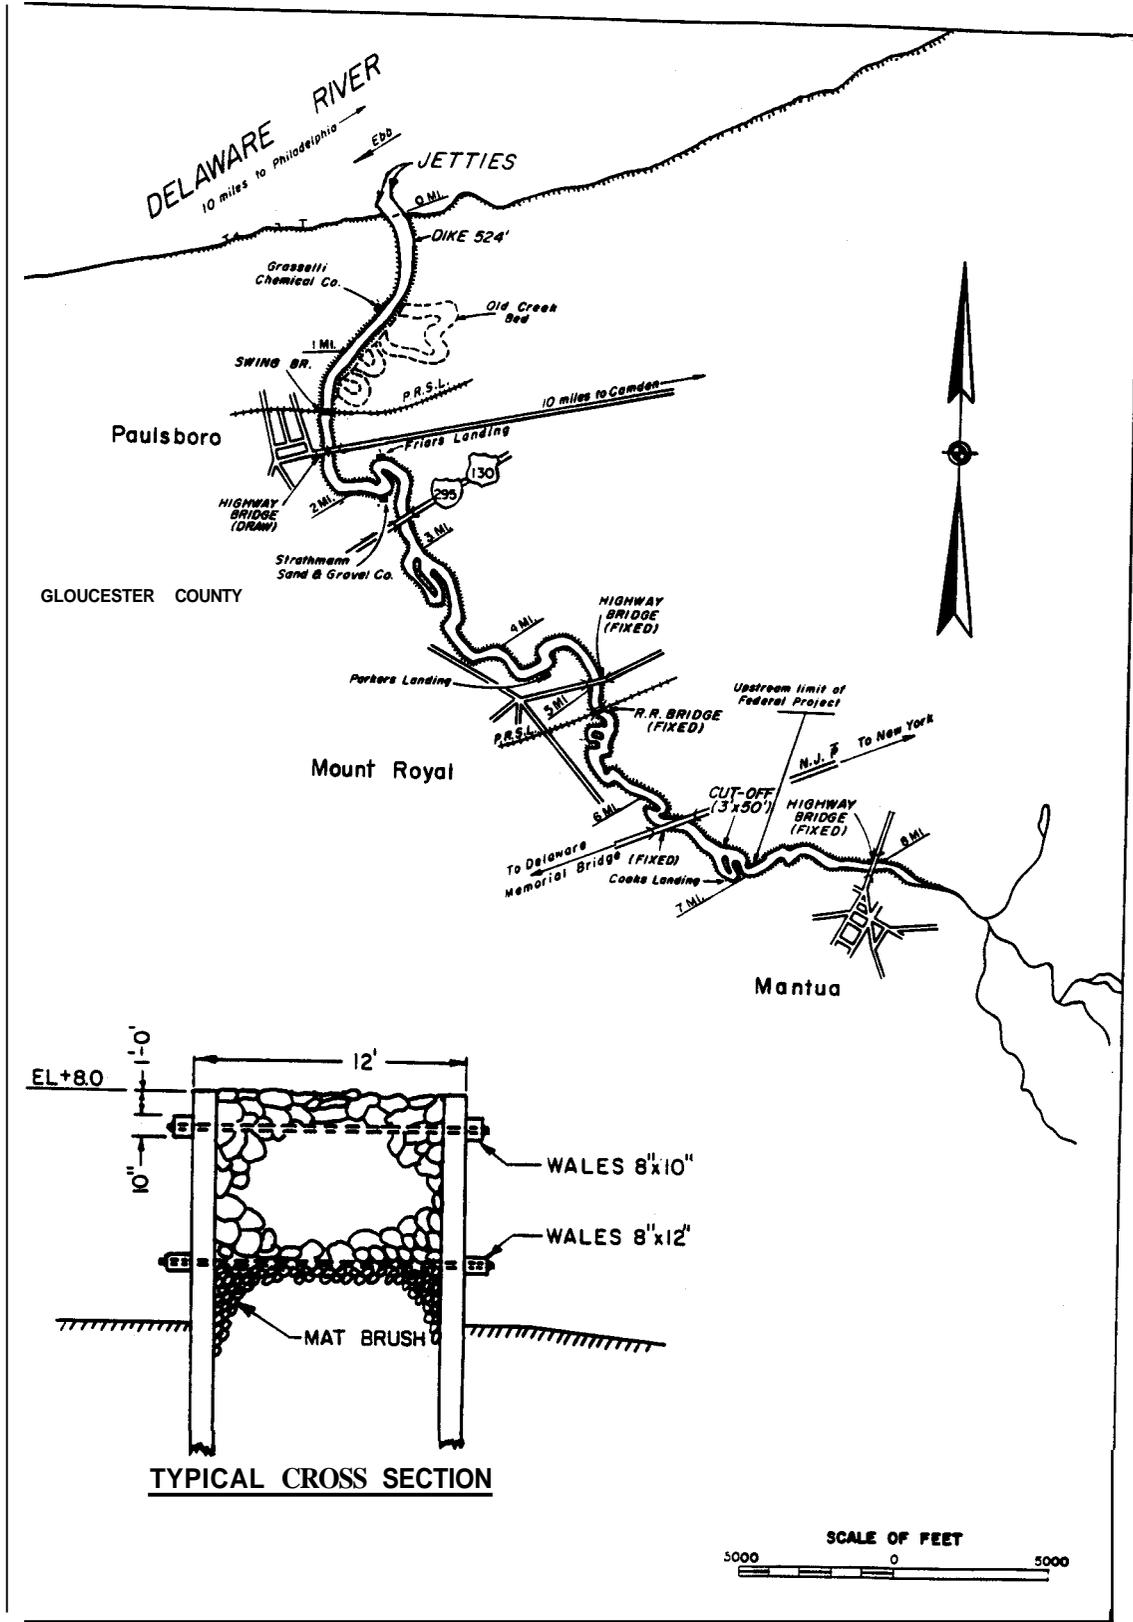
Figure 28. Mantua Creek, New Jersey

Date(s)	Construction and Rehabilitation History
1907	Two jetties were constructed to provide channel protection. Lengths were 754 ft and 580 ft east and west, respectively. The jetties were constructed of stone-filled timber cribs, with mat brush placed to support the stone (Figure 28). Top width and elevation were 12.0 ft and +8.0 ft mlw, respectively, for each jetty.
1912- 1913	The east jetty was extended to 1,577 ft, and the west jetty was extended to 1,456 ft (Figure 28).
1918	Repairs were made by the addition of stone.
1962	An investigation of the jetties revealed the jetties had settled an average of 2.0 ft. Approximately 100 ft of the offshore end of the east jetty had deteriorated, with most of the pilings gone, and stone had fallen out to below the waterline. Most of the walings had deteriorated and were missing. Piles were missing at intermediate locations along the jetties, but there was no significant loss of stone at those locations. Piles that remained were in good condition.

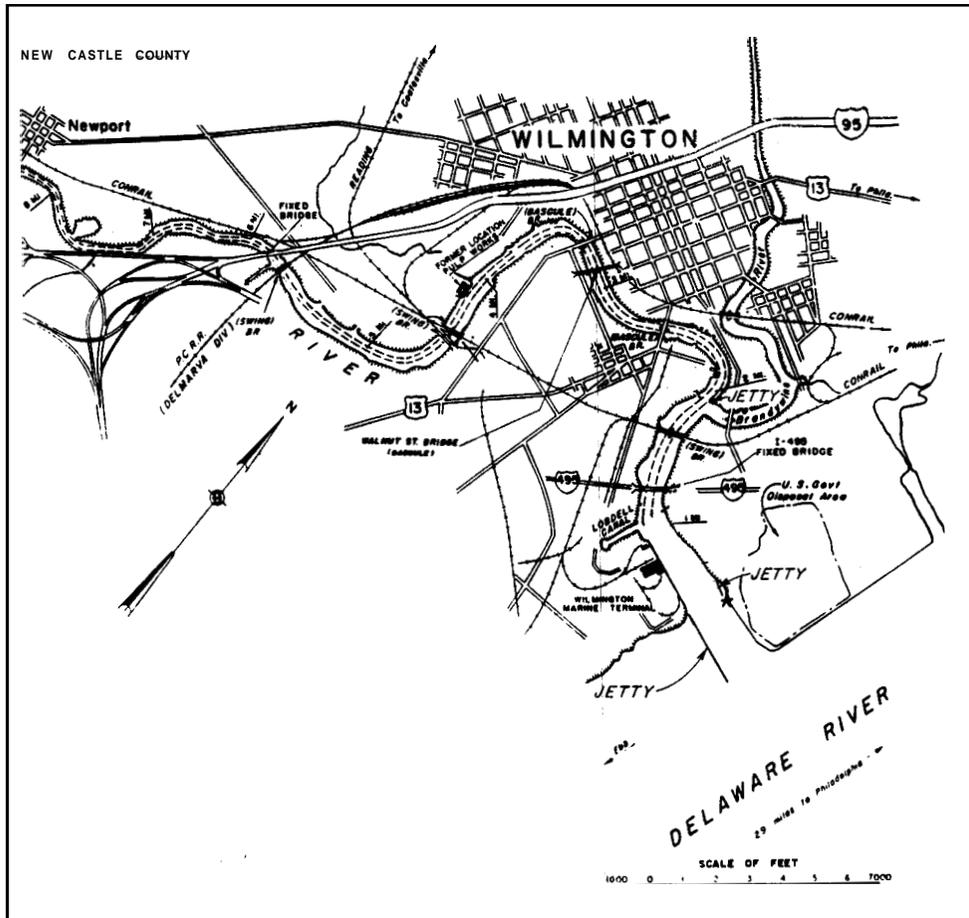
Figure 31. Wilmington Harbor, Delaware

Date( s)	Construction and Rehabilitation History
1883	A 1,740-ft-long curved stone-filled pile and timber crib jetty was constructed north of the Christina River mouth.
1884	The north jetty was raised 4.0 ft to a height above high water (no information on exact height).
1900	The north jetty was repaired and extended 313 ft. A terminal crib was also constructed. The total length of the north jetty was 2,150 ft. Jetties were constructed on the south side of the Christina River and at the mouth of the Brandywine River. The length of the south Christina River jetty was 1,515 ft and was built of pile and stone. A cross dike was built to connect the inner end of the jetty to the shore at high water. The Brandywine River jetty was V-shaped and was built of stone-filled pile and timber crib. The total length of this jetty was 690 ft, 430 ft on the Brandywine River side and 260 ft on the Christina River side (Figure 31).

Date(s)	Construction and Rehabilitation History
1937- 1939, 1948	Damages to the Christina south jetty, caused by ships colliding with it, were repaired each of these years at a total cost of \$90,000.
1961	The landward 500 ft of the Christina south jetty was removed to accommodate marine terminal expansion. The total length of the jetty was 1,800 ft.
1962	275 ft of buttressed steel sheet-pile wall failed during an extremely low tide and was eventually repaired,
1985	The Christina south jetty is in good condition.

1905	Repairs were made to the Brandywine River jetty and the north Christina River jetty. New wales were put on the Brandywine jetty, and face timber was replaced on the north Christina jetty. Stone was replaced where needed on both jetties.
1916	Repairs were made to the north Christina River jetty. Broken timber and piling was replaced with new material. Fender piles were placed along the channel face, and the interior of the crib was filled with stone where settling had occurred along the entire length of the jetty.
1925	The south jetty was removed, and a new jetty was to be built south of the Christina River.
1931	Approximately 1,200 ft of the north jetty was removed to improve the channel regime. The total length of the north jetty was 950 ft (Figure 31).
1936	A new jetty was completed south of the Christina River mouth. The jetty was 2,300 ft long (Figure 31) and consisted of 1,352 lin ft of steel sheet-pile wall, buttressed with 100-ft timber piles 12 ft on center, a 948-ft outboard section consisting of twelve 25.5-ft-diameter steel sheet-pile cells, and one 30.5-ft-diameter terminal cell with twelve 51-ft interconnecting fences. Crest elevation was +10 ft Corps of Engineers Datum (2.9 ft below mean sea level, 1929). The landward end of the jetty was connected to shore by a 120-ft steel sheet-pile anchor wall. The cost of construction was \$205,000.

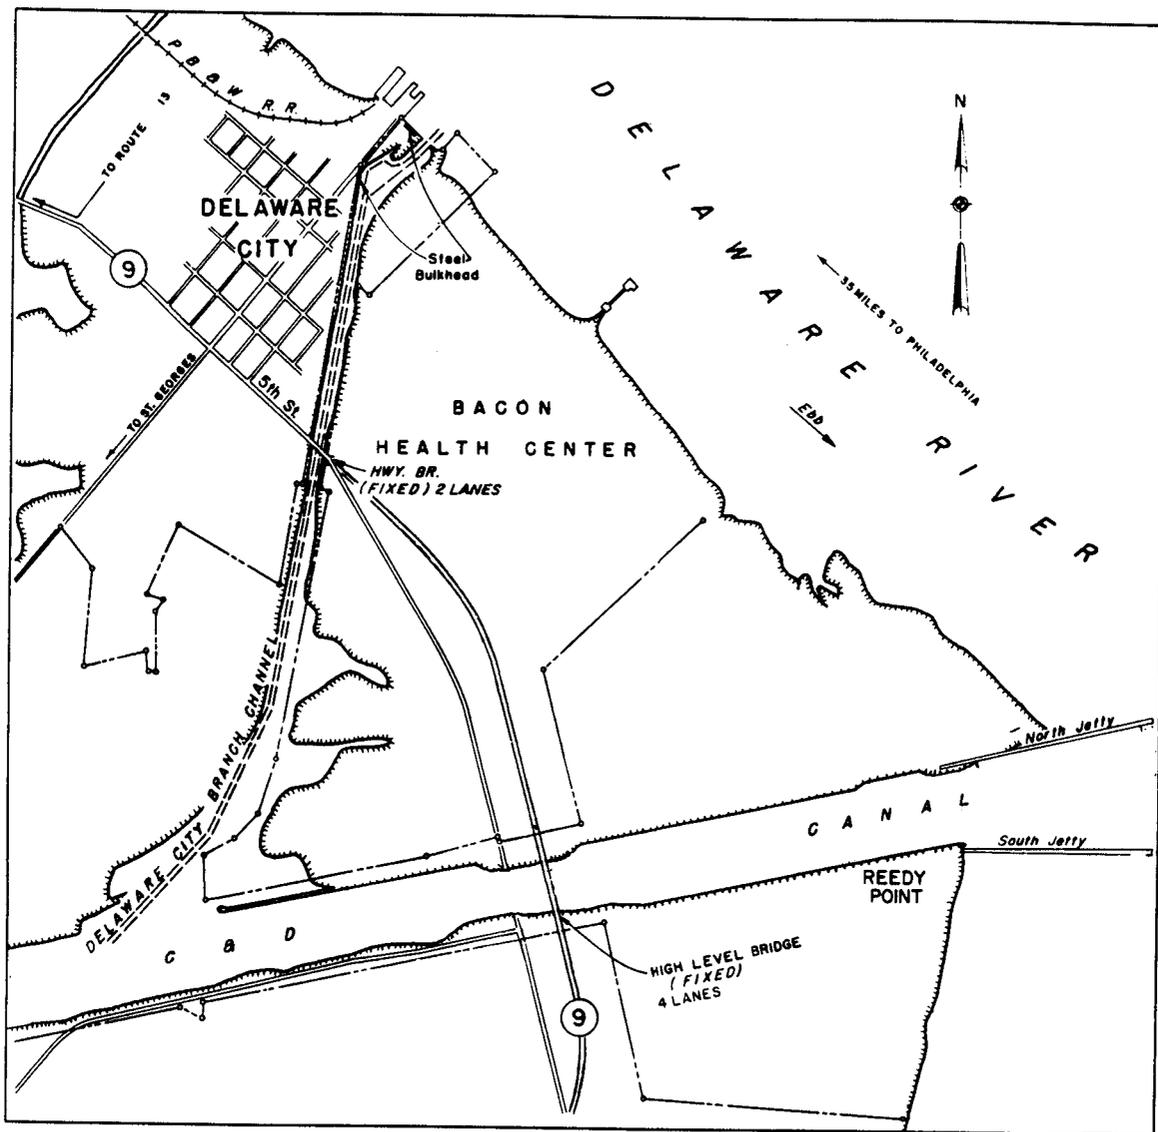
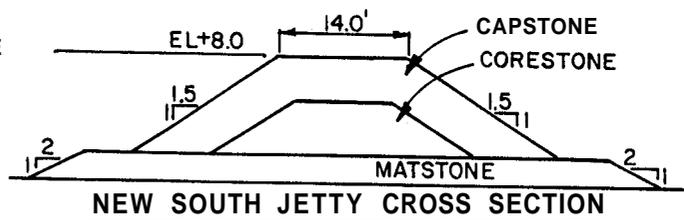
Figure 32. Delaware River and Chesapeake Bay Canal, Delaware

<u>Date( s)</u>	<u>Construction and Rehabilitation History</u>
<b>1903</b>	Construction of two rubble-mound jetties, north and south of the canal, was completed to provide channel protection. The length of each jetty was <b>725</b> ft, crest elevations were <b>+8.0</b> ft mlw, crown widths were <b>6.0</b> ft, and side slopes were <b>1:1</b> (Figure <b>32</b> ).
<b>1938</b>	Each jetty was extended to <b>2,095</b> ft (Figure <b>32</b> ).
<b>1960's</b>	The south jetty was removed and replaced by a new jetty to increase the entrance size to accommodate larger vessels and to improve navigation safety, The new jetty had a crest elevation of <b>+8.0</b> ft mlw and a 14.0-ft crown width (Figure <b>32</b> ). The design wave was <b>6.3</b> ft, <b>4.8</b> sec.
<b>1985</b>	The north jetty has subsided, lost stone, and the toe has scoured.

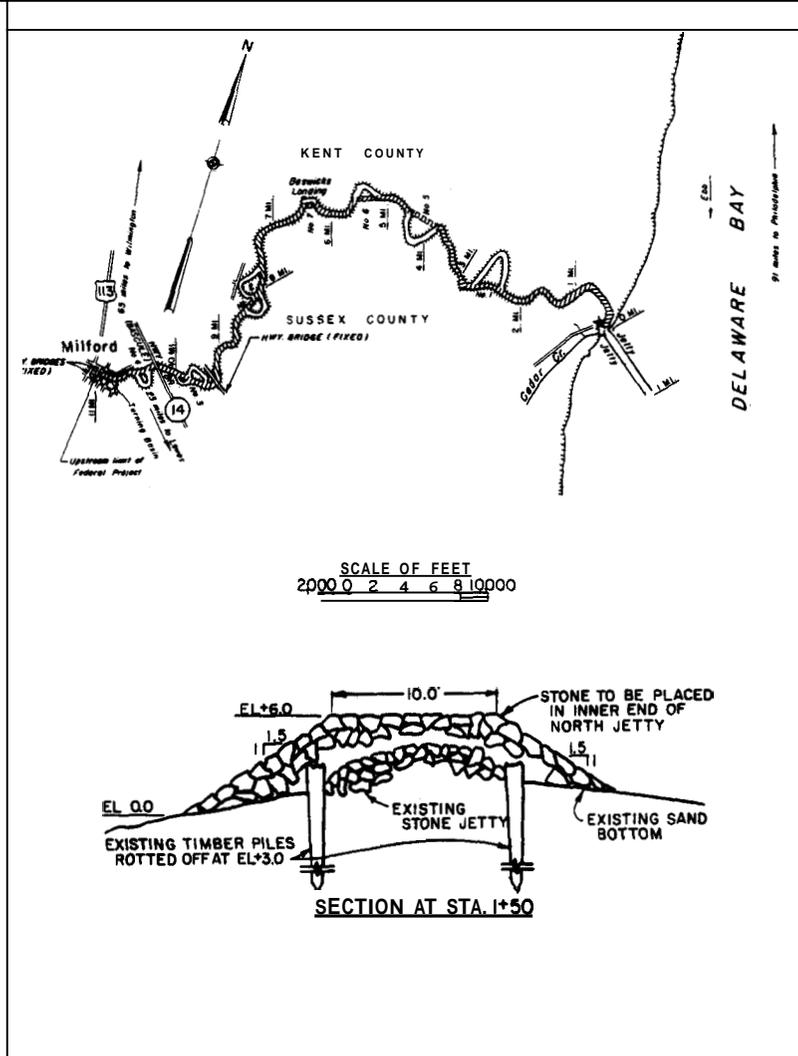
Figure 34. Mispillion River, Delaware

1944	Tops of piles were coated with tar on the north jetty near the river mouth at a cost of \$320.
1948	The north jetty was repaired beginning 708 ft from the shoreward end and extending 942 ft seaward. The original timber crib section was rehabilitated to a rubble-mound structure (Figure 34). The cost of repairs was \$51,493, and 4,870 tons of stone were used.
1963	A survey of the north jetty indicated there was no visible trace of the shoreward 708 ft. The total length of the existing jetty was 5,642 ft. The shoreward, rubble-mound, end had an average height of +6.2 ft mlw. The 1,200-ft-long timber crib structure adjacent to the rubble-mound section had deteriorated. Upper crib work was virtually nonexistent, and tops of piles were rotted or broken off. Stone had settled an average of 2.8 ft from design, was displaced, and had spilled out between piles. Piles, tie rods, and wales in the most seaward 3,500 ft appeared to be in good condition. Stone had settled an average of 1.5 ft in this section.

1964	Minor rehabilitation was done on the north jetty at a cost of \$377,848. The 1,200-ft-long deteriorated timber crib section was rehabilitated to a rubble-mound structure. The center line of the rubble-mound structure was placed north of the center line of the timber crib jetty to prevent failure of the jetty on the channel side due to lateral forces. The offset was 11.0 ft over a distance of 650 ft and 9.0 ft over a distance of 400 ft, shoreward and seaward ends of the section, respectively. Transition sections were on either end of the new structure and between the two offset sections. Crest elevation was +7.0 ft mlw, crown width was 10.0 ft, and side slopes were 1V:1.5H. Twenty-five ton minimum capstone was placed over 1- to 50-lb matstone. A layer of willow matting, compressed in

Date(s)	Construction and Rehabilitation History
1964 (Cont.)	<p>place to 1.5 ft thick, was provided as a filter. Core stone, 25 to 500 lb, was placed on the channel side of the existing jetty at a slope of 1V:1H to 1V:1.5H to ensure stability of the rubble-mound structure. The 3,500-ft-long timber crib on the seaward end of the jetty was filled with core stone, 150 to 300 lb, to the original design elevation of +5.5 ft mhw. Cross sections of the rehabilitation are shown in Figure 35.</p>
1985	<p>The jetties are in good condition and have been effective in providing safe navigation and preventing channel shoaling.</p>

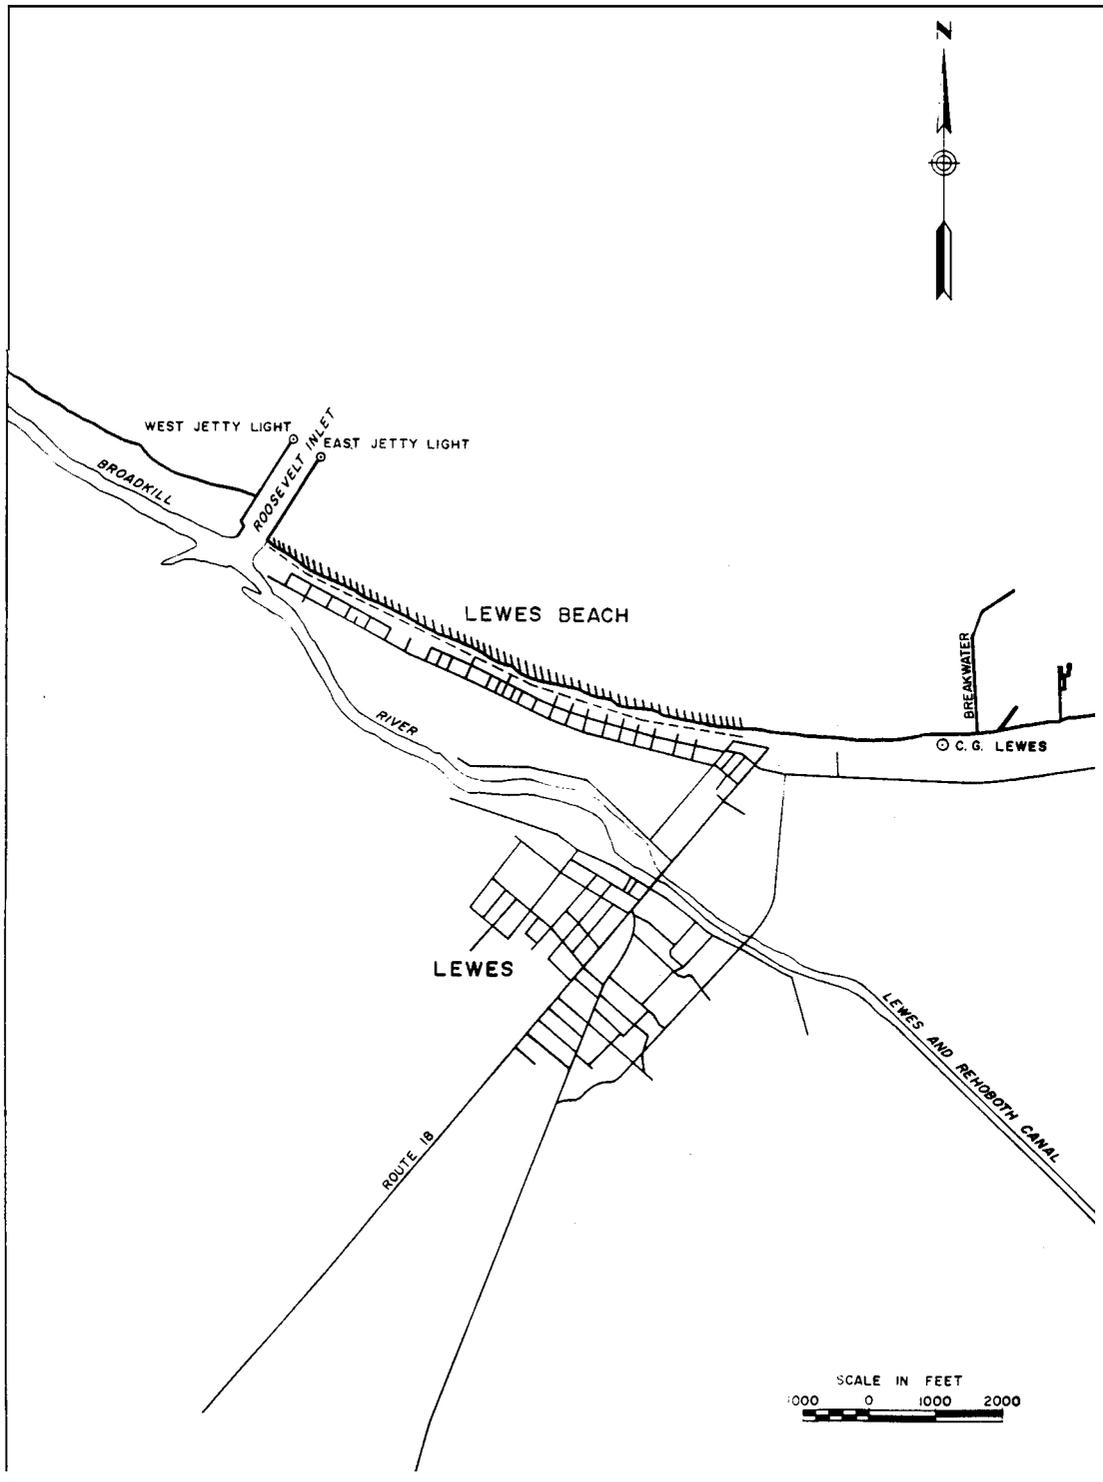
Figure 36. Roosevelt Inlet, Delaware

Date(s)	Construction and Rehabilitation History
1908	A 1,263-ft-long stone-filled timber crib jetty was constructed on the west side of the inlet.
1911- 1914 1917, 1920, 1923	Stone replacement repairs were made each of these years. Cause of damage was due to inadequate jetty design; waves easily damaged the timber cribs. The cribs were also permeable to sand.
1937	The timber crib jetty was replaced by two steel sheet-pile jetties, constructed 500 ft apart, on the east and west sides of the inlet. Both jetties were 1,700 ft long (Figure 36). Crest elevations were +8.0 ft mlw, except the shoreward ends which were +10.0 ft mlw.
1939	The jetties had deteriorated due to corrosion.
1944	The jetties were flanked and rubble was placed along the east bank. The additional rubble extended the east jetty shoreward 400 ft. The possibility of the west jetty becoming completely flanked was determined to be remote; therefore, no rubble was placed on the west bank. Seaward ends of both jetties were repaired due to deterioration by corrosion.

1985	The jetties are in poor condition and are ineffective. They are considered a navigation hazard and are to be removed.

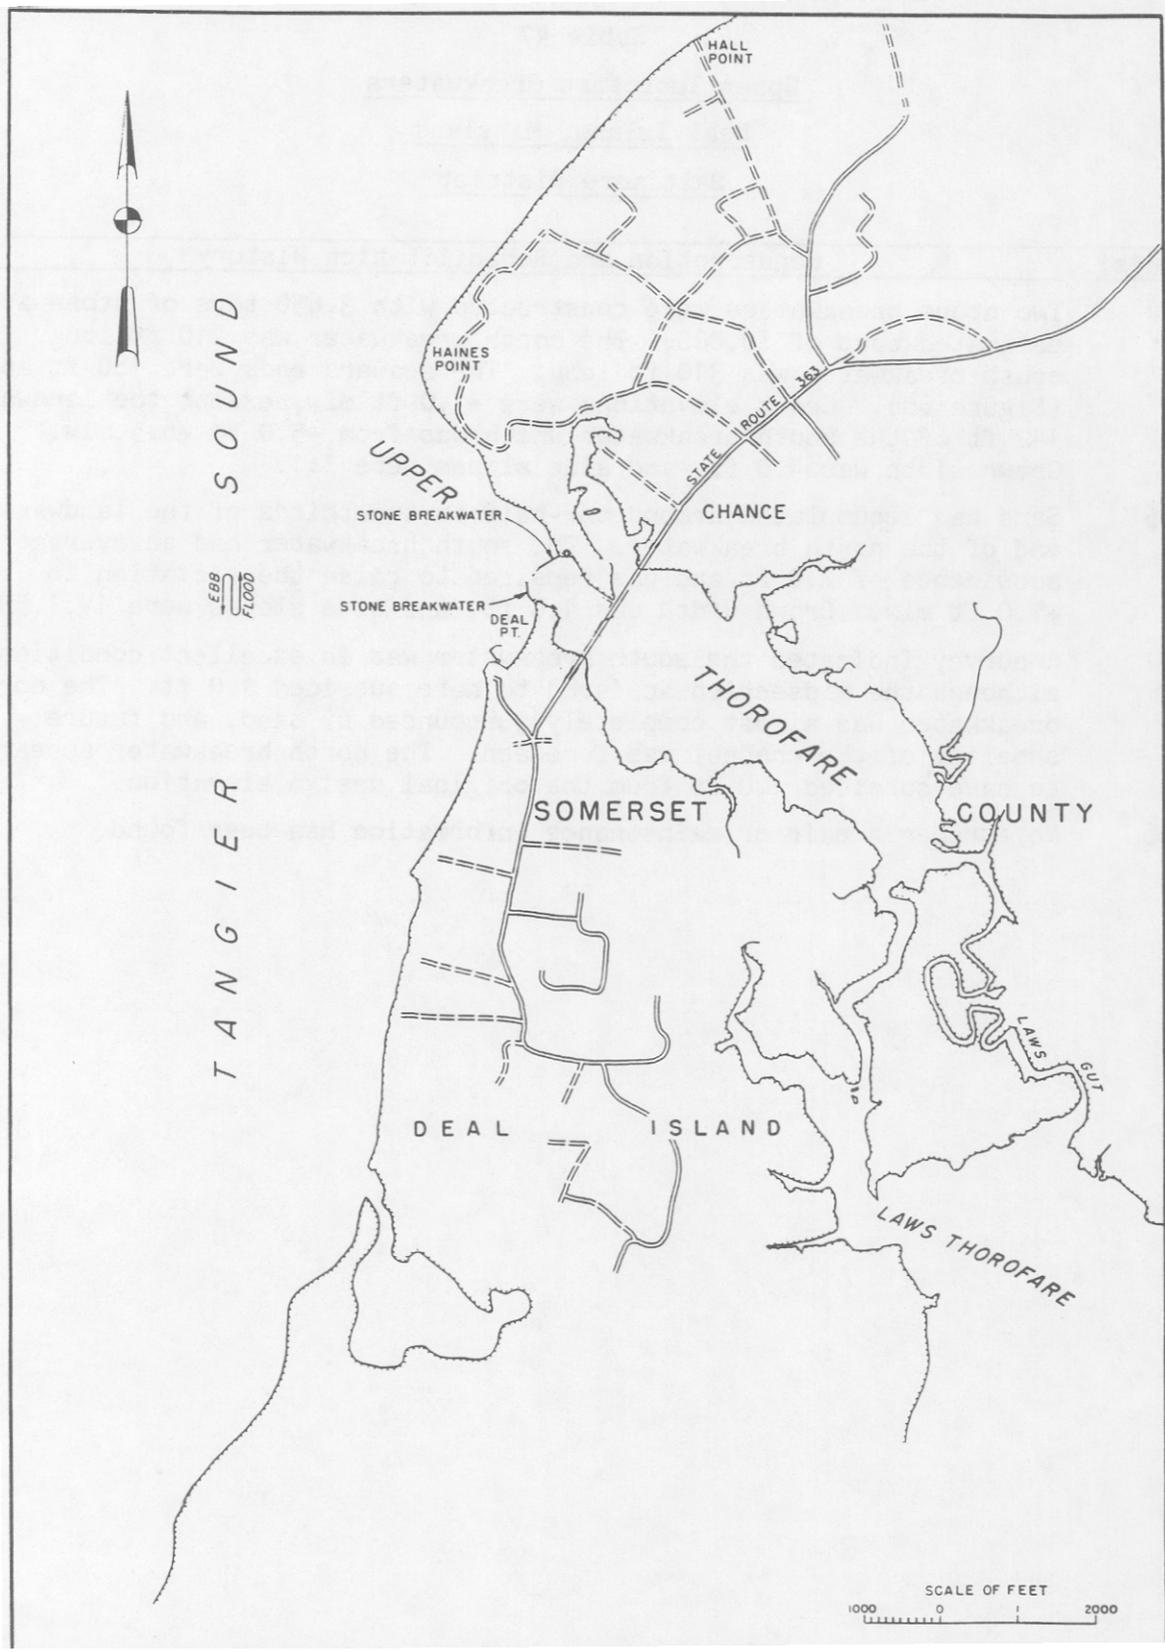
Figure 60. Upper Thorofare, Maryland

<u>Date( s)</u>	<u>Construction and Rehabilitation History</u>
<b>1934</b>	Two stone breakwaters were constructed with <b>3,650</b> tons of stone at an estimated cost of <b>\$9,000</b> . The north breakwater was <b>410</b> ft long. The south breakwater was <b>310</b> ft long. The seaward ends were <b>180</b> ft apart (Figure 60). Crest elevations were <b>+7.0</b> ft mlw, except the landward <b>142</b> ft of the south breakwater which was from <b>+5.0</b> to <b>+6.5</b> mlw. Crown width was <b>4.0</b> ft, and side slopes were <b>1:1</b> .
<b>1966</b>	Sand had accumulated around one-half to two-thirds of the landward end of the north breakwater. The south breakwater had an average subsidence of <b>2.0</b> ft and was repaired to raise the elevation to <b>+7.0</b> ft mlw. Crown width was <b>4.0</b> ft, and side slopes were <b>1V:1.5H</b> .
<b>1981</b>	A survey indicated the south breakwater was in excellent condition, although the midsection appeared to have subsided <b>1.0</b> ft. The north breakwater was almost completely surrounded by sand, and future shoaling of the channel was foreseen. The north breakwater appeared to have subsided <b>1.0</b> ft from the original design elevation.

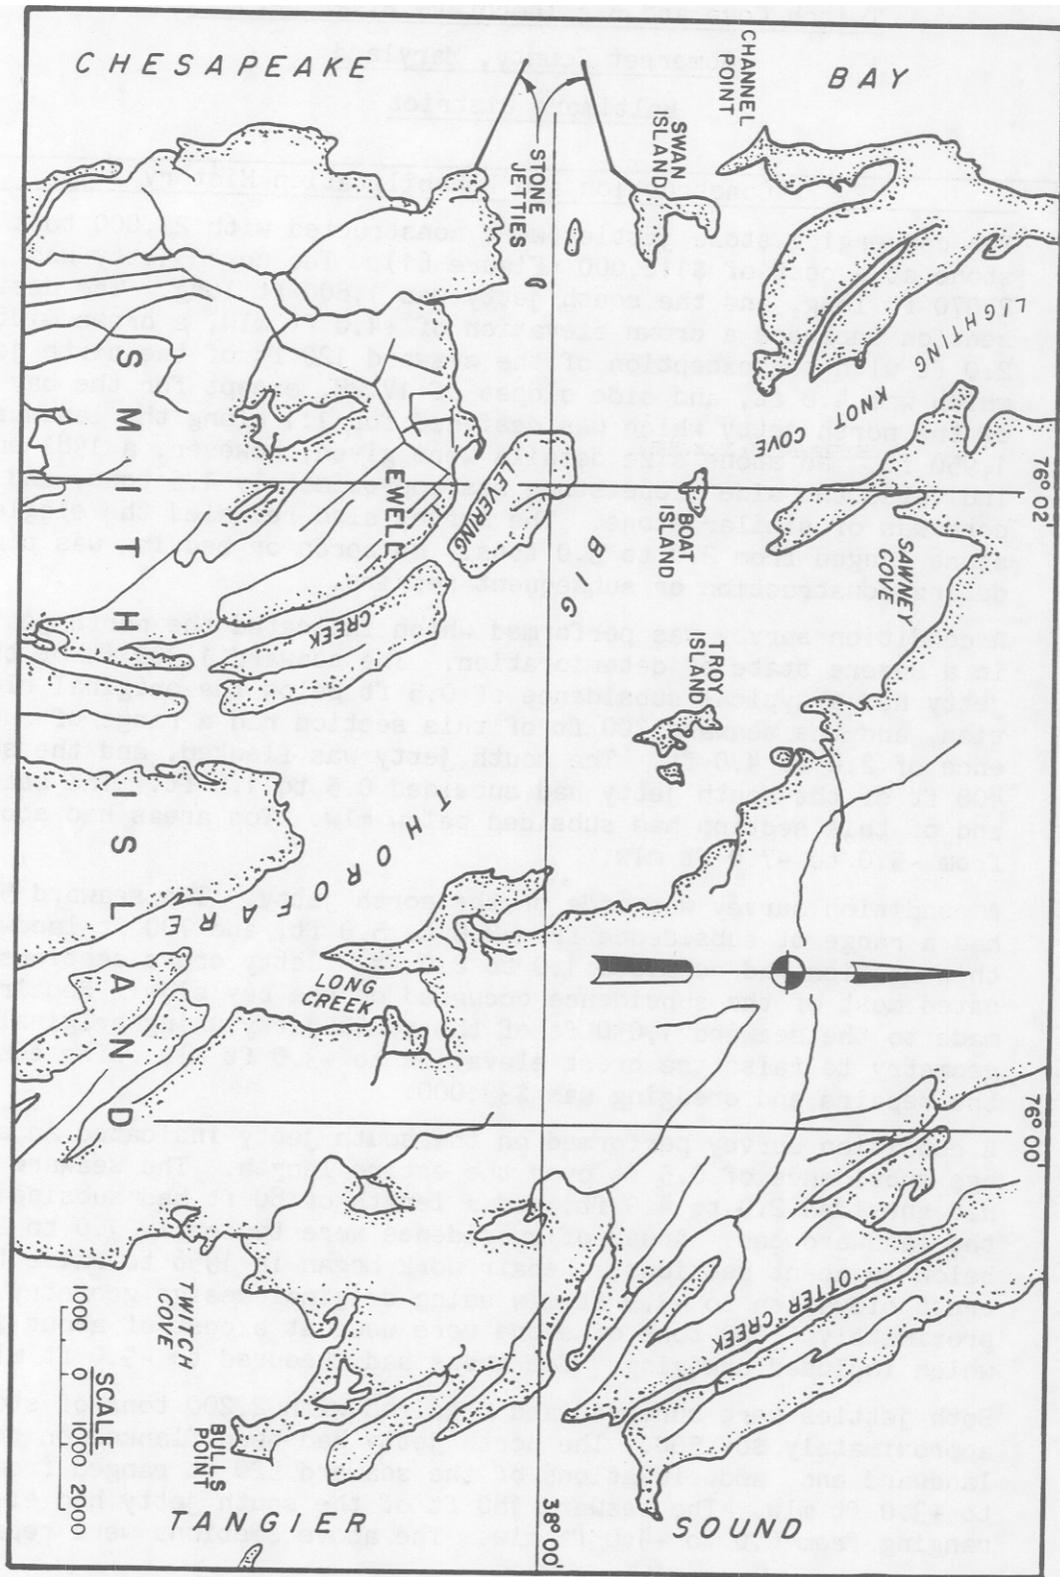
Figure 61. Twitch Cove and Big Thorofare River, Maryland

<u>Date(s)</u>	<u>Construction and Rehabilitation History</u>
1940	Two converging stone jetties were constructed with <b>23,000</b> tons of stone at a cost of <b>\$112,000</b> (Figure 61). The north jetty was <b>2,070</b> ft long, and the south jetty was <b>1,800</b> ft long. The design section included a crown elevation of <b>+4.0</b> ft mlw, a crown width of <b>2.0</b> ft with the exception of the seaward <b>120</b> ft of the north jetty which was <b>4.0</b> ft, and side slopes of <b>1V:2H</b> , except for the bay side of the north jetty which was designed for <b>1:1</b> along the landward <b>1,950</b> ft. No stone size details were given; however, a <b>1981</b> survey indicated the side slope stone was approximately <b>1.5</b> tons, and the core was of similar stone. The survey also revealed the single cap-stone ranged from <b>2.0</b> to <b>3.0</b> tons. <b>No</b> apron or bedding was placed during construction or subsequent repairs.

1945	A condition survey was performed which indicated the north jetty was in a severe state of deterioration. The seaward <b>1,300</b> ft of this jetty had a typical subsidence of <b>0.5</b> ft below the original elevation, and the seaward <b>300</b> ft of this section had a range of subsidence of <b>2.0</b> to <b>4.0</b> ft. The south jetty was flanked, and the seaward <b>400</b> ft of the south jetty had subsided <b>0.5</b> to <b>1.5</b> ft. The seaward end of this section had subsided below mlw. Toe areas had scoured from <b>-5.0</b> to <b>-7.0</b> ft mlw.
1952	A condition survey was made on the north jetty. The seaward <b>570</b> ft had a range of subsidence from <b>2.0</b> to <b>5.0</b> ft, and <b>700</b> ft landward of this section had subsided <b>1.0</b> to <b>2.0</b> ft. Jetty cross sections indicated most of the subsidence occurred on the bay side. Repairs were made to the seaward <b>1,030</b> ft of the north jetty using original design geometry to raise the crest elevation to <b>+3.0</b> ft mlw. The cost of the repairs and dredging was <b>\$33,000</b> .

1955- 1956	A condition survey performed on the south jetty indicated an average subsidence of <b>0.5</b> ft over the entire length. The seaward <b>300</b> ft had subsided <b>2.0</b> to <b>4.0</b> ft, and a length of <b>80</b> ft had subsided near the landward end. Areas of subsidence were typically <b>1.0</b> to <b>2.0</b> ft below adjacent sections. Repair work began in <b>1956</b> to raise the crest elevation to <b>+3.5</b> ft mlw using original design geometry. Approximately <b>1,000</b> tons of stone were used at a cost of about <b>\$35,000</b> which included dredging. Toe areas had scoured to <b>-9.0</b> ft mlw.
1962	Both jetties were surveyed and repaired with <b>2,200</b> tons of stone for approximately <b>\$64,500</b> . The north jetty had been flanked on the landward end, and elevations of the seaward <b>520</b> ft ranged from <b>+1.0</b> to <b>+3.0</b> ft mlw. The seaward <b>180</b> ft of the south jetty had elevations ranging from <b>0.0</b> to <b>+4.0</b> ft mlw. The above sections were repaired to

Date(s)	Construction and Rehabilitation History
1962 (Cont.)	a crown elevation of +4.0 ft mlw, with a 2.0-ft crown width, except the seaward 70 ft of the north jetty was 4.0 ft. The side slopes were <b>1V:2H</b> . The landward end of the north jetty was extended <b>120</b> ft. Voids along the remainder of the jetties were repaired by placing and resetting existing stone at existing section elevations. The depth at the toes of the jetties ranged from 10.0 to <b>12.0</b> ft mlw.
1981	<p>A survey report indicates both jetties are in "poor" condition. The seaward end of the north jetty and the landward ends of both jetties were flanked, and there were numerous areas of subsidence along their lengths. It is believed that scour is the reason for their deterioration for the following reasons:</p> <ul style="list-style-type: none"> <li>-- Existence of a homogeneous cross section (no smaller core placed).</li> <li>-- No bedding stone or apron stone being placed during original construction or during repairs.</li> <li>-- Increase in depth from a range of 5.0 to 6.0 ft to a range of 10.0 to 12.0 ft mlw at the seaward ends.</li> <li>-- Landward ends of the jetties being flanked at present. Each has been flanked once and repaired since original construction.</li> <li>-- General subsidence along the entire lengths of the jetties of 0.5 to 1.0 ft.</li> <li>-- Numerous voids or gaps where capstones were missing.</li> </ul>

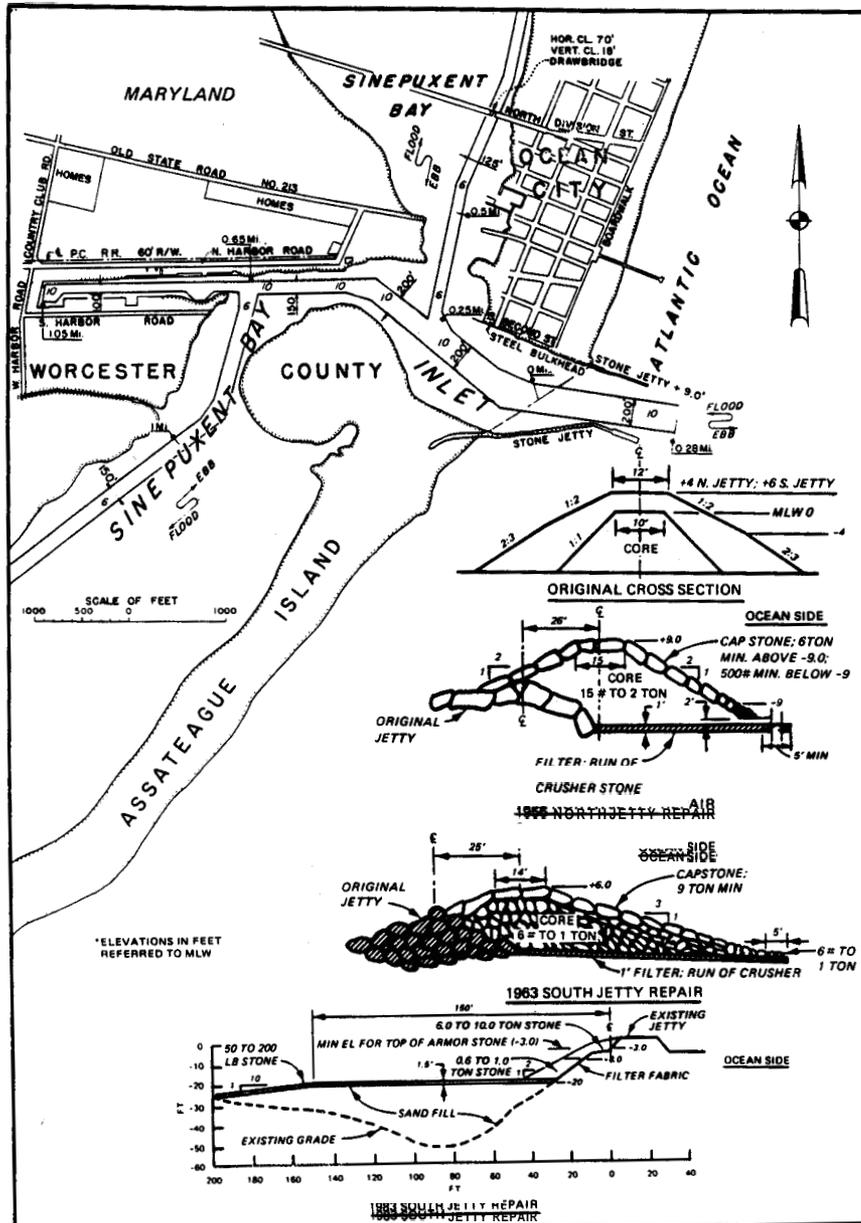
Figure 62. Ocean City Inlet, Maryland

Date(s)	Construction and Rehabilitation History
1934	A 1,100-ft-long jetty was constructed on the north side of a newly formed inlet at Ocean City (Figure 62). Crest elevation was +4.0 mlw, crown width was 12.0 ft, and side slopes were 1V:2H from the crest to -4.0 mlw and 1V:1.5H from -4.0 mlw to the bottom.
1935	Construction was completed on a jetty on the south side of the inlet. Crest elevation was +6.0 ft mlw, and crown width was 12.0 ft. The landward 750 ft of the jetty was 1,100 ft south of the north jetty. The south jetty angled north 1,100 ft to a point 600 ft from the north jetty. The final 530 ft of the south jetty was parallel to that of the north jetty. The crest elevation decreased from +6.0 ft mlw to the apron elevation beginning 170 ft seaward of this final section. The apron extended 200 ft farther seaward. The total length of the jetty was 2,380 ft, including the apron. A total of 39,500 tons of stone was used for core; 17,300 tons were used for capstone on the south jetty.

1937	Sand on the north side of the north jetty had reached the top of the jetty and was depositing in the inlet. A concrete superstructure was built to raise the jetty elevation. The first 100 ft from the boardwalk was raised to +12.0 ft mlw, the next 254 ft was raised to +9.0 ft, and the next 170 ft was raised to +7.0 ft mlw.
1956	Repairs were made on the seaward 750 ft of the north jetty because of slope failures on the channel side from toe scour. The existing concrete cap was repaired and raised to +9.0 ft. Armor stone was placed on the seaward 575 ft. The armor stone section was placed 26 ft north of the center line to use existing stone as toe protection and to minimize the stone required. The landward end of the south jetty was repaired to maintain integrity with the shoreline.
1963	Approximately 720 ft of the south jetty was rehabilitated due to slope failures caused by a scour hole that had an elevation of -37 ft mlw. Armor stone was placed 25 ft seaward of the center line for the same reasons stated above in positioning the north jetty. The landward end of the south jetty was again repaired to maintain integrity with the shoreline.

1984	The seaward 1,100 ft of the south jetty was rehabilitated due to slope failures. The section repaired in 1963 had deteriorated. The scour hole had a maximum depth of -54 ft mlw. Repairs consisted of filling the scour hole with dredged material to -20 ft mlw, covering the hole with 18 in. of blanket stone, and placing stone berm quarry run and armor stone along the toe on the channel side of the

Date(s)	Construction and Rehabilitation History
1984 (Cont.)	existing jetty. The landward end of the south jetty was sand tightened to prevent material from passing through the jetty and shoaling into the channel. Three rubble mound breakwaters were constructed landward of the jetty to prevent expected erosion from occurring as a result of sand tightening.
1986	No further repair or maintenance information has been found.
