TECHNICAL REPORT REMR-CO-3

CASE HISTORIES OF CORPS BREAKWATER  
AND JETTY STRUCTURES

Report 5

NORTH ATLANTIC DIVISION

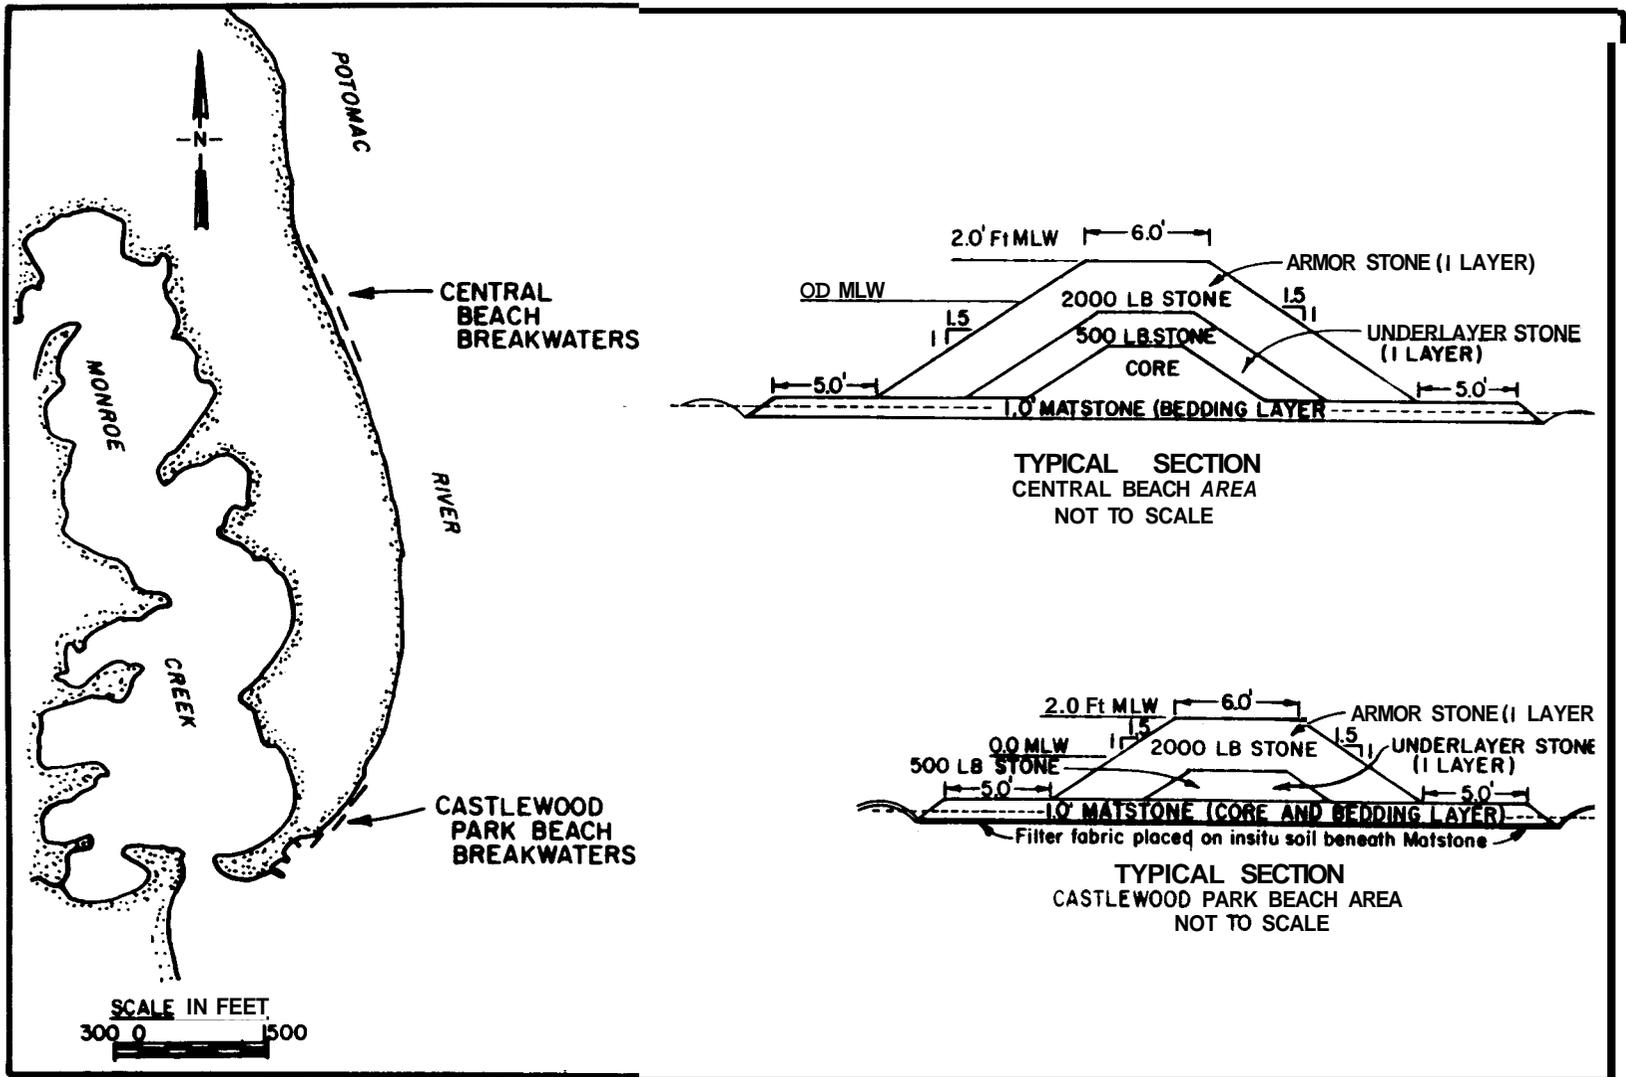
Figure 63. Colonial Beach, Virginia

<u>Date(s)</u>	<u>Construction and Rehabilitation History</u>
1982	Seven offshore breakwaters were constructed as part of a beach restoration project for approximately \$447,000, using over 9,000 tons of stone (Figure 63). One 300-ft breakwater and two 200-ft breakwaters were placed at Castlewood Beach, and four 200-ft breakwaters were placed at Central Beach. All were placed parallel to the shoreline and approximately 100 ft offshore, and they were separated by 150-ft gaps. Crest elevations were +3.0 ft msl but allowed for settlement to +2.0 ft msl. Crown widths were 6.0 ft, and side slopes were 1V:1.5H. One layer of 2,000-lb cover stone was placed over one layer of 500-lb underlayer resting on a core and 1 ft bedding layer. Design wave height was 6.0 ft.
1985	The breakwaters are in excellent condition and serving their intended function.

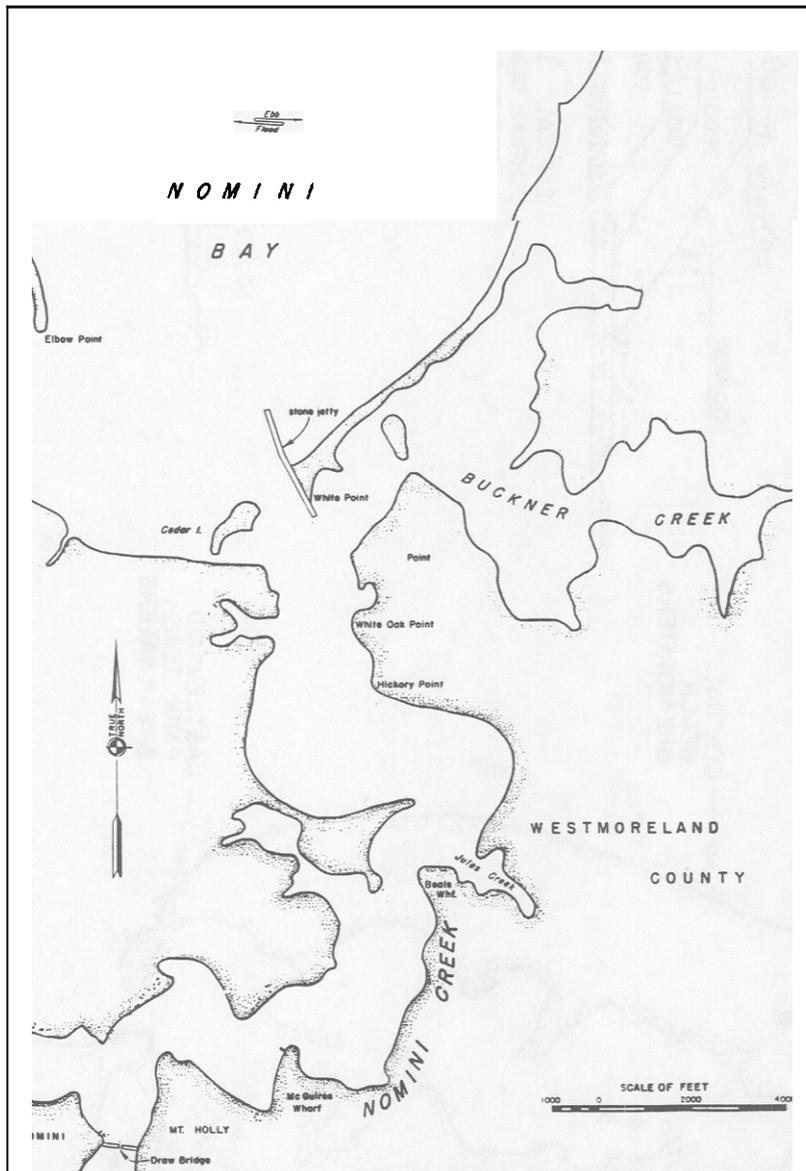
Figure 64. Nomini Bay and Creek, Virginia

Date( s)	Construction and Rehabilitation History
1912	A 2,410-ft-long stone jetty was completed (Figure 64).
1981	A survey indicated the jetty was in good condition.
1986	No further repair or maintenance information has been found.

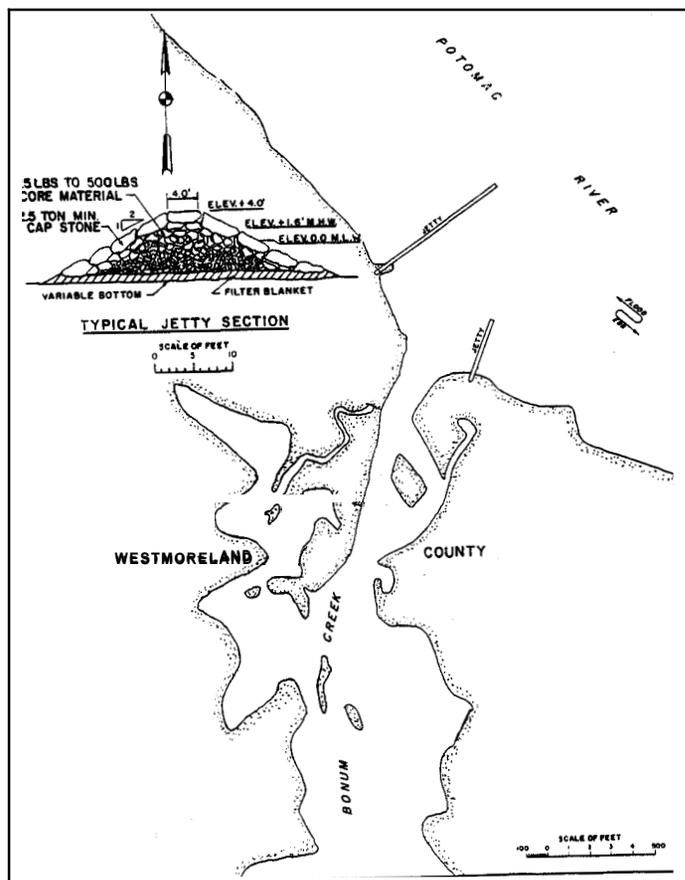
Figure 65. Bonum Creek, Virginia

Date(s)	Construction and Rehabilitation History
1968	Construction was completed on two stone jetties at an estimated cost of \$221,000 using 8,000 tons of stone. The north jetty was 800 ft long, and the south jetty was 300 ft long (Figure 65). Crown elevation was +4.0 ft mlw, crown width was 4.0 ft with a single capstone, and side slopes were 1V:2H. Cover stone used was 2.5 tons, and core stone ranged from 25 to 500 lb. Design wave height was 9.0 ft.
1981	A condition survey revealed that the jetties had undergone some settlement but were in <b>good</b> condition.
1986	No further repair or maintenance information has been found.

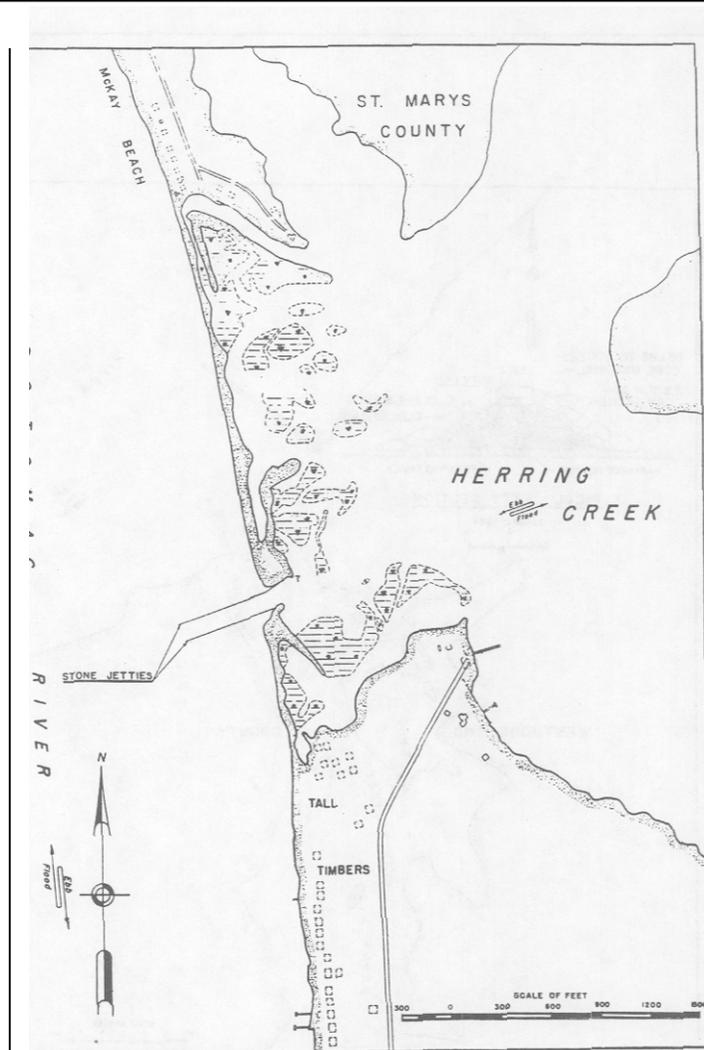
Figure 66. Herring Creek, Maryland

Date(s)	Construction and Rehabilitation History
1960-1961	Two jetties were constructed to 750- and 700-ft lengths north and south, respectively (Figure 66). Crown elevation was +4.5 ft msl, crown width was 4.0 ft, and side slopes were 1V:2.5H. A 1.0-ft-thick bedding layer was placed, and a 1.0-ft-thick by 10.0-ft-wide apron was placed along both jetty toes.
1981	A survey indicated the jetties were in good condition with only minor settlement.
1986	No further repair or maintenance information has been found.

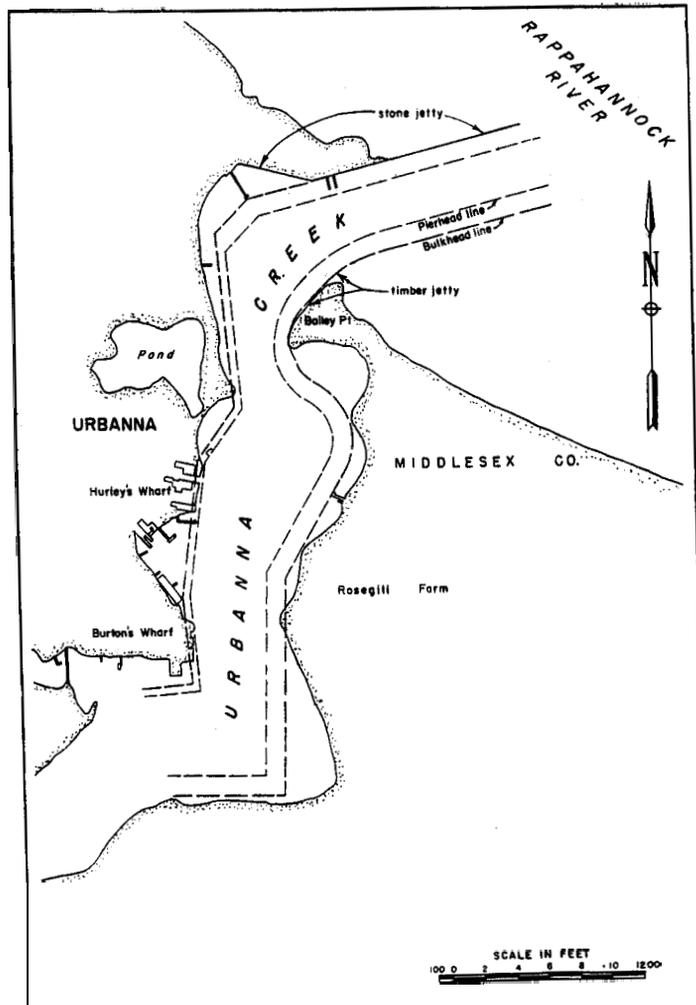
Figure 68. Urbanna Creek, Virginia

Date(s)	Construction and Rehabilitation History
1956	Two jetties were constructed for channel control. The north jetty, 1,895 ft long, was rubble mound. The 717-ft-long south jetty was built of timber (Figure 68).
1962	The north jetty was rehabilitated.
1986	No further repair or maintenance information has been found.

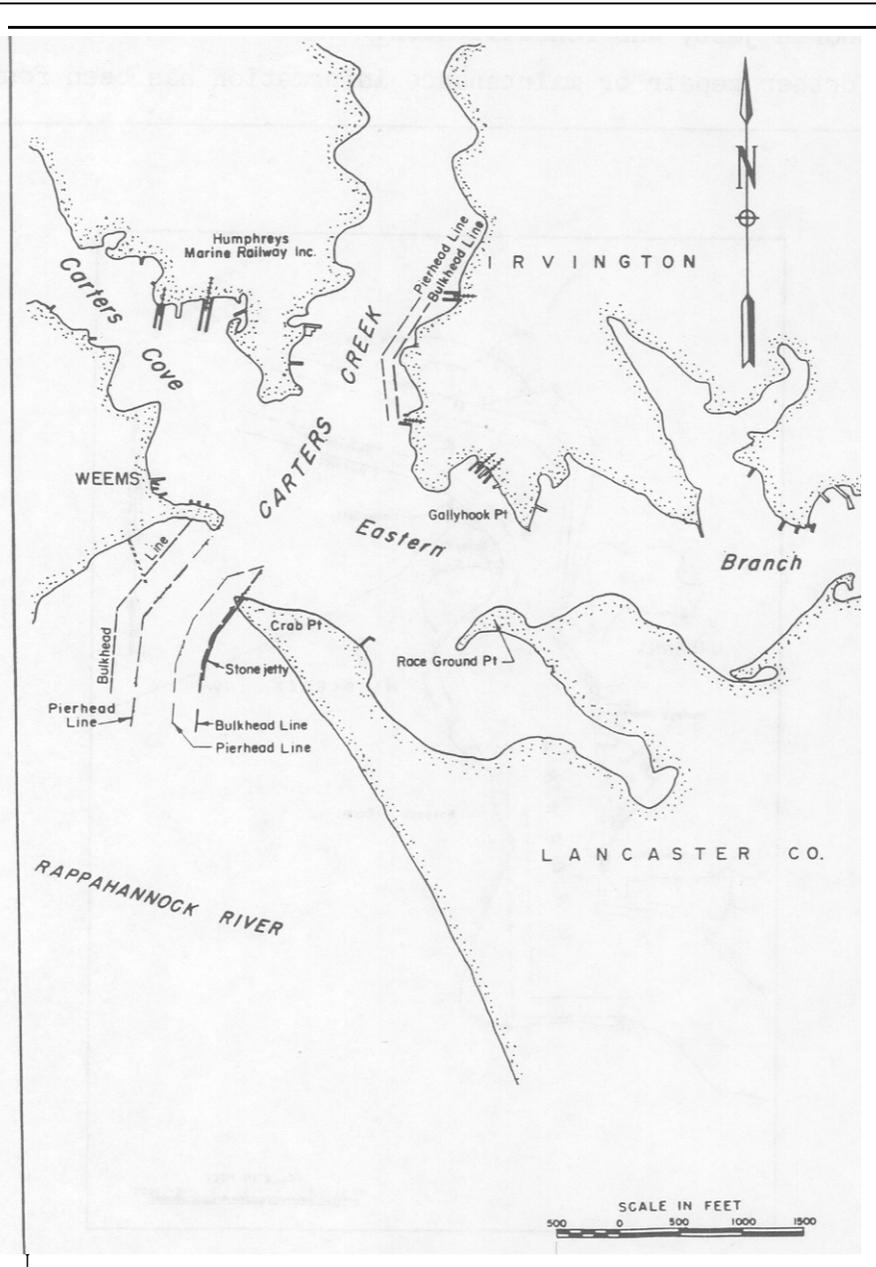
Figure 69. Carters Creek, Virginia

Date(s)	Construction and Rehabilitation History
1902-1906	A 742-ft-long rubble-mound jetty was built to provide channel control (Figure 69).
1986	No further repair or maintenance information has been found.

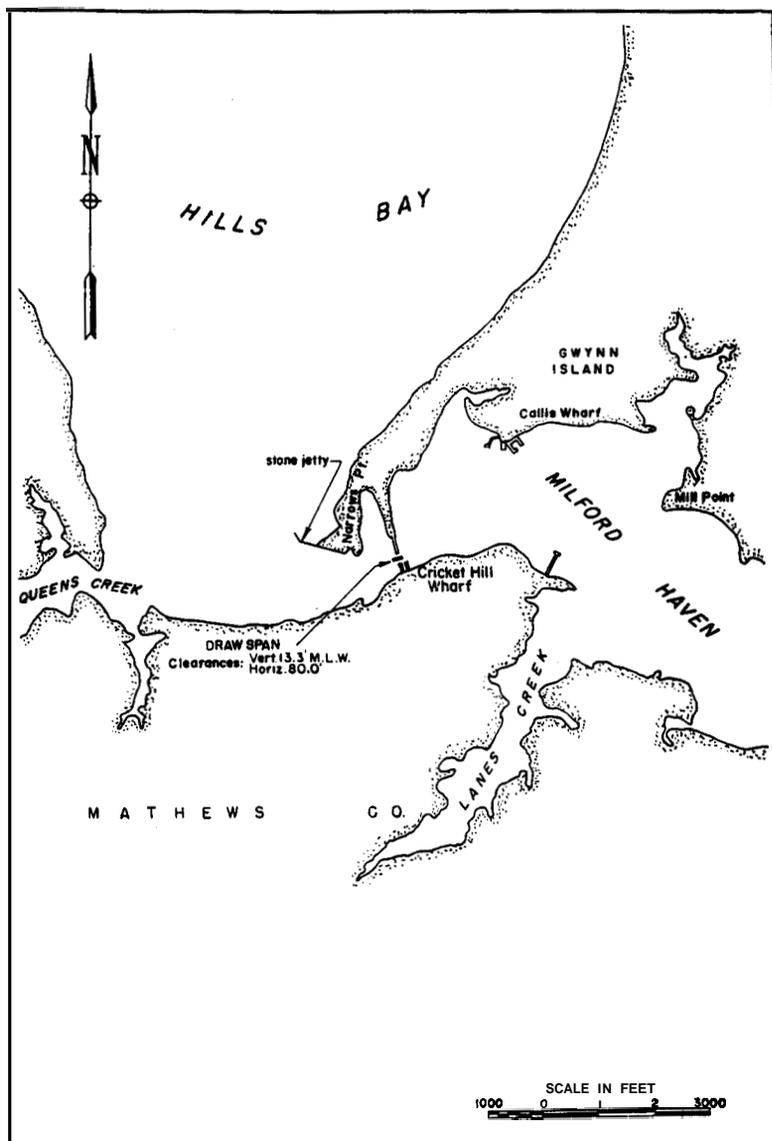
Figure 70. Milford Haven, Virginia

<u>Date(s)</u>	<u>Construction and Rehabilitation History</u>
1913	A 1,183-ft-long rubble-mound jetty was constructed to provide channel control (Figure 70).
1986	No further repair or maintenance information has been found.

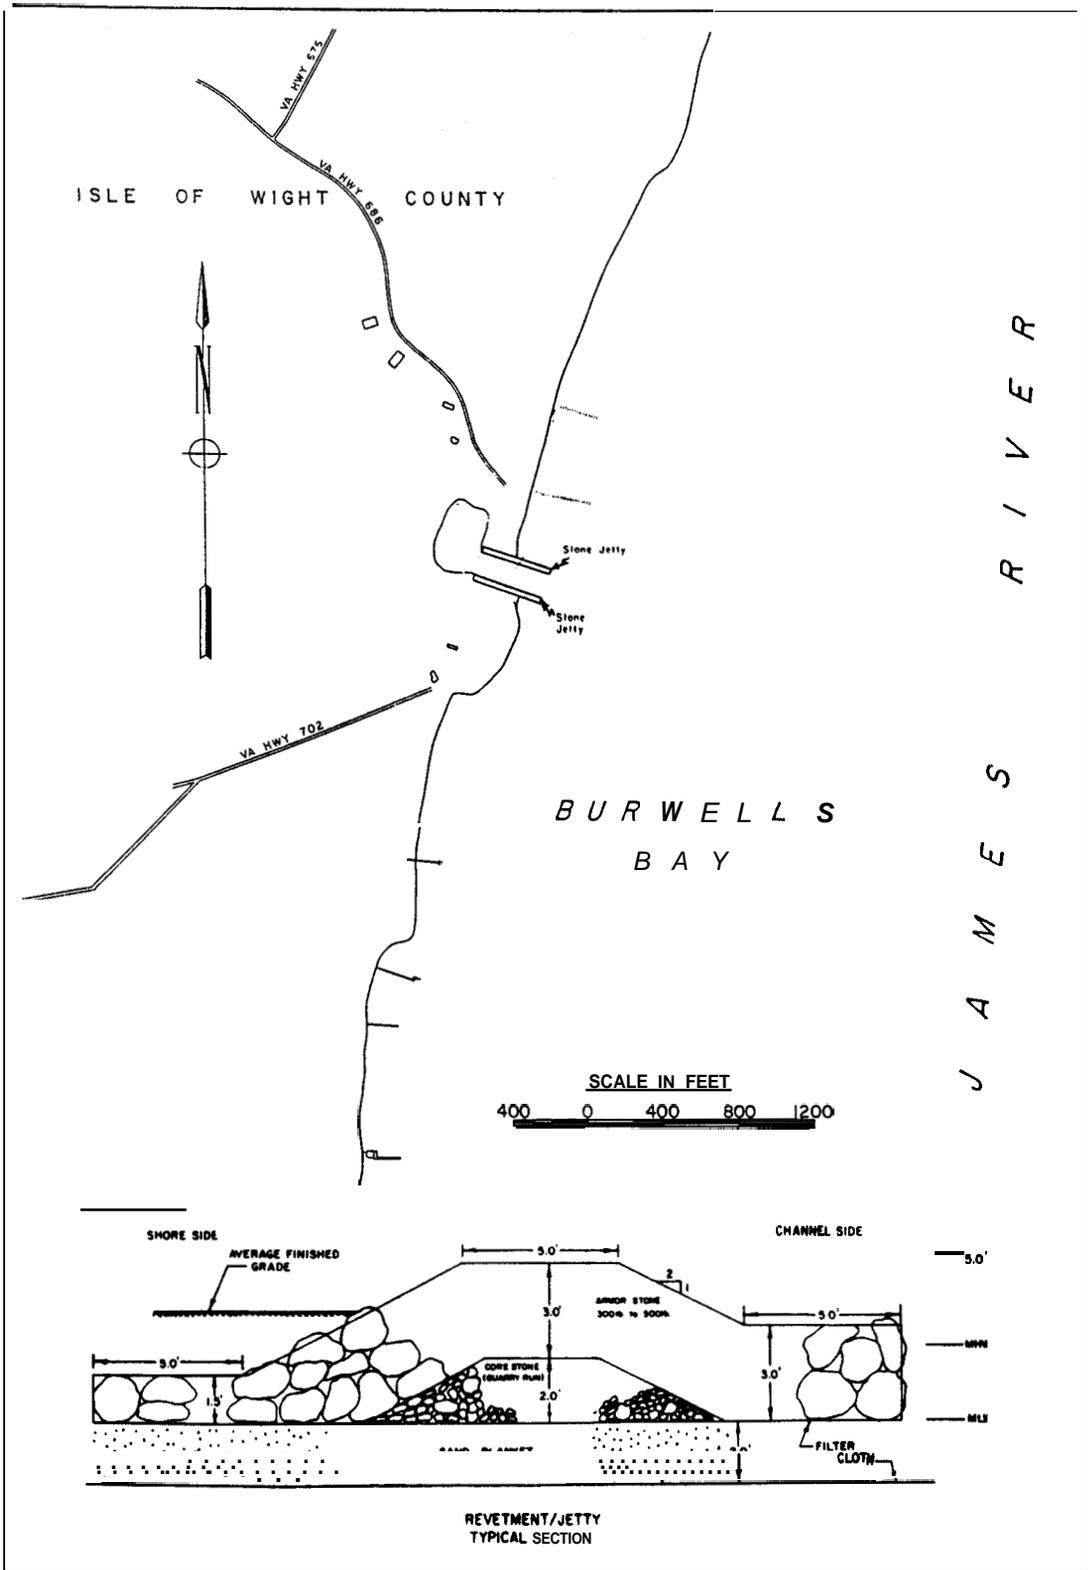
Figure 71. Tylers Beach, Virginia

Date(s)	Construction and Rehabilitation History
1981	Two parallel rubble-mound jetties were constructed to provide channel control. Both jetties were 370 ft in length and spaced 120 ft apart (Figure 71). Crest elevation was +5.0 ft mlw but allowed for 0.5 to 1.0 settlement; crown width was 5.0 ft; and side slopes were 1V:2H. One layer of armor stone, 300 to 500 lb, was placed over one layer of core stone, 3.0 to 40 lb. The jetties rested on a 2.0-ft-thick sand blanket. The sand was encased by filter fabric. A 5.0-ft-wide, 1.5-ft-thick apron and a 5.0-ft-wide, 3.0-ft-thick apron were placed on the shore and channel sides, respectively (Figure 71). A 6.0-sec, 4.1-ft design wave was used. Estimated cost of construction was \$245,000.
1986	No further repair or maintenance information has been found.
