TECHNICAL REPORT REMR-CO-3

CASE HISTORIES OF CORPS BREAKWATER  
AND JETTY STRUCTURES

Report 7

NEW ENGLAND DIVISION

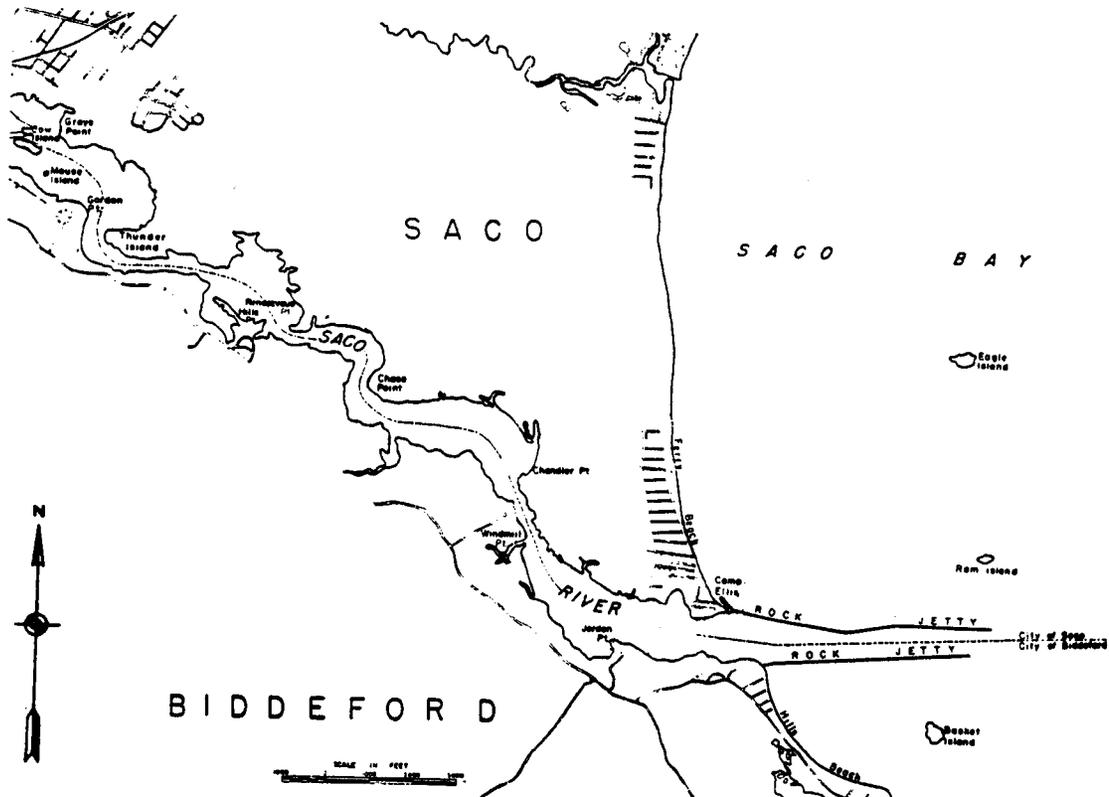
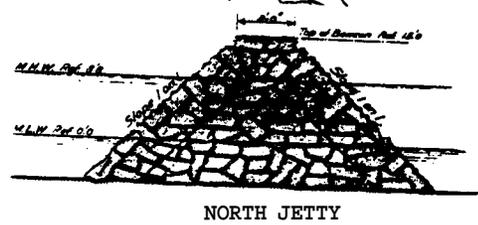
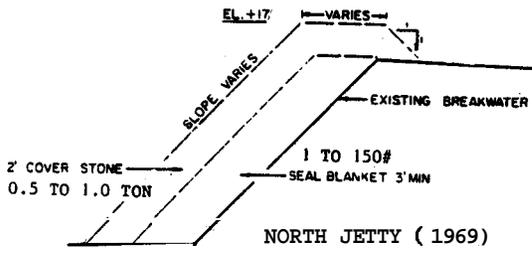
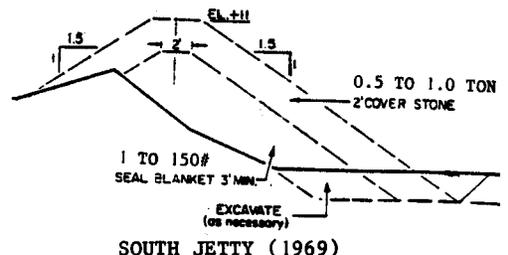
Figure 12. Plan view and typical sections of Saco River Jetties, Saco, Maine

Date(s)	Construction and Rehabilitation History
1873- 1912	During this period (noninclusive) the north (Sharp's Ledge) and south (Hills Beach) jetties were constructed to lengths of 4,100 and 4,800 ft, respectively. The north jetty had an elevation of +15 ft mlw and an 8-ft crown width. The south jetty top elevation and width were +5.5 ft mlw and 10 ft, respectively. Jetty side slopes were 1V:1H. The jetties are roughly parallel and spaced 700 ft apart (Figure 12, present plan view). The south jetty extended approximately 1,600 ft bayward of the north jetty. The mean tide range is 8.8 ft.
1927- 1930	The north jetty was extended 1,600 ft bayward. The design cross section was identical to that used on the south jetty. The extension resulted in adjacent bayward ends of the jetties. Repairs were made on the outer 1,600 ft of the south jetty. The repair cross section was identical to the original design. Extension and repair costs totaled \$53,800 with approximately 18,100 and 2,450 tons of stone placed on the north and south jetties, respectively.

Date( s )	Construction and Rehabilitation History
1971	About 650 ft of shoreline revetment was placed landward of the south jetty terminus. The cost for placing 7,350 tons of stone and 3,000 cu yd of sand fill was \$93,100.
1983	An inspection indicated the south jetty was in good condition. The 1968 north jetty repair section was in good condition, but the remainder of the jetty was in poor condition.

1934- 1938	The north jetty was extended 900 ft bayward, and at the landward end a 160-ft section was repaired. The extension gave the jetty a total length of 6,600 ft, and the design cross section was similar to that of the previous extension. The design cross section for the landward repairs specified a +18 ft mlw elevation, a 12-ft crown width, and 1V:1H side slopes.
1958	The landward 700 ft of the north jetty were repaired to a crown elevation of +15 ft mlw, a 12-ft crown width, and slopes of 1V:1H and 1V:1.7H on the channel and bay sides, respectively. Stone size varied from 0.5 to 7 tons or more, with 75 percent of the stone averaging more than 5 tons apiece. Prior to the repairs, existing center-line elevations varied from +9 to +15 ft mlw. A total of 5,100 tons of stone was placed for a cost of \$38,000.
1969	Repairs were made at the landward ends of the jetties by placing a seal blanket of 1- to 150-lb stone and 0.5- to 1.0-ton cover stone. Repair sections were 1,000 and 1,100 ft in length on the north and south jetties, respectively. The repair geometry was placed on the bayside slope of the existing jetty sections, with a minimum blanket thickness of 3 ft and a 2-ft cover layer. The north jetty design geometry had a +17 ft mlw crown elevation, various crown widths from 3 to 12 ft, a variable bayside slope matching the existing slope, and a 1V:1H channel side slope. The south jetty design geometry consisted of a +11 ft mlw crown elevation, 3-ft crown width, and 1V:1.5H side slopes. The cost for placing 16,600 tons of stone was \$199,000.

TYPICAL CROSS SECTION SHOWING REQUIRED DIMENSIONS  
SCALE 1"=10'  
EXISTING BREAKWATER 2-6 TON GRANITE STONE  
REQUIRED REPAIRS WALL AVERAGE 3 TON SP RAP  
NORTH JETTY REPAIR SECTION (1958)

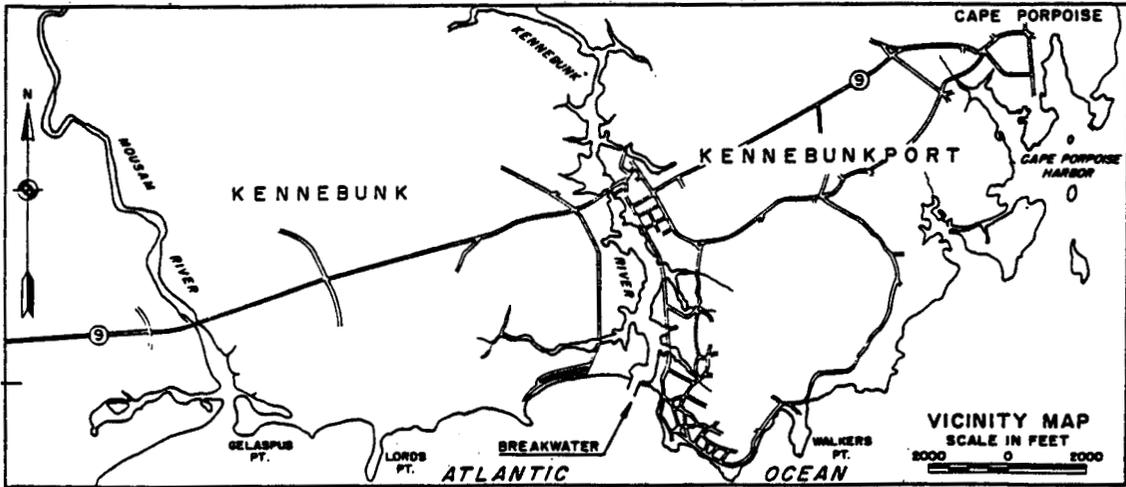
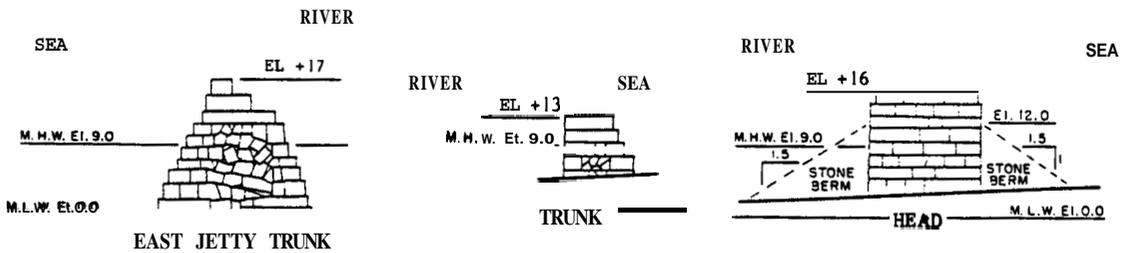
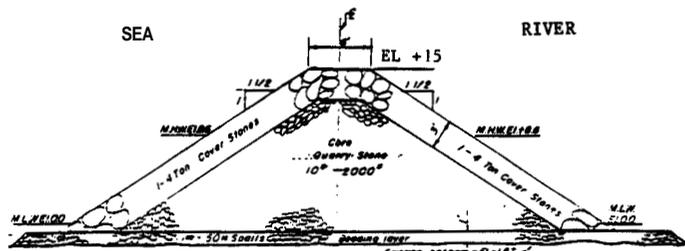
1977- 1978	Visual inspections indicated the jetties were in poor condition. On the east jetty the seaward side of the head (stone pier) was severely damaged, void spaces in the seaward slope armor stone were evident, and the channel side toe was in a deteriorated state due to undermining. On the west jetty extension the outer 150 ft had large amounts of displaced cover stone with typical elevations from +6 to +13 ft mlw. The remainder of the extension was in considerably better shape with only minor displacement and settlement of the armor stone.
1981	The jetties were repaired with armor stone along the damaged sections observed on previous inspections and a topographic survey. The channel side of the east jetty, from 1+66 to 3+80, was repaired with 5- to 8-ton stone placed to an elevation of +12 ft mlw, a 1V:1H side slope, and a top width varying from 0 to 4 ft. The east jetty's seaside was repaired between 4+20 and 5+24 using 5- to 8-ton stone

WEST JETTY AND SEAWARD  
STONE BERM (1962)

SECTION A-A  
WEST JETTY EXTENSION (1964-65)

EAST JETTY REPAIR SECTION (1969)

1969	Repairs were made by placing quarried stone on the east jetty seaward slope from approximately 1+00 to 5+00. Also included were repairs of an undermined channel side section between 2+50 and 2+60 and a breached section, with a maximum depression of about 9 ft, between 3+20 and 3+50. Prior inspections between 1964 and 1967 indicated the jetty was in poor condition. The seaward slope armor stone was placed to +16 ft mlw, a minimum, composite top width of 6 ft (including the existing capstone), and a 1V:1.5H side slope. The core consisted of chips to 2,000-lb stone, and the cover layer was 5- to 8-ton stone. The damaged sections were repaired by resetting existing stone blocks and adding new stone. The design channel side slope was 1V:1H. A total of 5,600 tons of stone was placed for a cost of \$100,800. The west jetty was in good condition with only minor displacement of armor stone along the recent extension.

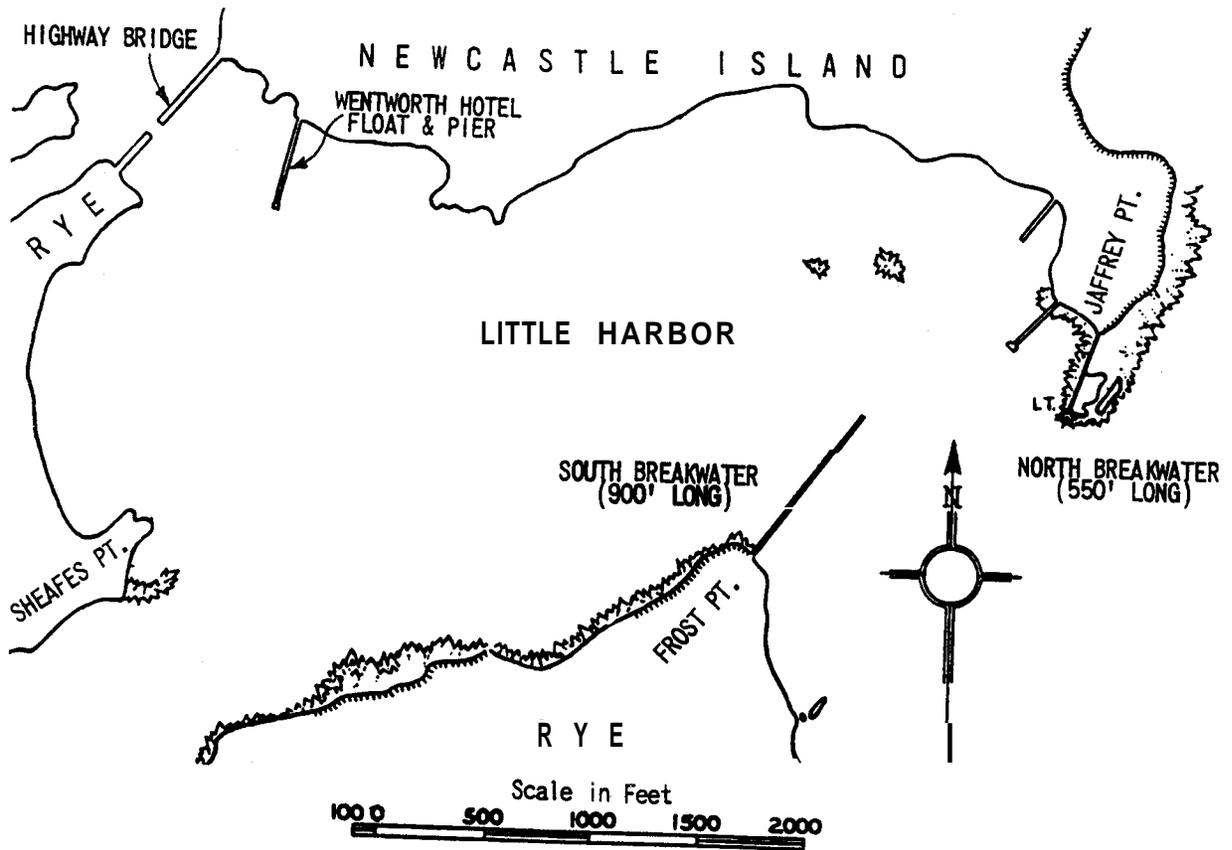
Figure 16. Plan view and cross sections of breakwaters at Little Harbor, N.H.

Date(s)	Construction and Rehabilitation History
1894-1903	Two rubble-mound breakwaters were constructed to lengths of 550 and 900 ft on the north and south sides of the entrance to Little Harbor (Figure 16).
1905	Minor repairs were made using 476 tons of stone.
1959-1974	Based on several visual inspections, the jetties were considered to be in poor condition.
1975	Seaward sections of the north and south jetties, 350 and 850 ft long, respectively, were repaired using 4 to 7-ton stone. The design cross section (Figure 16, inset) had a +12 ft mlw crown elevation, a 12- or 14-ft top width, and <b>1V:1.5H</b> side slopes. The side slope on the seaward facing quadrant of the breakwater heads was 1V:2H. The cost for placing 7,800 tons of stone was \$159,500.
1983	An inspection showed that the north jetty had a few small areas of displaced stone, and the south jetty had substantial damage which was subsequently repaired along the seawardmost 150 ft.

TYPICAL SECTION-NORTH BREAKWATER (1975)

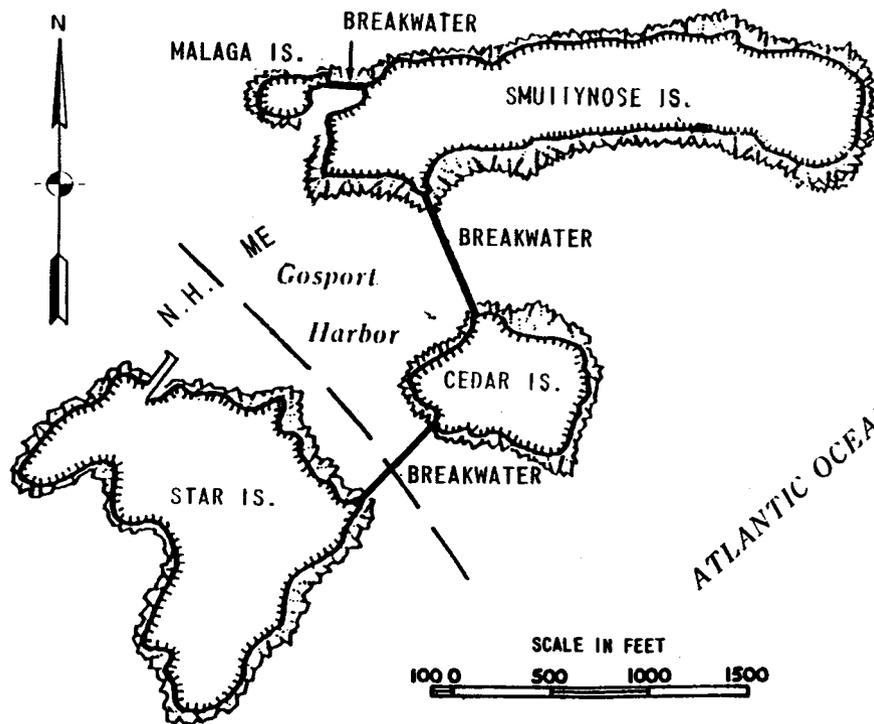
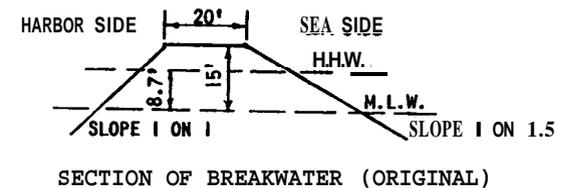
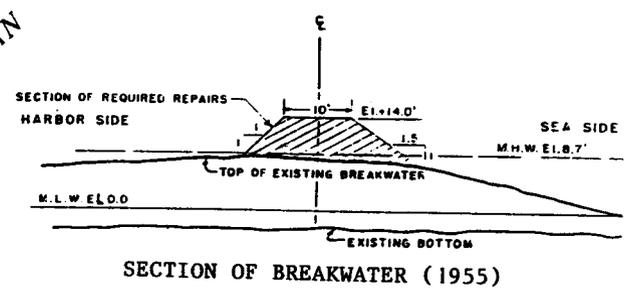
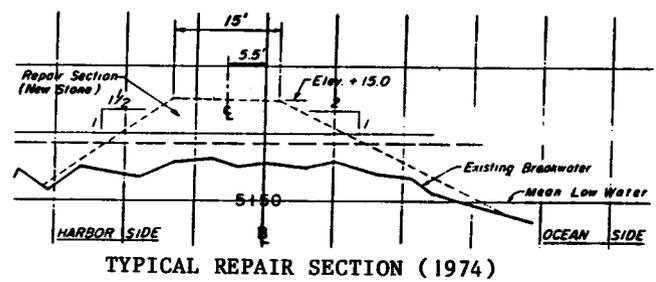
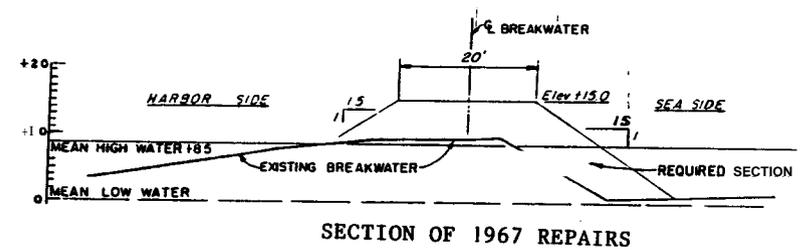
Figure 17. Breakwaters at Isles of Shoals, Maine, and N.H.

1967	The Cedar Island to Star Island breakwater was inspected and found to be in poor condition. Plans and specifications were prepared for repairing a 500-ft section adjacent to Star Island. But, due to contract bids substantially above the Government estimate, no contract was awarded. The plans show the breakwater to be approximately 650 ft long with a 200-ft dogleg section adjacent to Star Island, apparently adding 120 ft to the original length. Existing center-line elevations were typically from +9 to +13 ft mlw along the proposed repair section.
1974	About 575 ft of the Cedar Island to Star Island breakwater, adjacent to Star Island, were repaired using 6- to 10-ton stone. Prior to repair, typical center-line elevations varied from +6 to +10 ft mlw. The stone was placed to an elevation and top width of +15 ft mlw and 20 ft, respectively. Slopes were 1V:2H and <b>1V:1.5H</b> on the sea and harbor sides, respectively. In addition to 14,000 tons of new stone, displaced stone on the harbor side was used in reconstructing the lower portions of the breakwater. The repair cost was \$665,000.

1983	Visual inspections of the Cedar Island to Star Island and Cedar Island to Smuttynose Island breakwaters indicate the former was in good condition, while the latter was in fair to poor condition with a significant amount of damage along its midsection.
1986	Present conditions of the breakwaters are not known.

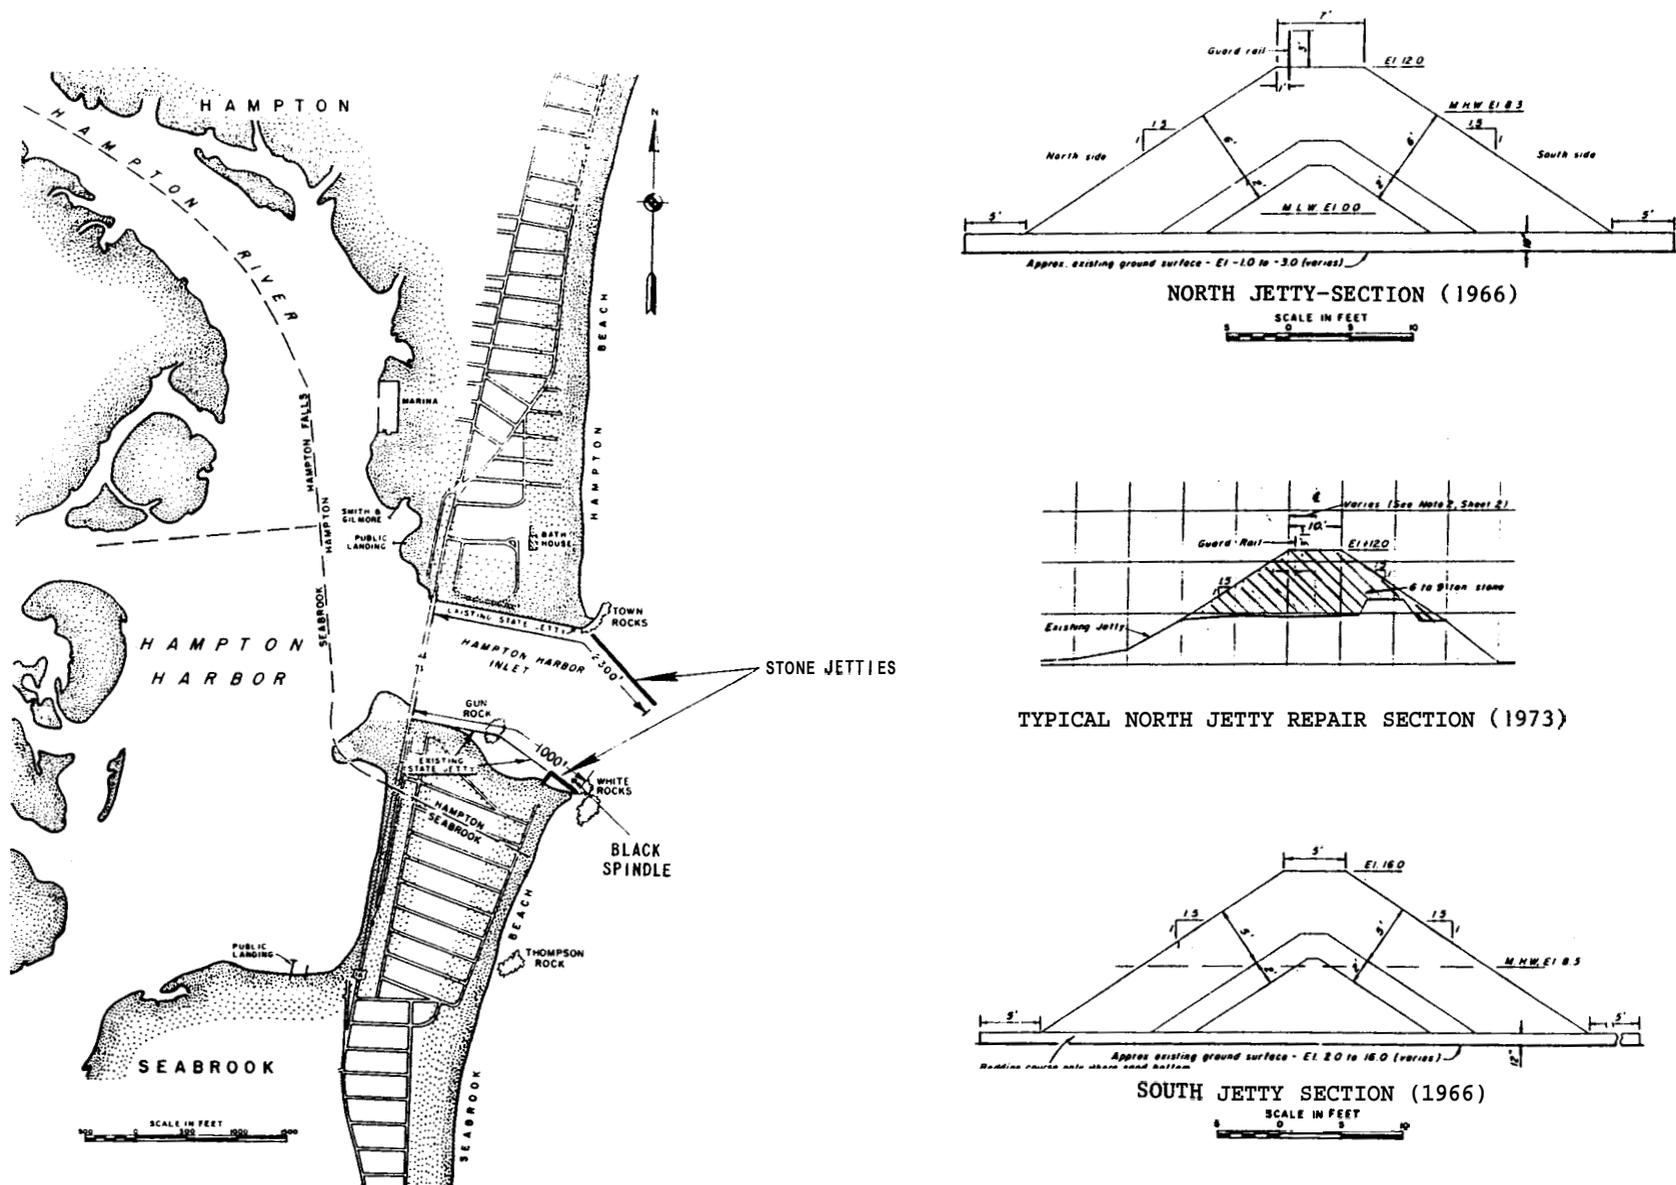
Figure 18. Jetties at Hampton Harbor, N.H.

1969	Plans and specifications were prepared for north jetty repairs, but no work was done at this time. The outer 110 ft was in an unraveled condition with typical center-line elevations from +3 to +10 ft mlw.
1973 1974	The north jetty extension was repaired. Prior to repair, the jetty had numerous void spaces and gaps along its entire length. The seaward 300 ft was in a severely unraveled state with typical crest elevations between 0 and +10 ft mlw. The seaward 490 ft was brought up to +12 ft mlw with 6- to 9-ton stone placed to an 8- to 10-ft crown width and <b>1V:1.5H</b> side slopes. The jetty head semicircle had a 1V:2H side slope. The landward 55 ft was rebuilt to the 1966 design geometry with 2- to 3-ton stone. Void areas on the remaining jetty section were repaired with 2- to 3-ton stone. A total of 8,380 tons of stone was placed at a cost of \$165,400.
1981	Repairs to the north jetty consisted of placing 4- to 9-ton stone on a 535-ft section at its seaward end. The design geometry was essentially identical to the earlier 1973-74 repair geometry. Before the repairs, typical crown elevations varied from +3 to +12 ft mlw with most of the subsidence occurring at the seaward end of the repair section. A total of 1,290 tons of stone was placed at a cost of \$109,905.

1984	The jetties were inspected and found to be in excellent condition. Figure 19 is an aerial photograph of the jetties taken on 16 October 1984.

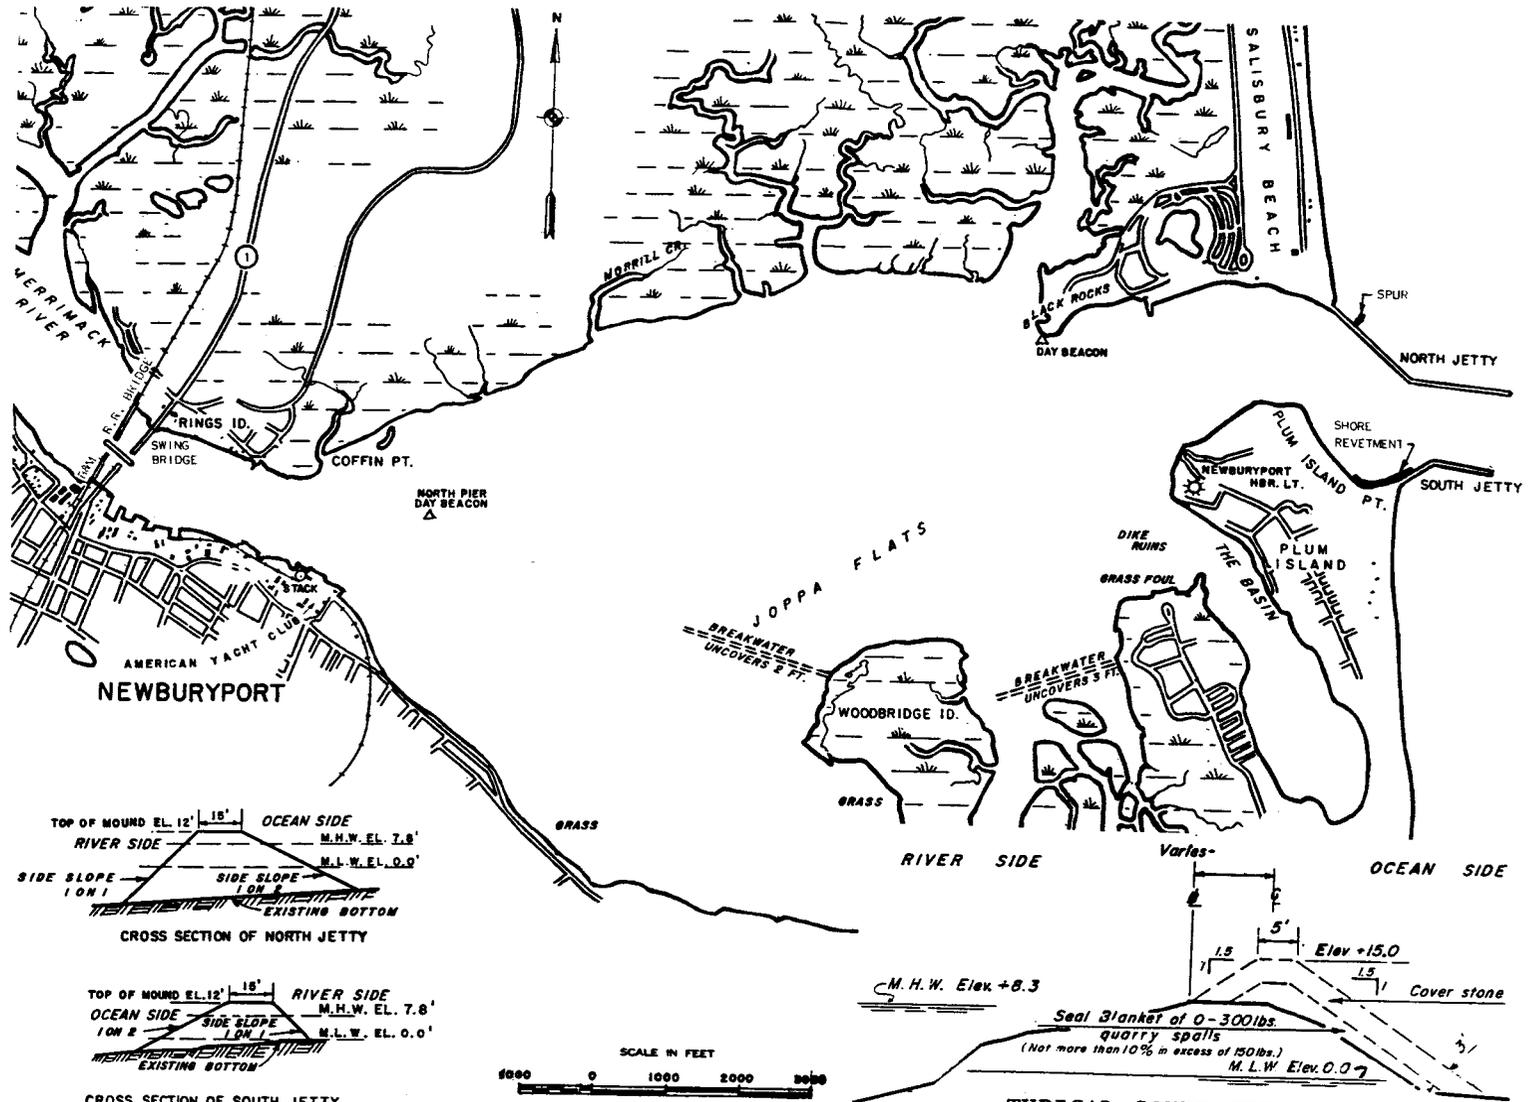
Figure 20. Location map and typical sections of jetties at Newburyport Harbor, Mass.

1936-1938	Repairs were made to the north and south jetties for a total cost of <b>\$143,700</b> using <b>29,930</b> and <b>7,810</b> tons of stone, respectively.
1963	An inspection showed both jetties were in poor condition.
1968-1970	Extensive repairs were made to <b>2,920-</b> and <b>1,095-ft-long</b> sections of the north and south jetties. The repaired sections would best define the existing lengths of the jetties (Figure 20, plan view). <b>Also</b> completed were <b>700 lin ft</b> of revetment adjacent to, and landward of, the south jetty repairs. The north jetty repairs started from its reconstructed landward end at <b>1+00</b> and continued to the existing seaward end at <b>30+20</b> . The south jetty repairs started from its reconstructed landward end at <b>0+00</b> , stopped at <b>6+00</b> , started again at <b>10+05</b> and continued to its reconstructed seaward end at <b>15+00</b> . An undetermined length of south jetty seaward of <b>15+00</b> was not repaired. Seaward of <b>5+50</b> both jetties were built up to <b>+12</b> ft mlw with a <b>15-ft</b> crown width and slopes of <b>1V:1H</b> and <b>1V:2H</b> on channel and sea sides, respectively. The landward sections (Figure 20, inset) had <b>1V:1.5H</b> side slopes, a crown width of <b>5</b> ft, and maximum crown elevations of <b>+17</b> and <b>+15</b> ft mlw on the north and south jetties, respectively. The stone size varied from a minimum of <b>0.5</b> tons at the landward ends to a maximum of <b>12</b> tons at the seaward ends. The estimated quantity of

Date(s)	Construction and Rehabilitation History
1968- 1970 (cont.)	stone was 53,600 tons which were to be placed for a total contract cost of \$1,267,500. Similarly, the south jetty costs were \$221,500 for placing an estimated 13,500 tons of stone and 7,000 cu yd of sand and gravel.
1974	Inspections up to this time indicate the jetties were in good condition overall. Both jetties had isolated areas of settlement, with two areas on the north jetty being severe.
1983- 1987	Visual inspection of jetties indicated the jetties were in good condition.

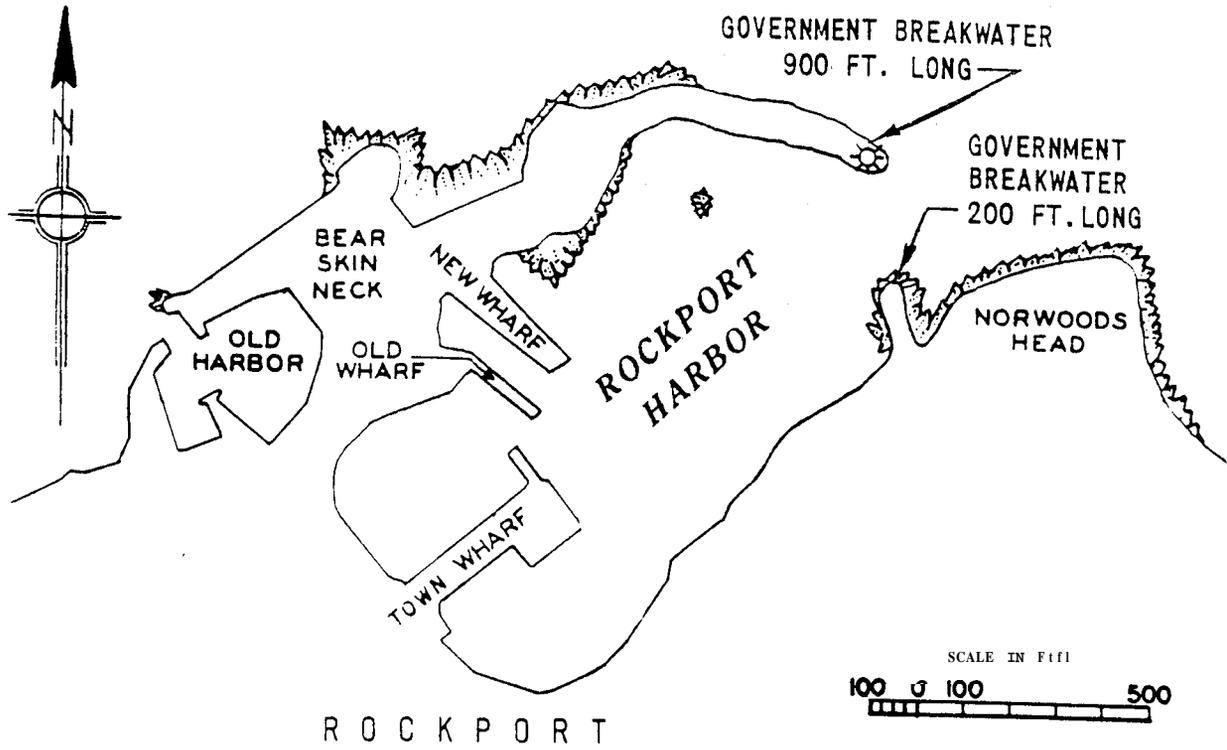
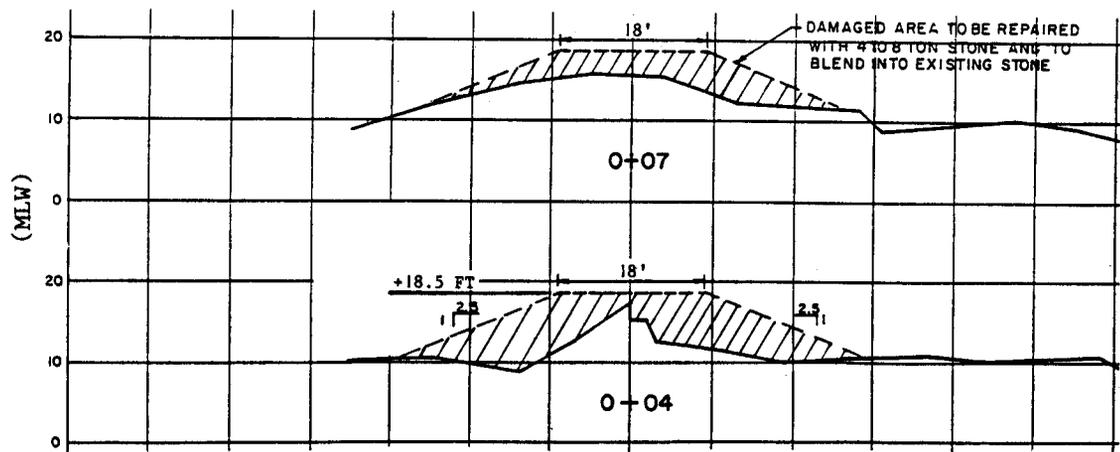
Figure 22. Breakwaters at Rockport Harbor, Mass.

1970	Repairs were made at the seaward end of Bearskin Neck breakwater where stone had been displaced from a lower portion of the head side slope. The existing head section cover layer had a fairly smooth appearance due to careful placement and addition of concrete grout. <b>Also</b> , iron tie rods had been placed, connecting individual cover stone throughout this section. The remainder of the breakwater is composed of 500-lb to <b>5-ton</b> stone with an outward appearance typical of rubble-mound structures. The <b>45-ft-long</b> repair section was located mostly on the harbor side quadrant of the head. Stone weighing <b>5</b> to <b>8</b> tons was placed at a <b>1V:2H</b> side slope. The repairs were made for a lump sum of <b>\$25,500</b> .
1973	The seaward end of Bearskin Neck breakwater was repaired with <b>5-</b> to <b>8-ton</b> stone. The stone was placed on two sections, one totaling <b>55</b> ft in length on the seaside head and trunk and the other totaling <b>50</b> ft in length, the same area repaired in <b>1970</b> . The repairs consisted of adding stone to void areas such that the resulting side slopes were fairly uniform. Lump sum cost of the repair was <b>\$28,700</b> .

1977- 1978	Repairs were made to the seaward <b>100</b> ft of Bearskin Neck breakwater. Existing displaced stone was reset throughout this section and, to complete the repairs, approximately <b>1,600</b> tons of new <b>4-</b> to <b>8-ton</b> stone were used. The repair geometry had a <b>+18.5</b> ft mlw crown elevation, a crown width varying from <b>18</b> to <b>28</b> ft (widest at seaward end), and side slopes varying from <b>1V:2.5H</b> to <b>1V:1.5H</b> (steepest at

TYPICAL REPAIR SECTION (1977-78)

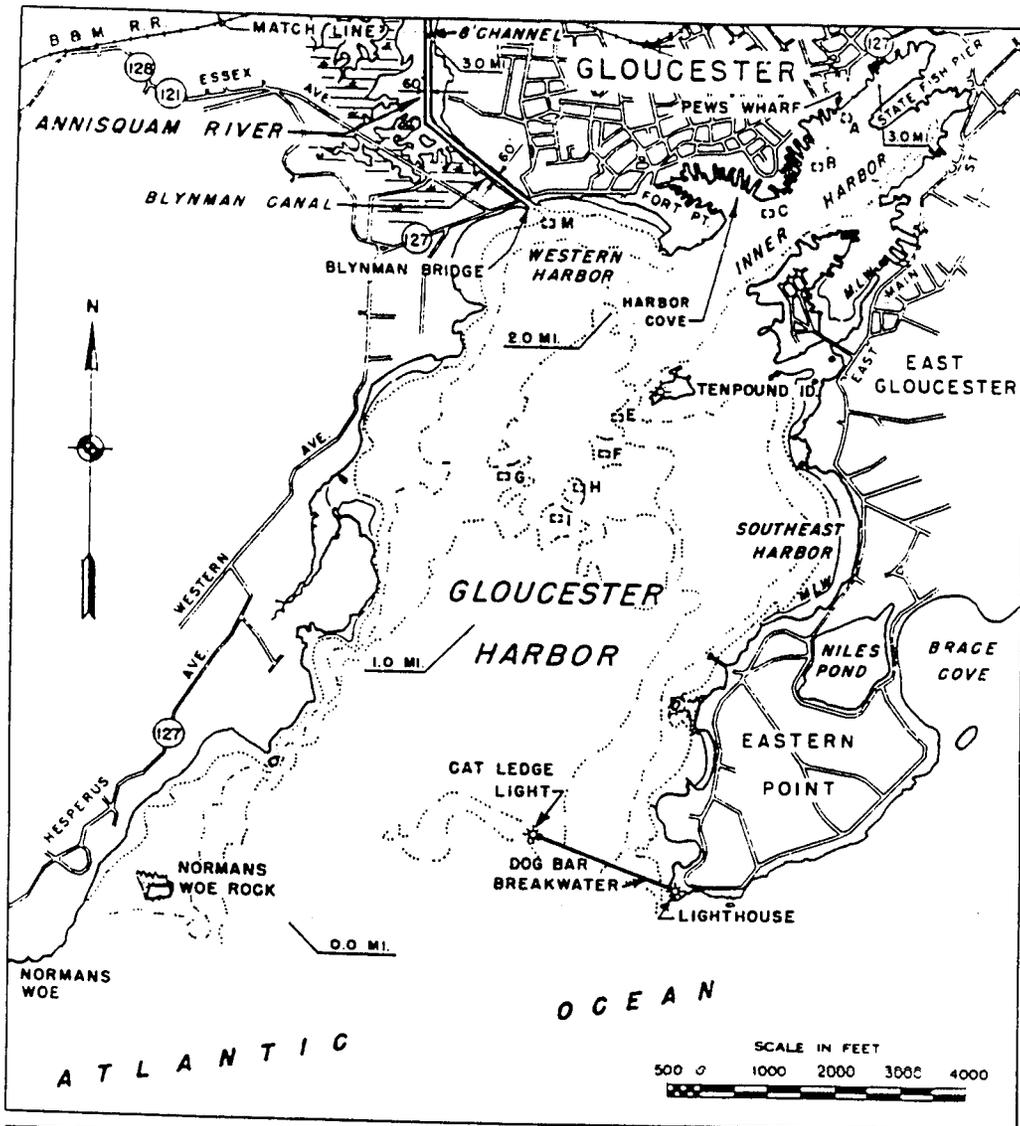
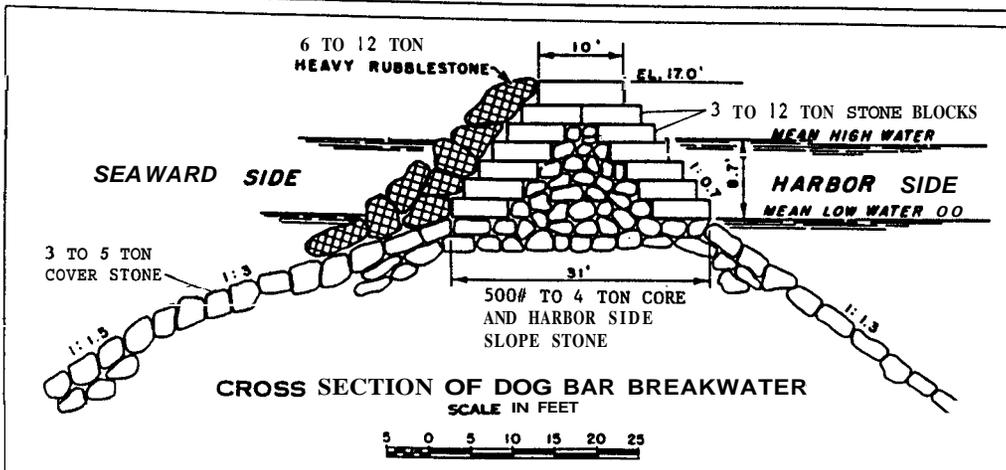
Figure 23. Plan view and typical section of Dog Bar breakwater at Gloucester Harbor, Mass.

1967- 1978	Breakwater inspections, taken over this period, showed a gradual deterioration of the sea-side armor stone at several locations. Most of the damage was on the outer half of the breakwater.

1931- 1940	Minor repairs were made to the superstructure in 1931, 1933-34, 1935, 1939, and 1940. The work (approximate totals in parentheses) included resetting (2,000 tons) and replacing (1,000 tons) stone blocks, placing rubble stone (7,000 tons) on the seaward face (Figure 23, inset), and placing iron pins (700) on the harbor side stone blocks to act as buttressing for the upper courses of stone. The total repair costs were \$35,700.
1962	A breakwater inspection showed the stone block superstructure was in good condition with only localized areas needing repair. The sea-side armor stone, placed during 1931-40, was in poor condition with several large cavities and a general subsidence along the entire breakwater length.
1965- 1966	Repairs were made to the breakwater superstructure, and 10,920 tons of 6- to 12-ton armor stone were placed on the sea side between 0+00 (landward end) and 21+85. Displaced stone blocks were reset from 1+14 to 1+72 and 9+96 to 10+22. Total cost of the repairs was \$96,400.

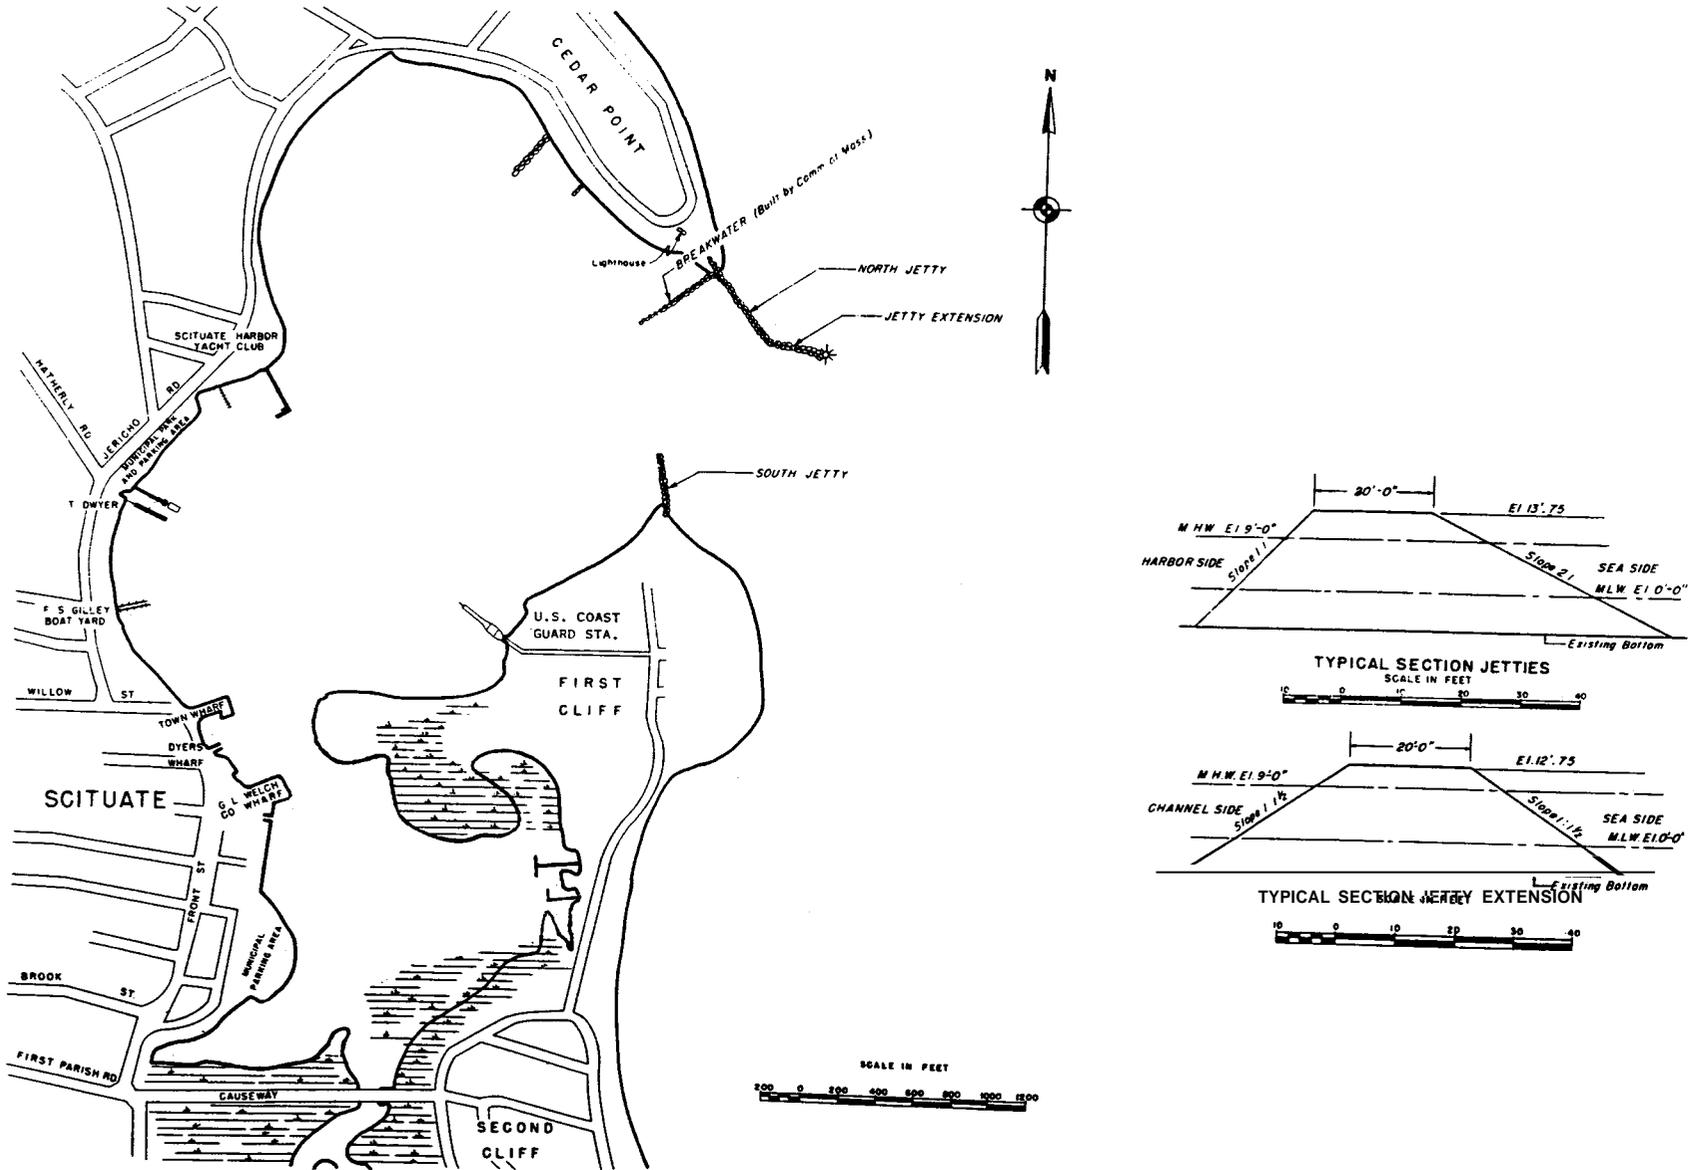
Date( s)	Construction and Rehabilitation History
1881- 1882	A 720-ft-long rubble-mound jetty was constructed on the north side of the entrance to Scituate Harbor (Figure 24). The stone was placed to an elevation of +13.75 ft mlw, a 20-ft crown width, and slopes of 1V:2H and 1V:1H on the sea and harbor sides, respectively. A total of 16,780 tons of stone was used at an approximate cost of \$26,000.
1892- 1895	A 450-ft-long south jetty (Figure 24) was constructed using 13,040 tons of stone for a total cost of \$17,750. The cross-section geometry was identical to that of the north jetty geometry.
1929- 1930	Repairs were made over the length of the north jetty using 4,680 tons of riprap for a total cost of \$22,000.
1940	The north jetty was repaired and extended 300 ft seaward. The design section consisted of core and cover stone placed to an elevation of +12.75 ft mlw, a 20-ft crown width, and <b>1V:1.5H</b> side slopes. The extension required placing 18,300 tons of stone for a total cost of \$41,000. The repairs were made for a total cost of \$7,400 using 3,100 tons of stone.

1960	A topographic survey of the jetties was completed (no details at hand).
1981- 1984	Visual inspections of jetties indicated they were in <b>good</b> condition.

Figure 24. Plan view and typical sections of jetties at Scituate Harbor, Mass.

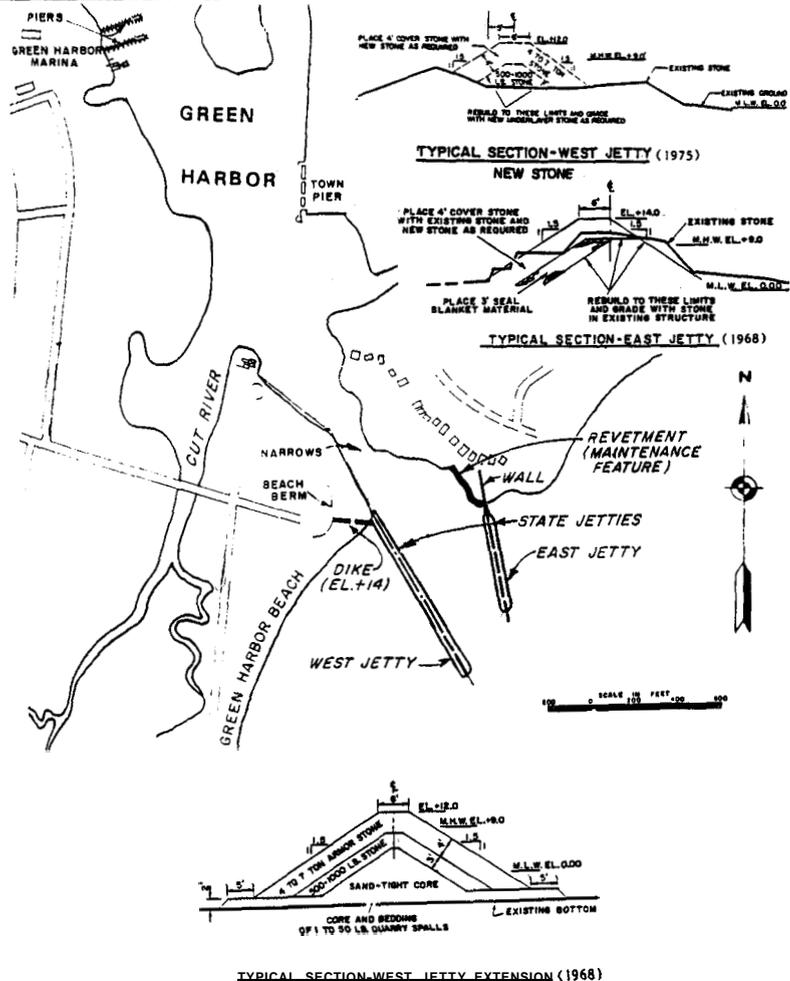
Date(s)	Construction and Rehabilitation History
1898-1899	Two rubble-mound jetties were constructed by the Commonwealth of Massachusetts at the entrance to Green Harbor and have been repaired periodically since that time (Figure 25, present plan view). Information on the original jetty lengths was not found.
1931	The state constructed 196 ft of concrete wall at the east jetty's landward end.
1965	The Federal government adopted the project under authority of the River and Harbor Act of 1960.
1968-1969	Repairs were made to seaward sections of both jetties, and the west jetty was extended 200 ft seaward (Figure 25, insets). The east and west jetty repair sections were 494 and 650 ft long, respectively, and consisted of placing a 3- to 4-ft-thick seal blanket of 1- to 50-lb quarry spalls on the seaward slope of the jetties followed by a 2- to 4-ft-thick layer of cover stone. The cover stone was from 4 to 7 tons and 0.5 to 4 tons on the east and west jetty repair sections, respectively. The design geometry, including the west jetty extension, called for a 6-ft crown width, <b>1V:1.5H</b> side slopes, and crown elevations of +14 and +12 ft mlw on the east and west jetties, respectively. The west jetty extension was built up on a core and 2-ft-thick bedding layer of 1- to 50-lb stone, followed by a 3-ft-thick underlayer of 500- to 1,000-lb stone, and covered with 4- to 7-ton armor stone. The jetties' seaward ends had 1V:2H side slopes. A 175-ft-long dike of 0- to 25-lb stone was placed at the landward end of the west jetty repair section. The stone was placed to a 4-ft top width, <b>1V:2H</b> side slopes, and a crown elevation increasing from +12 to +14 ft mlw in the landward direction. Prior to the repairs, crown elevations varied from +8 to +11 ft mlw and +6 to +13 ft mlw on the east and west jetty repair sections, respectively. The majority of the east jetty was in a severely unraveled state. Improvements cost \$149,000 using a total of 14,900 tons of stone.

1970	Approximately 335 ft of stone revetment was placed at the landward end of the east jetty. The contract price for placing 3,400 tons of stone was \$37,400.
1972-1974	Inspection reports indicate the east jetty was in good to excellent condition. West jetty inspections showed the outer 350 ft was severely unraveled and other void areas existed landward of this section. A 1974 topographic survey showed crest elevations in the

Date(s)	Construction and Rehabilitation History
1972-1974 (cont.)	worst areas as low as +4 ft mlw. It was estimated that 1,000 and 500 tons of new and salvageable stone, respectively, were needed to repair the jetty.
1975	The seaward 525-ft section of the west jetty was repaired to the 1968-69 design cross section using 4- to 7-ton cover stone and 500- to 1,000-lb underlayer stone as needed (Figure 25, inset). The repairs were made for a total cost of \$40,000.
1977	An inspection indicated that the east jetty was in good condition but that the west jetty needed some armor stone reset.
1986	Yearly inspections indicate that the jetties are in good condition. For the purpose of this report, the lengths of the east and west jetties are considered to be 645 and 850 ft long, respectively (the 1968-69 improvements plus approximately 150 ft of concrete wall landward of the east jetty repair section).

Figure 25. Plan view and cross sections of jetties at Green Harbor, Mass.

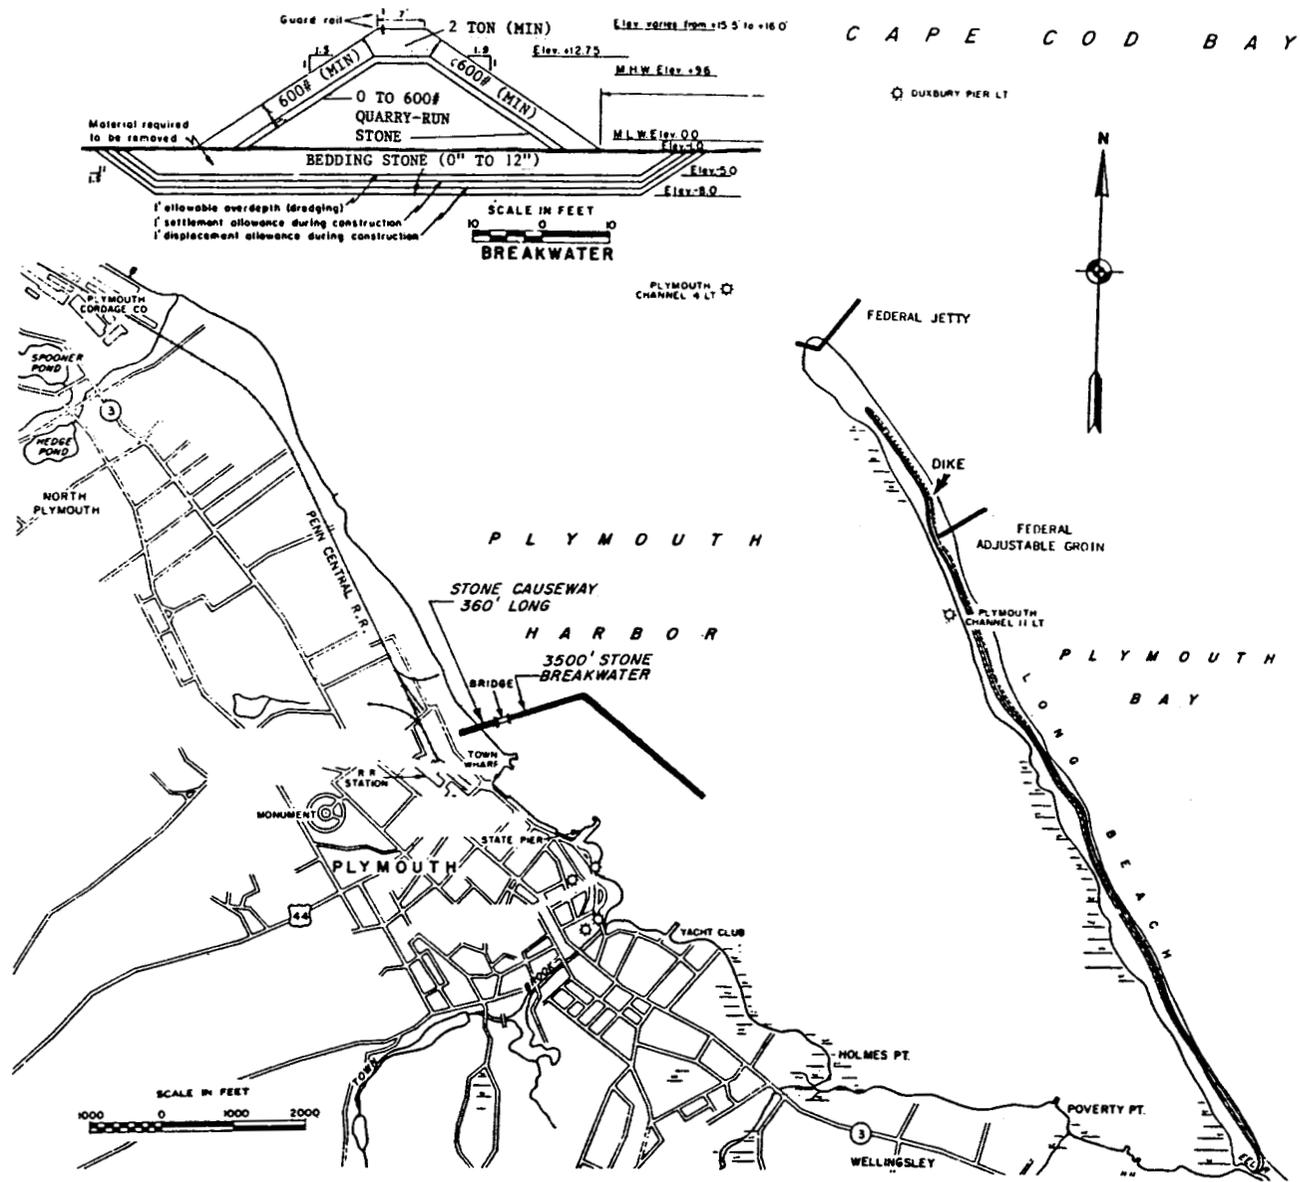
Date(s)	Construction and Rehabilitation History
1968- 1971	<p>A rubble-mound breakwater, with east and west legs 2,100 and 1,400 ft long, respectively, was constructed providing protection to recreational and commercial vessels using Plymouth Harbor (Figure 26, plan view). The design crown elevation was +15 ft mlw, but to allow for foundation settlement the construction elevations were +16 and +15.5 ft mlw on the east and west legs, respectively. The crown width was 7 ft, and side slopes were 1V:1.5H. The breakwater cross-section was made up of 2-ft-thick bedding layer of 0- to 12-in. stone, followed by a core of 0- to 600-lb stone, and the 3-ft-thick outer layer required stone weighing a minimum of 600 lb and 2 tons on the side slopes and crown, respectively. The stone size was based on Hudson's slope stability formula and a design wave height of 3.5 ft, and the crown elevation was based on a design tide of +12.7 ft mlw. The contract price for breakwater construction, using an estimated total of 219,000 tons of stone, was \$1,145,100.</p>

1972- 1978	<p>Inspections during this period showed the breakwater was in excellent condition.</p>
1982- 1984	<p>Visual inspections of the breakwater indicated it was in good condition.</p>

Figure 26. Breakwater at Plymouth Harbor, Mass.
