TECHNICAL REPORT REMR-CO-3

CASE HISTORIES OF CORPS BREAKWATER  
AND JETTY STRUCTURES

Report 7

NEW ENGLAND DIVISION

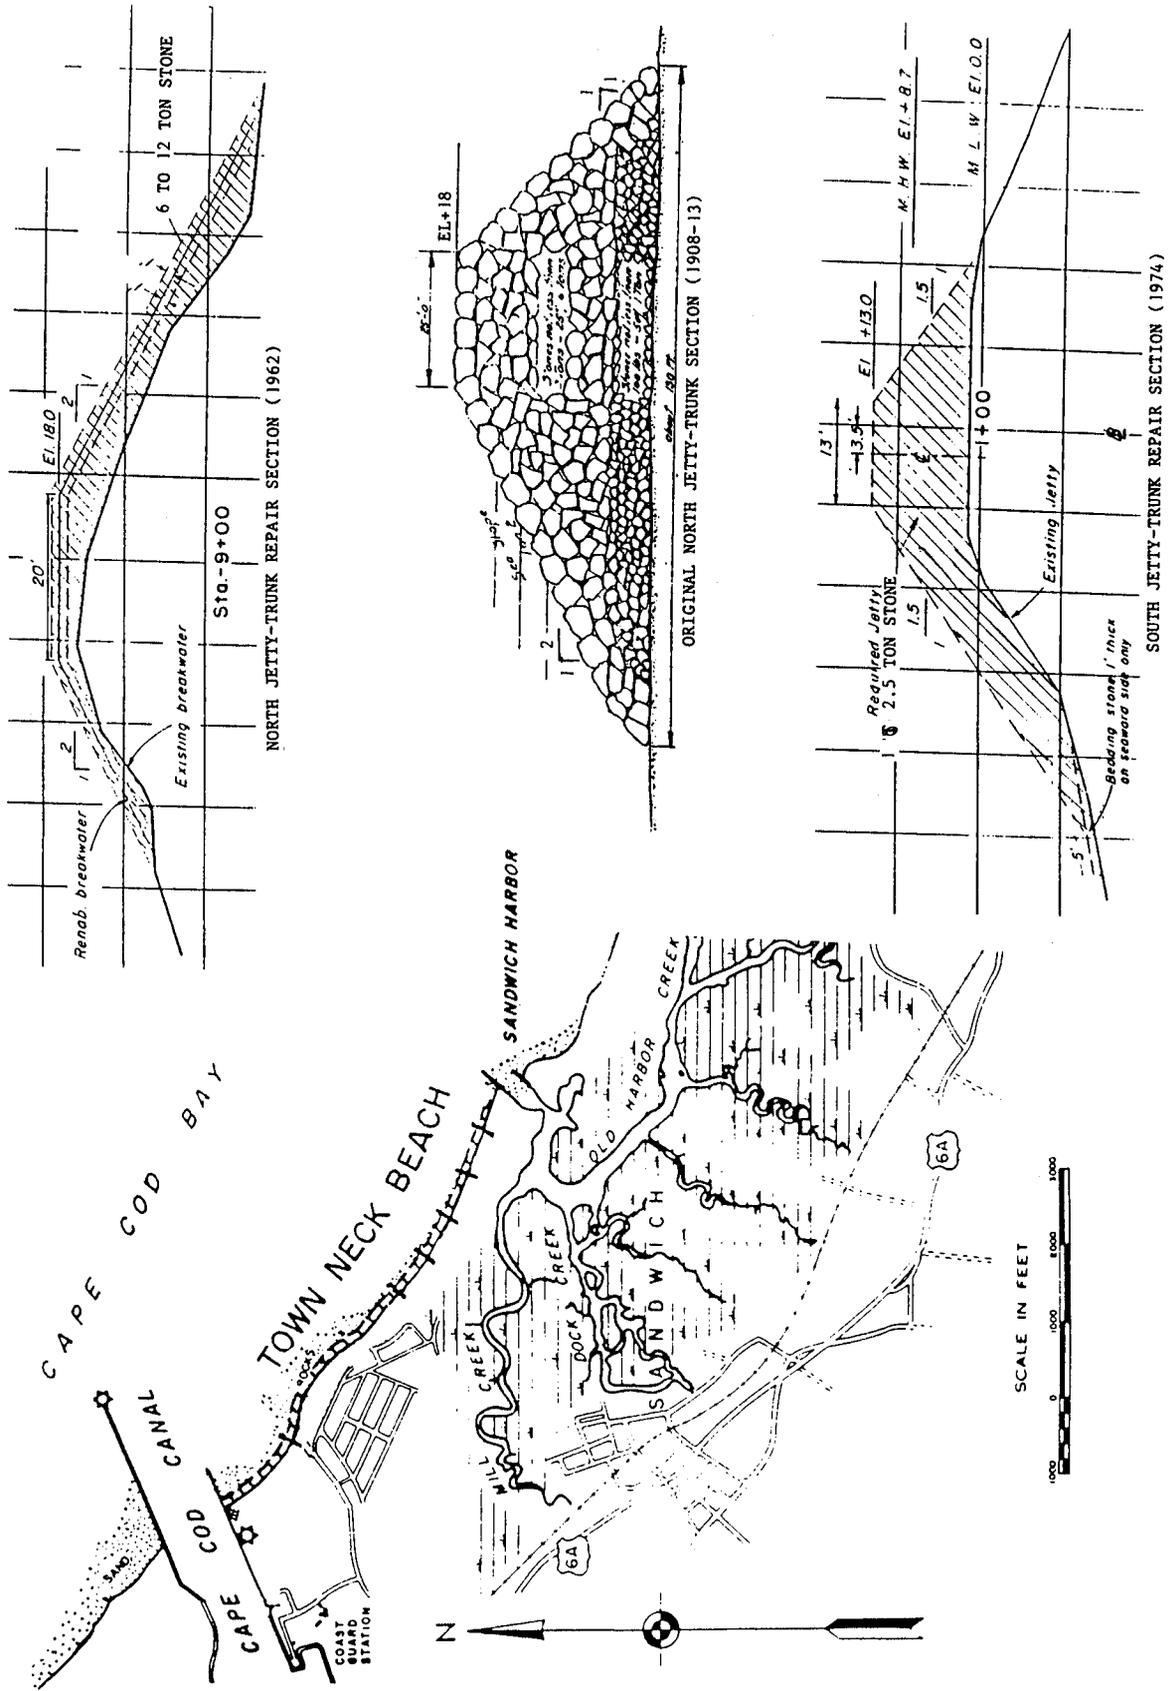
Date(s)	Construction and Rehabilitation History
1908- 1913	Two rubble-mound jetties were constructed by non-Federal interests at Cape Cod Canal's eastern entrance (Figure 27). The north jetty was 3,000 ft long, with a +18 ft mlw crown elevation, a 25-ft crown width, a 1V:1H channel side slope, and a composite seaside slope of 1V:2H and 1V:1H above and below -12 ft mlw, respectively. Stone placed above and below -12 ft mlw weighed approximately 3 to 6 tons and 100 lb to 2 tons, respectively. At the seaward end a concrete cap was placed. The crown width was 30 ft, and the existing bottom elevation was -32 ft mlw. The south jetty appears to have been constructed to a length of 600 ft, a +10 ft mlw crown elevation, a 20-ft crown width, and 1V:1H side slopes. The south jetty armor stone weighed approximately 3 to 5 tons.
1927	The Cape Cod Canal, including the eastern entrance jetties, was purchased by the Federal government.

1962-	The seaward 925 ft of the north jetty was rebuilt to +18 ft mlw. Stone placed on the structure weighed a minimum of 6 tons, except on the 125-ft-long head section, where the minimum size was <b>12 tons</b> . The head section had a 25-ft crown width and a transition in side slopes from 1V:2H to 1V:3H in the seaward direction. A 20-ft crown width and 1V:2H side slopes were specified on the jetty trunk section. Prior to the repairs, typical crown elevations were from +14 to +18 ft mlw on the trunk section and from +7 to +18 ft mlw on the head section. The contract price for placing an estimated 20,000 tons of stone was \$260,000.
1967- 1974	Inspection reports indicate the north jetty was in good condition, while the south jetty was in poor condition with numerous voids and displaced slope stone along its entire length.
1974	The south jetty was rebuilt to <b>+13 ft mlw</b> . The rebuilt section was 690 ft long and terminated at the jetty's seaward end. Side slopes were <b>1V:1.5H</b> . A 13-ft crown width and 5- to <b>7-ton</b> stone were specified on the seaward 200 ft. The remaining section required a 10-ft crown width and 1- to 2.5-ton stone. A 1-ft-thick layer of bedding stone, 0 to 50 lb in size, was placed along the outermost 450 ft of the jetty's seaside toe. Prior to the repairs, crown elevations were typically from +3 to +8 ft mlw. The contract price for placing an estimated 15,500 tons of stone was \$224,800.

1977	The jetties were visually inspected. The south jetty was found to be in good condition, while the north jetty needed repairs throughout its entire length.
1986	Recent yearly visual inspections indicated the jetties were in good condition.

Figure 27. Plan view and typical sections of jetties at Cape Cod Canal, Mass.

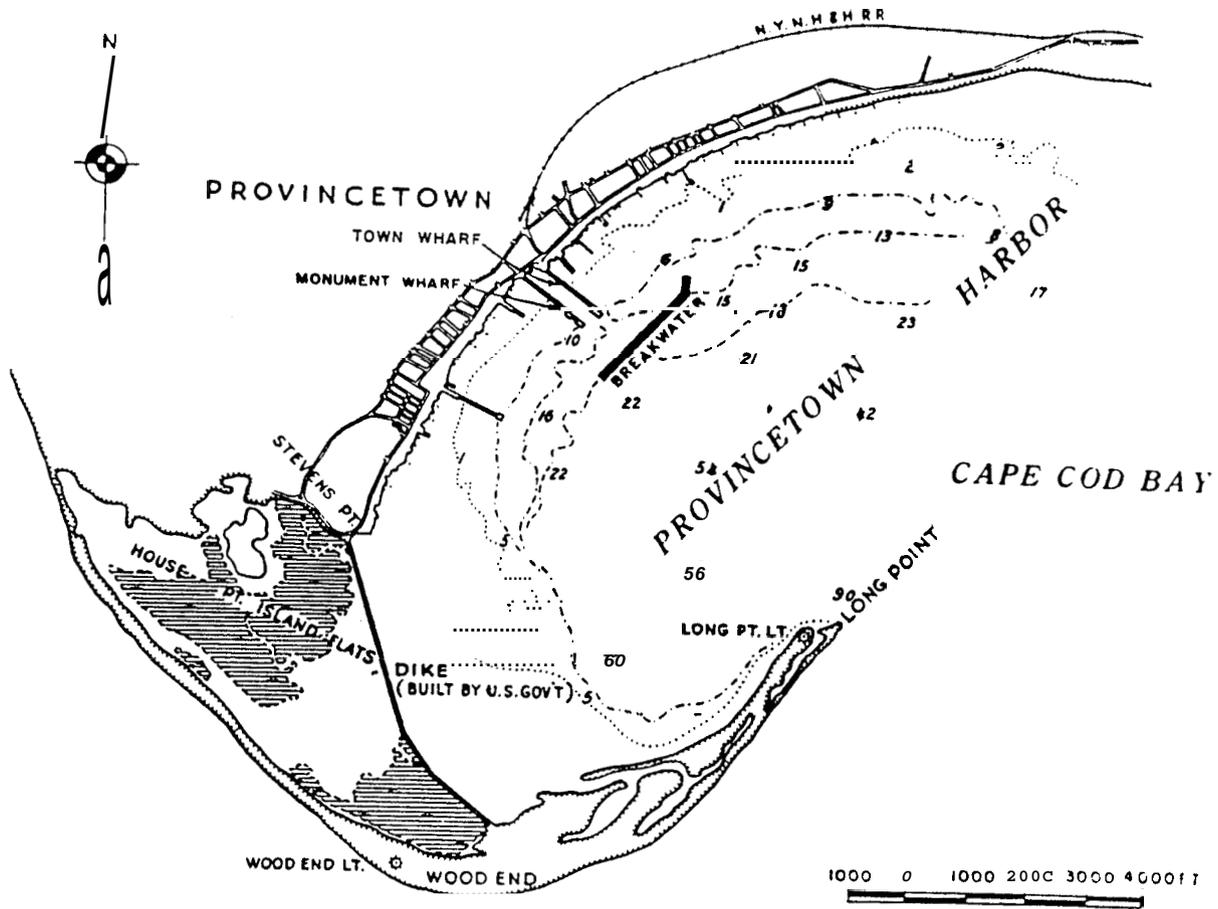
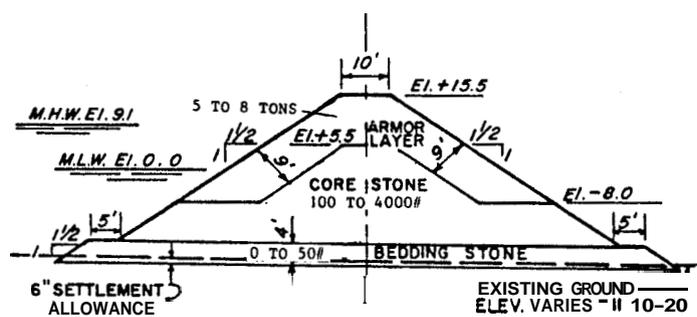
<u>Date(s)</u>	<u>Construction and Rehabilitation History</u>
1970- 1972	<p>A 2,500-ft-long rubble-mound breakwater was constructed, providing Provincetown Harbor protection from storm waves (Figure 28, plan view). The breakwater was placed shore parallel, except for a 350-ft-long shoreward hook at its northern end, and located approximately 2,000 ft offshore in water depths of -11 to -20 ft mlw. The design geometry consisted of a +15.5 ft mlw crown elevation, a 10-ft crown width, and 1V:1.5H side slopes. The breakwater heads differed only in having 12-ft crown widths (via 100-ft width transition sections). The 0- to 50-lb bedding stone was placed in a 3- to 4-ft-thick layer and extended 5 to 8 ft beyond the cross-section toe. The core stone and slope stone below -8 ft mlw were 100 to 4,000 lb in size. A double layer of 5- to 8-ton cover stone was placed above -8 ft mlw. The contract cost for placing an estimated 328,000 tons of stone was \$3,534,000. The design was based on an 8-ft, 7.3-sec fetch-limited wave height and a maximum tide level of +12.2 ft mlw. Stone size was selected using Hudson's slope stability formula.</p>

1978	<p>The breakwater was found to be in excellent condition during a visual inspection.</p>
1984	<p>Recent yearly visual inspections indicated that the breakwater was in good condition.</p>

Figure 28. Breakwater at Provincetown Harbor, Mass.

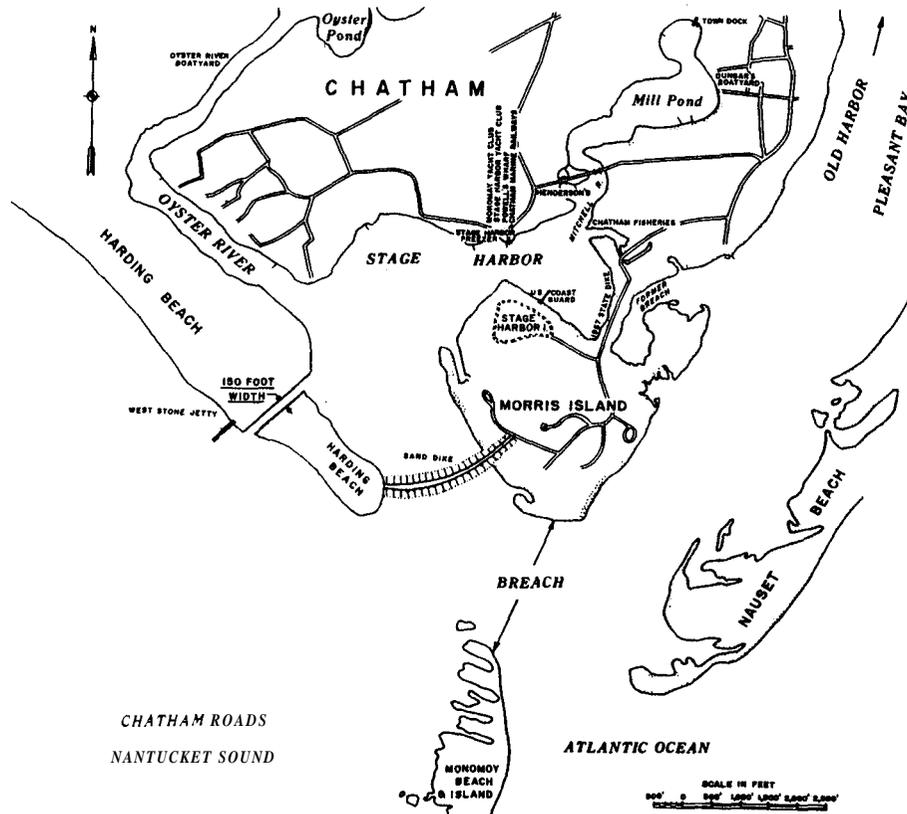
Date(s)	Construction and Rehabilitation History
1965	As part of improvements at Chatham Harbor, a 200-ft-long rubble-mound jetty was constructed on the west side of the entrance channel (Figure 29). The armor stone was approximately 0.5 to 2 tons in size, and the core stone varied from 0 to 500 lb (cross-section details not known). The cost for placing an estimated 1,375 tons of stone was \$13,750.
1967	The jetty was extended approximately 300 ft landward via rubble-mound and stone revetment. Erosion of the adjacent shoreline had resulted in flanking of the jetty's inshore end. The rubble-mound section was built using 0.5- to 2-ton cover stone and 0- to 50-lb core stone. The contract cost for placing 945 tons of stone in the extension was \$12,950.
1968- 1977	Visual inspections indicated the jetty was in excellent condition.
1986	The present condition of the jetty is not known.

Figure 29. Plan view of Chatham Harbor Jetty, Chatham, Mass.

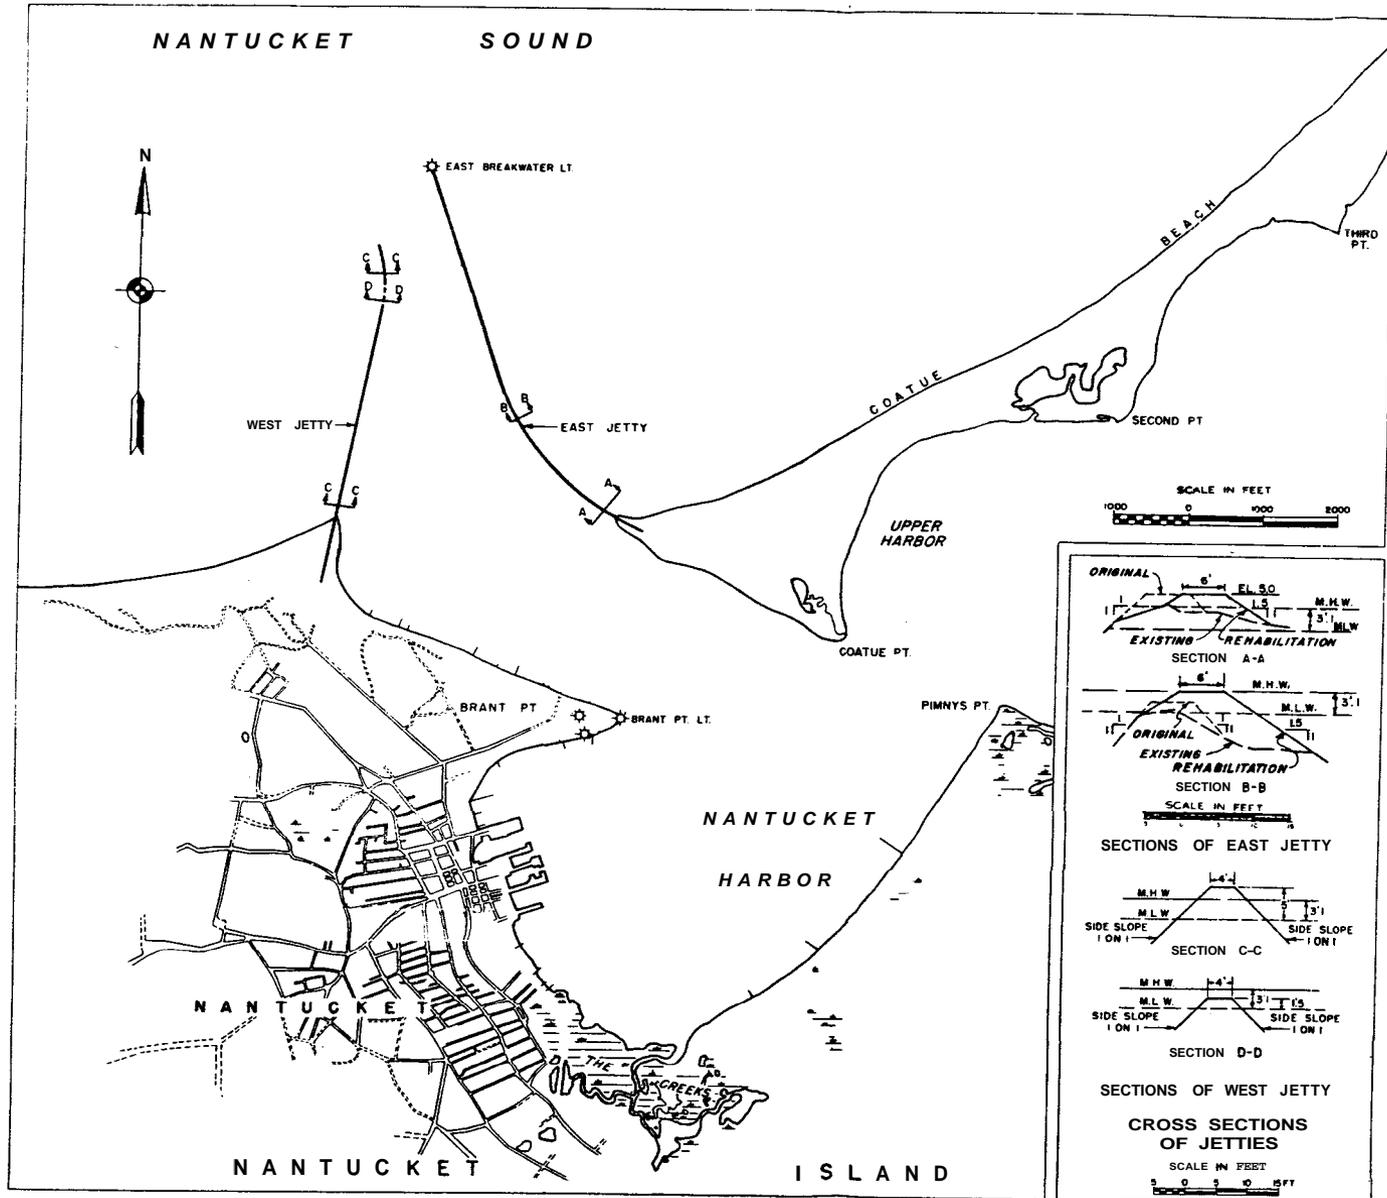
<u>Date(s)</u>	<u>Construction and Rehabilitation History</u>
1881- 1907	The east and west rubble-mound jetties were constructed to lengths of 6,987 and 4,955 ft, respectively. The jetties converged to a distance of approximately 1,000 ft, with the east jetty extending 800 ft seaward of the west jetty (Figure 30, plan view). Crown elevations were typically +5 ft mlw, side slopes 1V:1H, and crown widths 4 and 6 ft on the west and east jetties, respectively. Approximately 63,000 and 59,000 tons of stone were used in the east and west jetties, respectively.
1917	The outer end of the east jetty was reconstructed for the purpose of mounting a navigation light. A total of 1,790 tons of stone was used for a total cost of \$5,300.
1926	East jetty repairs were made on all but the outer 300 ft of its length. The total repair cost was \$41,600.
1936- 1937	East jetty repairs were made using 15,900 tons of stone at a total cost of \$56,900.

1962- 1963	About 4,400 lin ft of the east jetty was rehabilitated. The repair sections were located from 5+50 to 6+00 and from 8+34 to 52+00. The jetty's seaward end was at approximately 52+75. The design crown width and side slopes were 6 ft and 1V:1.5H, respectively. The landward and seaward sections were raised to +5 and +3 ft mlw, respectively. Minimum stone size was 1.5 tons, with 75 percent of the total stone quantity in pieces weighing a minimum of 2 tons. Prior to repairs, the seaward section had typical crown elevations between +1 and -2 ft mlw. The repairs required 15,100 tons of stone for a total cost of \$181,000.
1967- 1977	Visual inspections indicated the east jetty was in fair condition with some displacement of stone noted. The west jetty was in poor condition, with most of the structure below mhw (+3 ft mlw).
1981	Yearly visual inspections indicated the jetties were in good condition.

Figure 30. Plan view and typical sections of Nantucket Harbor jetties, Nantucket Island, Mass.

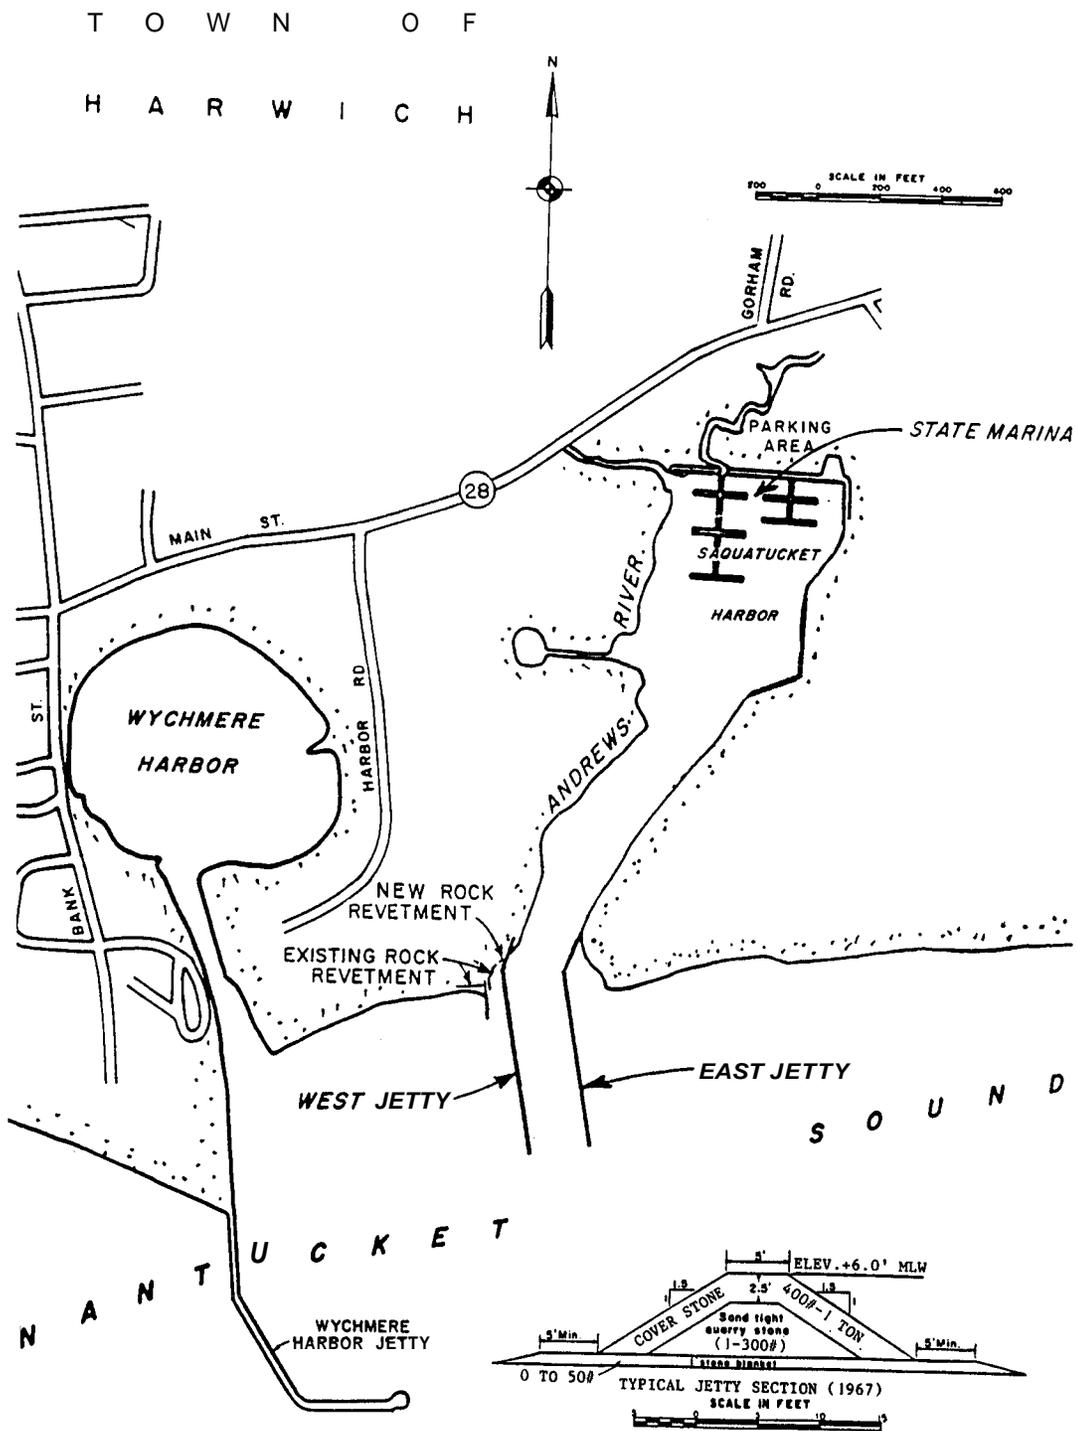
<u>Date(s)</u>	<u>Construction and Rehabilitation History</u>
1967	As part of improvements which included a small-boat harbor, a 600-ft-long rubble-mound jetty was constructed on the east side of the Andrews River mouth (Figure 31). The design cross section (from a detailed project report (DPR) dated May 1966) consisted of a +6 ft mlw crown elevation, a 5-ft crown width, and <b>1V:1.5H</b> side slopes. The section was to be built on a 1-ft-thick blanket of 0- to 50-lb stone, followed by a core of 1- to 300-lb sand tight quarry stone, and covered with 400-lb to 1-ton armor stone. Cover stone at the outer end was 1 to 2 tons. A total of 2,750 tons of stone was placed for a total cost of \$23,700.
1973	The 655-ft-long west jetty and 54 ft of wing wall were constructed using a total of 5,280 tons of stone for a total cost of \$78,400. The design cross section was probably identical to the east jetty section (based on 1966 DPR). Stone sizes were similar to the east jetty sizes, except that larger 1- to <b>2-ton</b> stone was not used at the seaward end.

1974	Visual inspection indicated the jetties were in excellent condition.
1981- 1986	Yearly visual inspections indicated the jetties were in good condition.

Figure 31. Plan view of Andrews River jetties, Harwich, Mass.

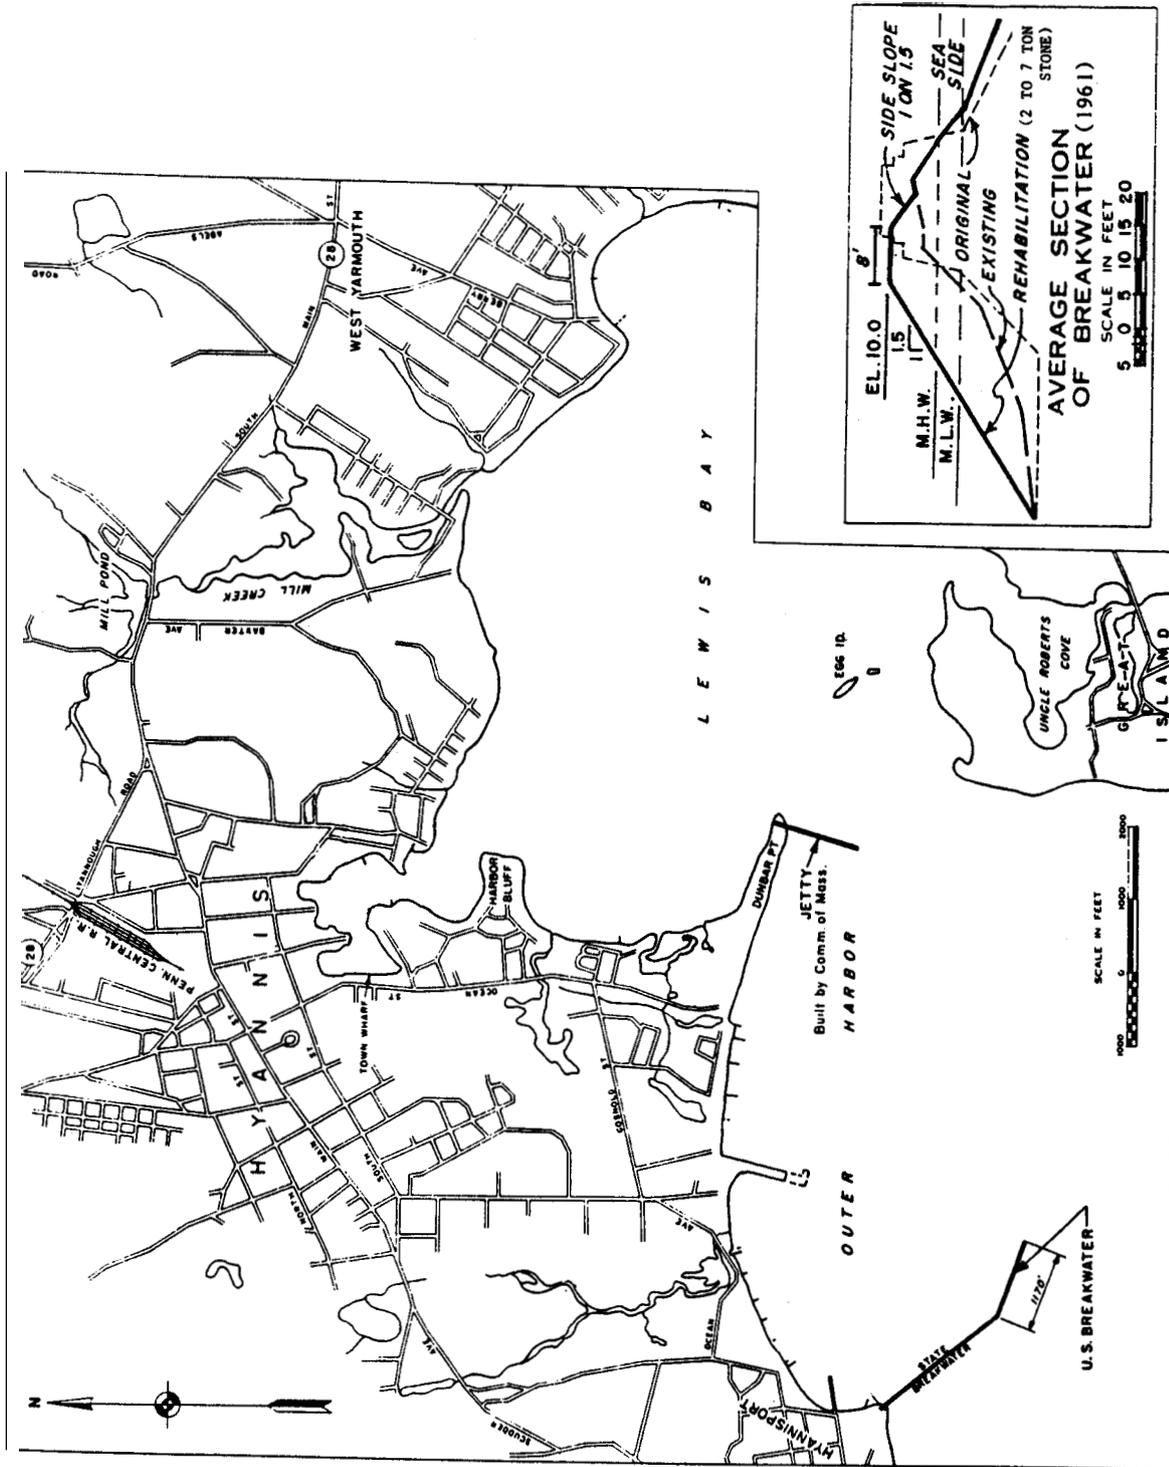
Date(s)	Construction and Rehabilitation History
1827- 1936	The breakwater (Figure 32, plan view) was constructed between 1827 and 1837 and rebuilt between 1870 and 1882. The inner leg of the breakwater, about 2,250 ft long, was built by the State of Massachusetts. The 1,170-ft-long outer leg of the breakwater was built and maintained by the Federal government. The rebuilt cross-section had a 10-ft crown width at +10 ft mlw and may have been of cut stone construction since the side slopes were nearly vertical. Minor repairs were made in 1936.
1950	The outer 1,170-ft-long leg of the breakwater and adjacent 10 ft of state breakwater were repaired with 1- to 6-ton stone. The repair geometry consisted of a 10-ft crown width at +10 ft mlw and 1V:1H side slopes. A total of 3,224 tons of stone was placed for a cost of \$29,200. Prior to the repairs, existing crown elevations varied from +5 to +10 ft mlw. The State portion of the breakwater was considered to be in poor condition.

1961	The outer leg of the breakwater was repaired from 0+00 to 7+80 and 10+75 to 11+15 (breakwater bend at 0+00, seaward end at 11+70). The repair section consisted of an 8-ft crown width at +10 ft mlw, 1V:1.5 side slopes, and 2- to 7-ton armor stone. Before the repairs, crown elevations were from +5 to +10 ft mlw. The repair costs were \$129,800 using a total of 13,588 tons of stone.
1966- 1974	Inspections indicated the Federal portion of the breakwater was in fair condition.
1982- 1986	Yearly visual inspections indicated the breakwater was in good condition.

Figure 32. Location map of breakwater at Hyannis Harbor, Mass.

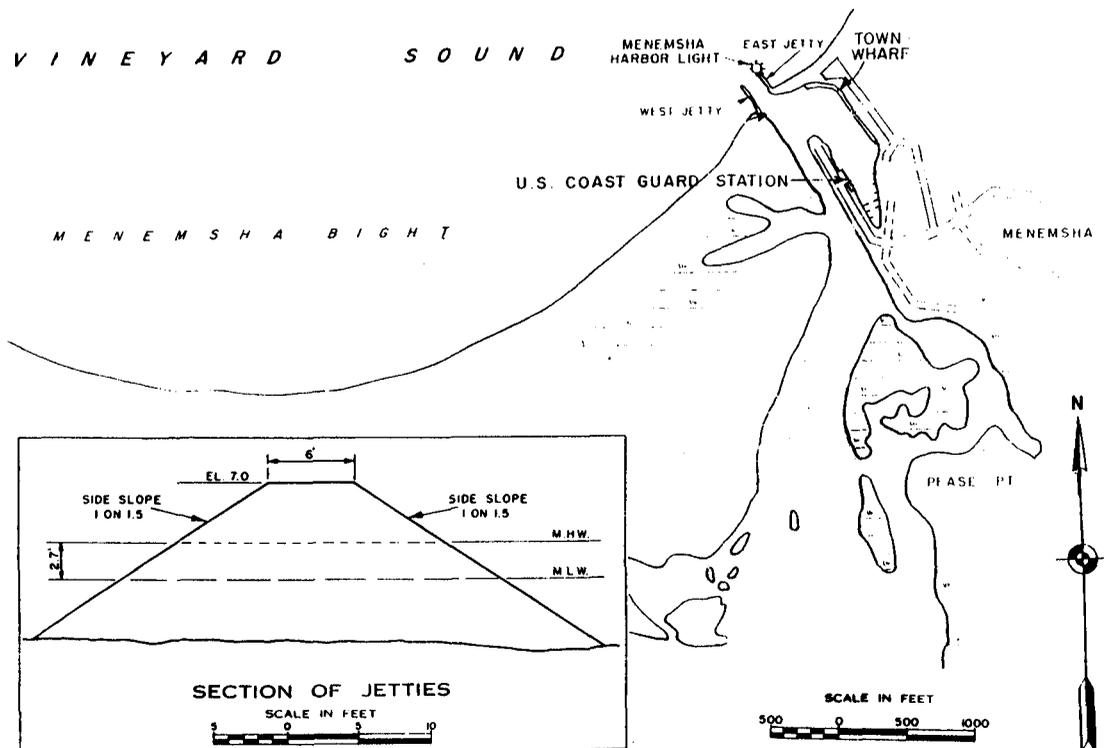
Date(s)	Construction and Rehabilitation History
1945	The east and west jetties, approximately 250 and 435 ft long, respectively, were constructed by non-Federal interests prior to 1945 (Figure 34). The project, adopted by the government in 1945, included maintenance of the riprap jetties.
1969	The west jetty was rebuilt by placing approximately 2,100 tons of cover stone and 900 tons of seal stone. The repairs were made over a distance of 435 ft at a contract cost of \$67,500. The design section consisted of a +7 ft mlw crown elevation, a 6-ft crown width, and 1V:1.5H side slopes.
1981	The east jetty was rebuilt with 20- to 400-lb core stone and 1- to 3-ton cover stone. The design section had 1V:1.5H side slopes and a 6-ft crown width at +7 ft mlw. The contract price for placing an estimated 2,750 tons of stone was \$91,600.
1982-1987	Annual visual inspections of the jetties indicated they were in good condition.

Figure 34. Plan view and typical section of Menemsha Creek jetties, Martha's Vineyard, Mass.

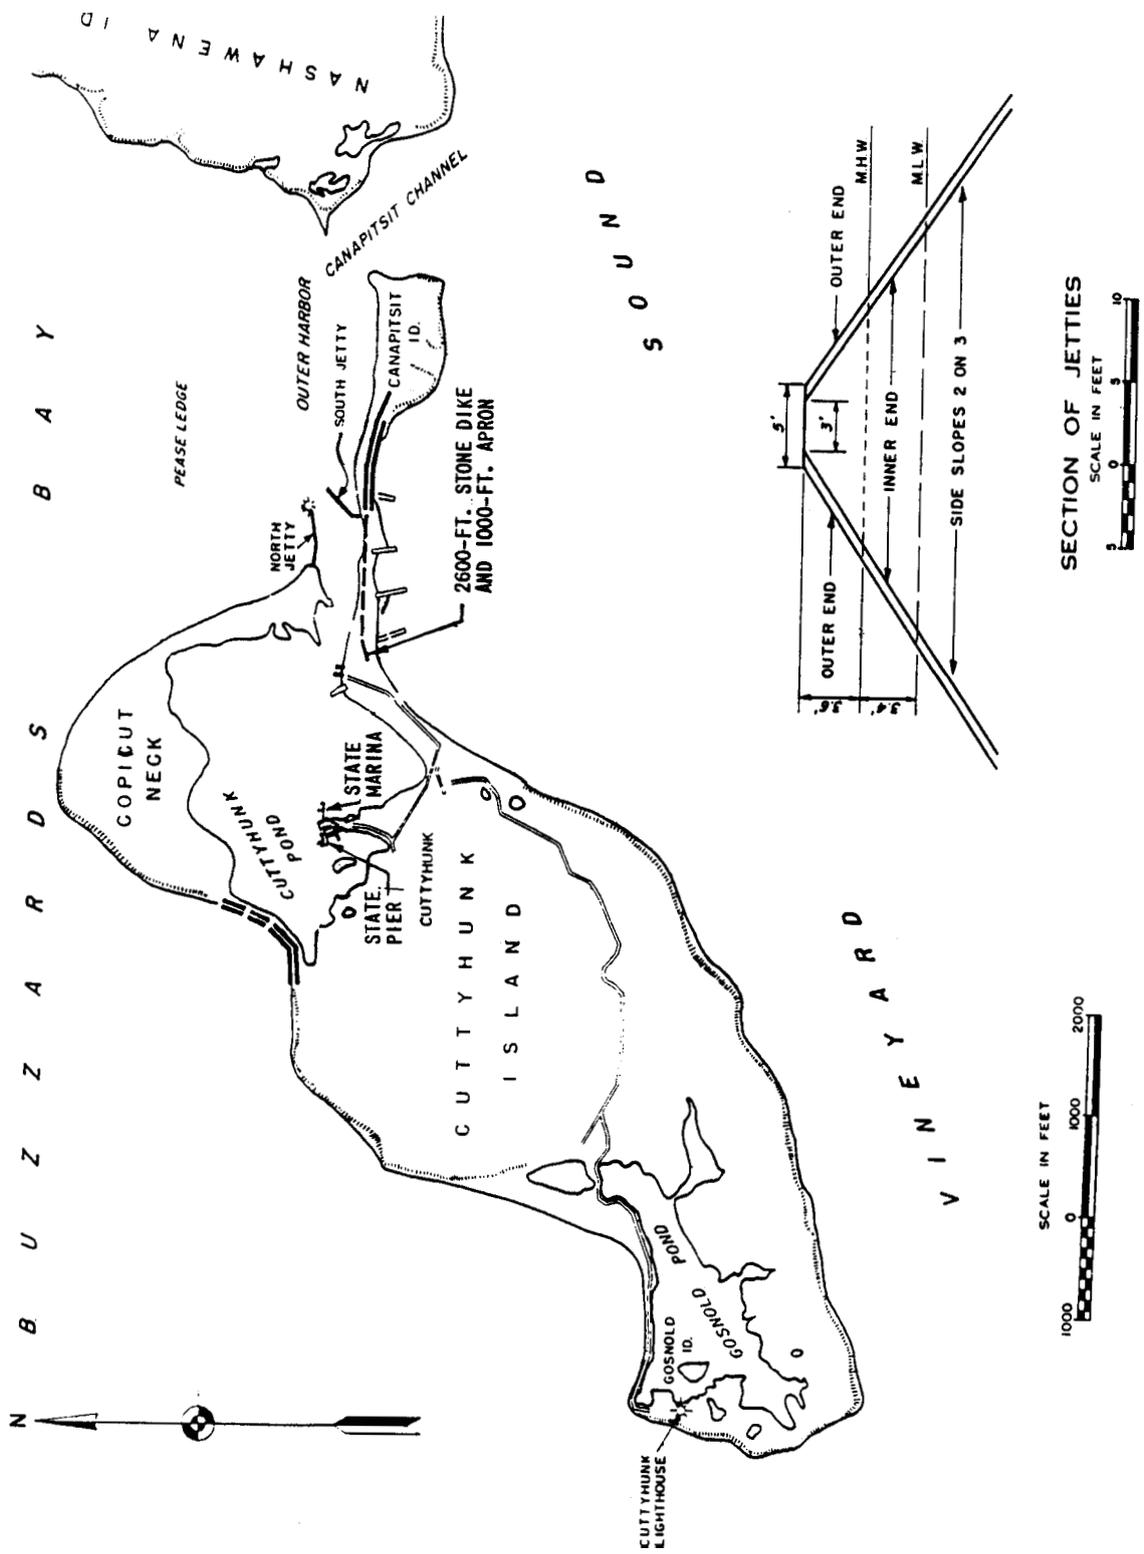
<u>Date(s)</u>	<u>Construction and Rehabilitation History</u>
1906- 1935	During this period the north and south rubble-mound jetties, approximately <b>520</b> and <b>280</b> ft long, respectively, were constructed and maintained by the State of Massachusetts (Figure 35).
1937- 1939	In <b>1937</b> the Federal government adopted the Cuttyhunk Harbor Project, which included maintenance of the jetties. In <b>1939</b> , repairs were made to the north jetty using 500 tons of stone at a cost of <b>\$3,600</b> . The repairs restored the crown elevation to <b>+8</b> ft mlw.
1951	The north jetty was repaired using approximately <b>1,800</b> tons of stone at a cost of \$14,400. The stone ranged in size from 0.5 to <b>8</b> tons and was placed to an elevation of <b>+7</b> ft mlw, <b>1V:1.5H</b> side slopes, and a <b>3-</b> to 5-ft crown width.
1962- 1977	Visual inspections indicated the north jetty was in good condition, and the south jetty was in very poor condition. During the early <b>1960's</b> recommendations were made which included repair of the south jetty, and subsequent repairs were made.

1984- 1986	Annual visual inspections indicated the jetties were in good condition.

Figure 35. Jetties at Cuttyhunk Harbor, Mass.

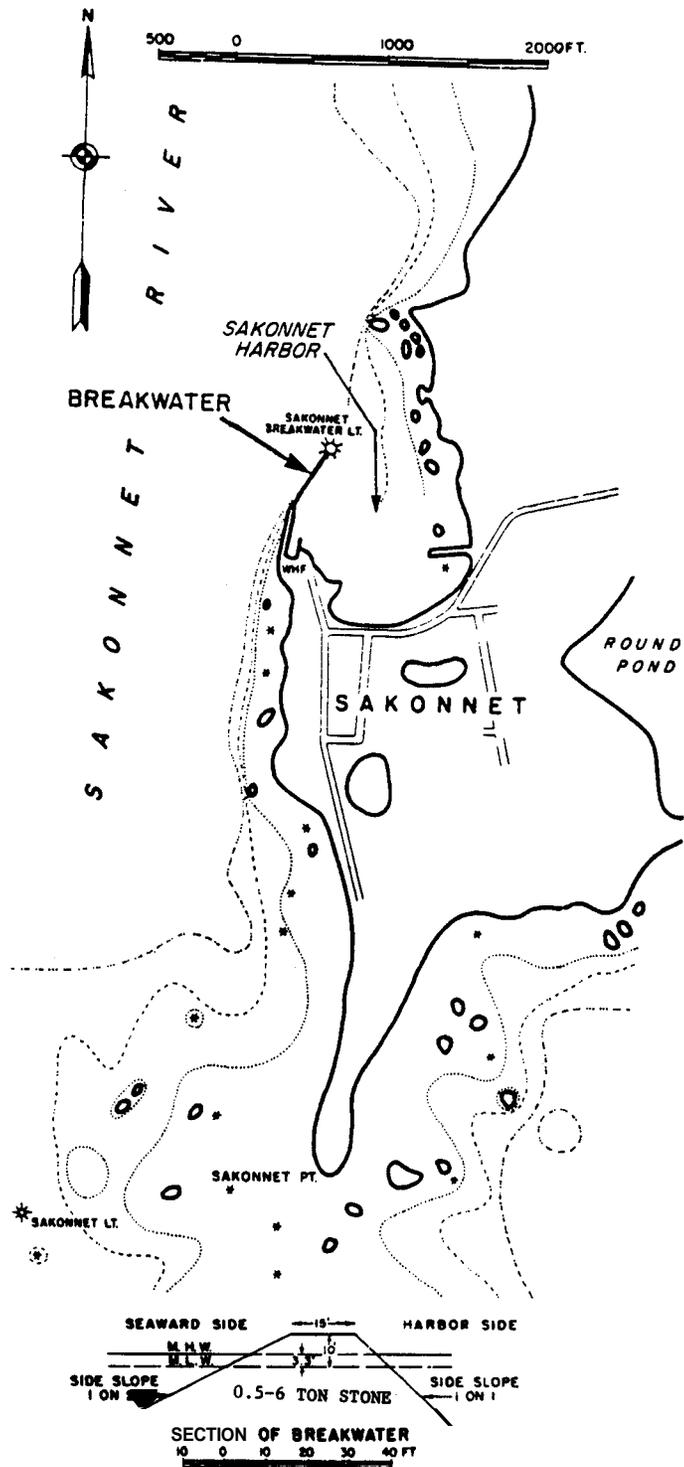
Date(s)	Construction and Rehabilitation History
1836	Two hundred feet of the proposed 400-ft-long rubble-mound breakwater was built for a total cost of <b>\$14,700</b> (Figure 36, present plan view).
1899-1901	The breakwater was extended <b>200</b> ft seaward to its authorized length of <b>400</b> ft. A total of <b>18,400</b> tons of stone was placed in the extension at a total cost of <b>\$25,000</b> .
1939	The breakwater was repaired using <b>1,120</b> tons of stone at a total cost of <b>\$5,800</b> .
1957	The breakwater was extended 400 ft seaward (Figure 37, aerial photograph), and approximately <b>800</b> tons of stone were placed at its landward end. The extension and repair sections were constructed with 0.5- to 6-ton stone placed to an elevation of <b>+8</b> ft mlw, a <b>15-ft</b> crown width, and slopes of <b>1V:2H</b> and <b>1V:1H</b> on the sea and harbor sides, respectively. A <b>1V:2H</b> side slope was also used on the head semicircle. The extension was made in water depths varying from <b>-15</b> to <b>-21</b> ft mlw. The 150-ft landward repair section included the landward 50 ft of breakwater. The contract cost for placing an estimated <b>30,000</b> tons of stone was <b>\$169,500</b> . The remainder of the breakwater was in good condition with center-line elevations of <b>+7</b> to <b>+9</b> ft mlw, typical.

1960	A June topographic survey shows cross sections for the entire breakwater approximately <b>2</b> ft above the design cross section used in <b>1957</b> . The reason for the apparent change in datum could not be found (for present report purposes).
1961	Repairs were made on three sections totaling 86 lin ft, including a 25-ft section at the seaward end and <b>9-</b> and 52-ft sections located approximately <b>140</b> and <b>430</b> ft from the seaward end, respectively. The repairs were made with <b>0.25-</b> to 5-ton stone placed to an elevation of <b>+10</b> ft mlw, a 15-ft crown width, and slopes of <b>1V:2H</b> and <b>1V:1H</b> on the sea and harbor sides, respectively. Except for the outermost <b>15</b> ft of repairs, which appears to have subsided prior to June <b>1960</b> , the repair areas were apparently damaged by storm waves sometime between the June <b>1960</b> survey and a visual inspection in February. The damaged areas had typically subsided from <b>3</b> to <b>5</b> ft. The contract cost for placing an estimated <b>1,200</b> tons of stone was <b>\$14,400</b> .

1971-1972	Minor harbor-side slope repairs were made near the landward end of the breakwater. The new riprap was placed for a total cost of <b>\$1400</b> . The overall condition of the breakwater was good, except for some seaside slope stone slippage.

Figure 36. Plan view and typical section of breakwater at Sakonnet Harbor, R.I.

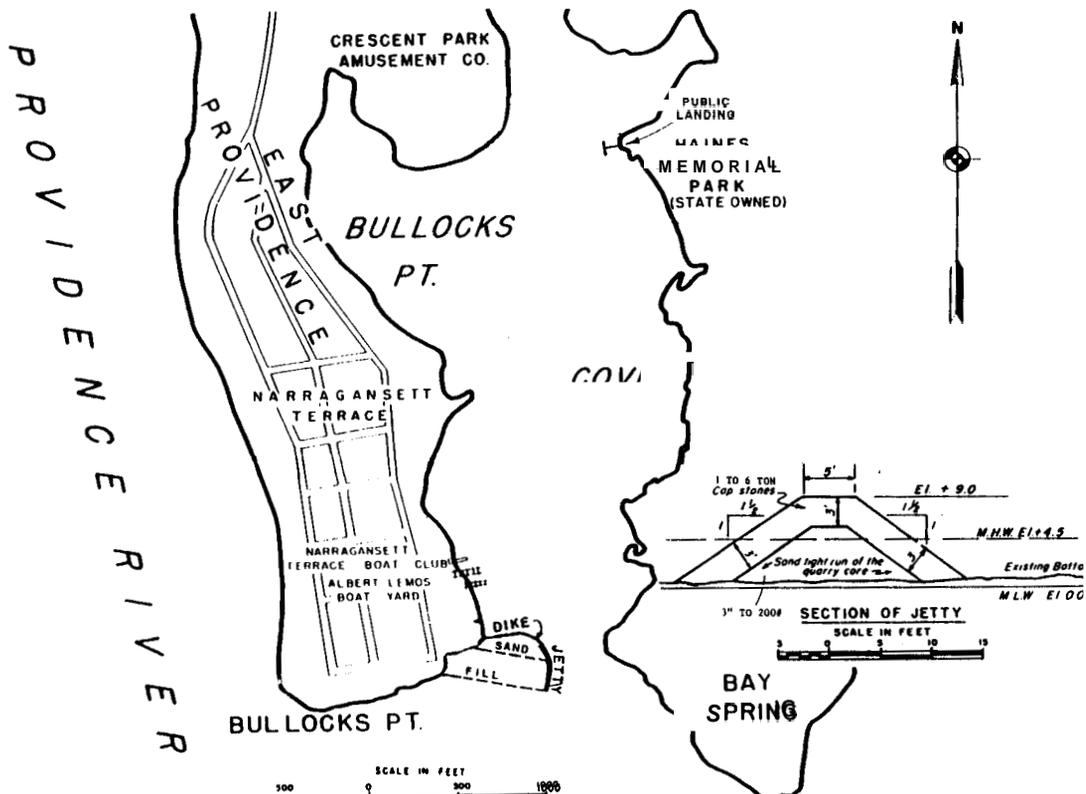
Date(s)	Construction and Rehabilitation History
1958	A 1,000-ft-long combination dike and jetty was constructed on the west side of the entrance to Bullocks Point Cove (Figure 38). The rubble-mound structure was constructed to an elevation of +9 ft mlw. The approximately 300-ft-long jetty had a 5-ft crown width, 1V:1.5H side slopes, a sand-tight core of 3-in. to 200-lb stone, and a cover layer of 1- to 6-ton stone. The contract cost for placing an estimated 10,000 tons of stone in the dike and jetty was \$54,000.
1965-1977	Visual inspections indicated the dike and jetty were in excellent condition.
1980	An annual visual inspection indicated that the jetty and dike were in good condition.
1986	The present condition of the structure is not known.

Figure 38. Plan view and design section of jetty at Bullocks Point Cove, R.I.

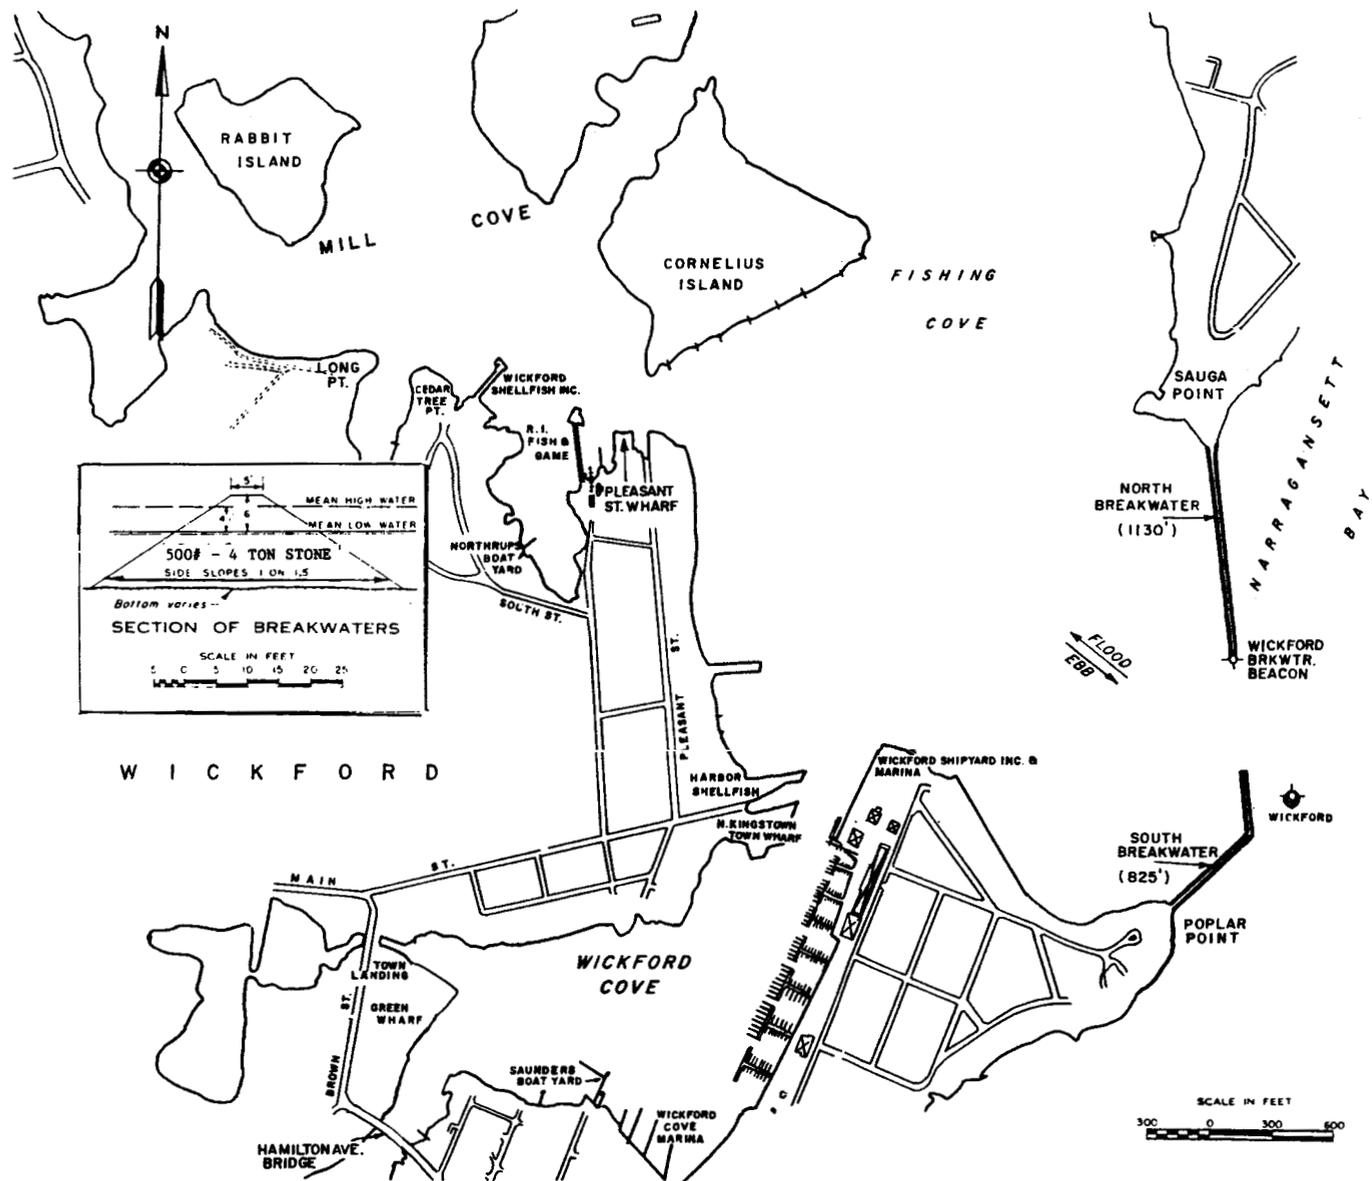
<u>Date(s)</u>	<u>Construction and Rehabilitation History</u>
1949	The north and south breakwaters were constructed of rubble stone to lengths of 1,130 and 825 ft, respectively (Figure 39). Stone weighing from 0.25- to 4-tons was placed to a crown elevation of +6 ft mlw, a 5-ft crown width, and <b>1V:1.5H</b> side slopes. Water depths varied from <b>-2</b> to -10 ft mlw along the breakwaters' center lines. A total of 23,920 tons of stone was placed for a cost of \$1 17,250.
1962- 1977	Visual inspections show that both breakwaters have minor displacement of stone. <b>As</b> of 1977, the north and south breakwaters were in good and fair conditions, respectively.
1985	Yearly visual inspection of the breakwaters indicated they were in good condition.

Figure 39. Plan view and typical section of breakwaters at Wickford Harbor, R.I.
