TECHNICAL REPORT REMR-CO-3

CASE HISTORIES OF CORPS BREAKWATER  
AND JETTY STRUCTURES

Report 7

NEW ENGLAND DIVISION

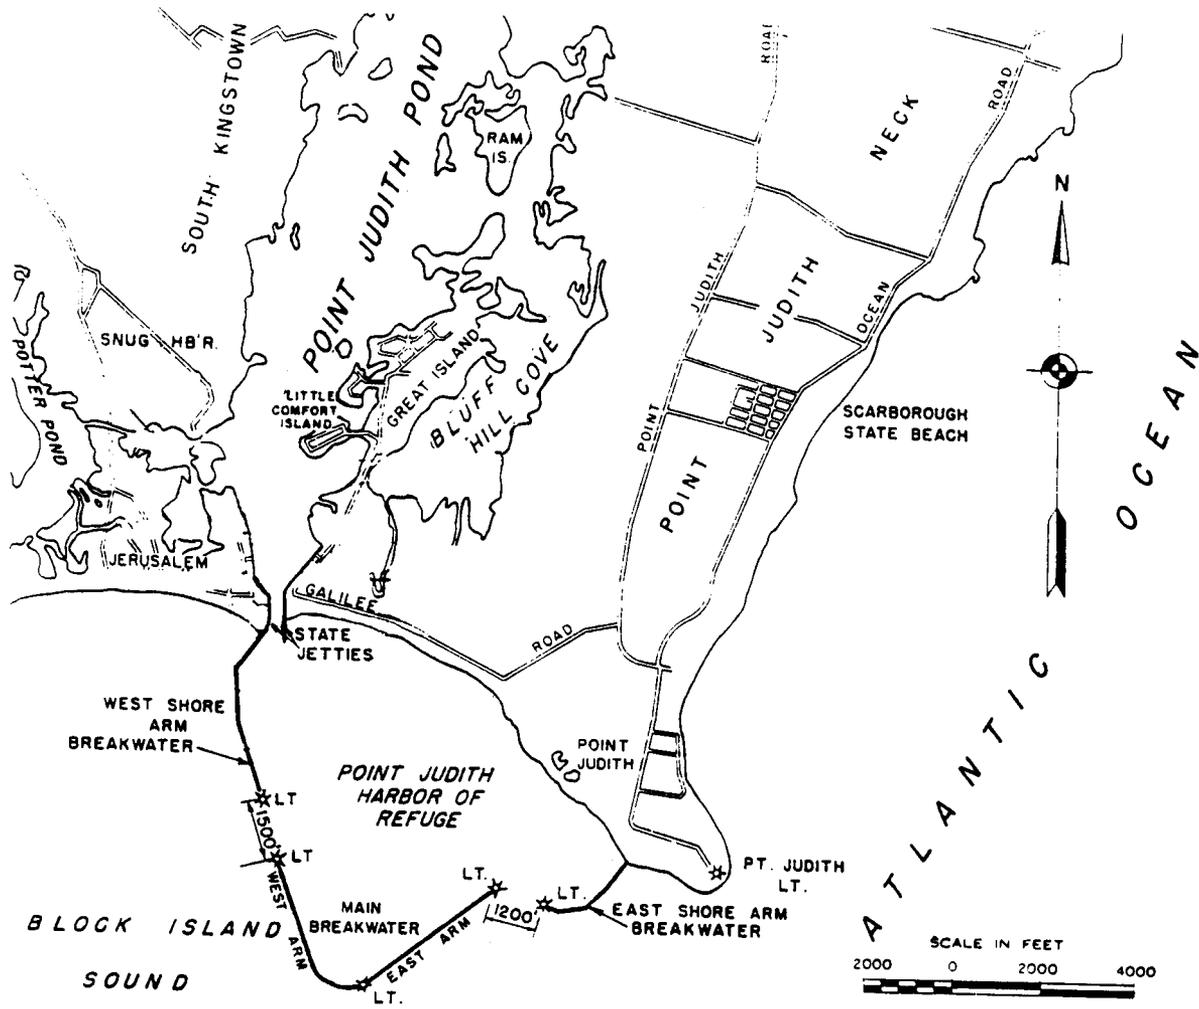
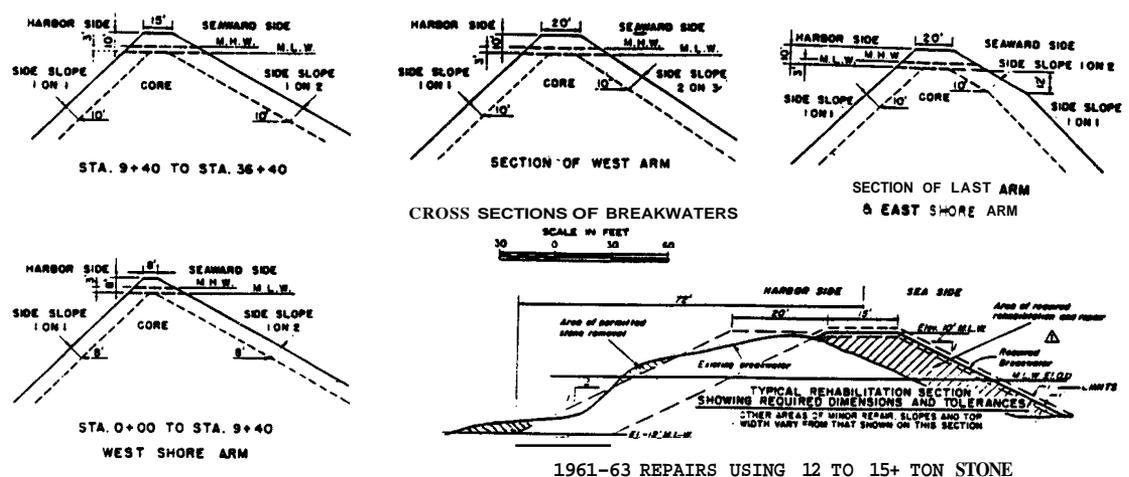
<u>Date(s)</u>	<u>Construction and Rehabilitation History</u>
1891- 1914	<p>Three rubble-mound breakwaters were constructed and maintained, providing a Harbor of Refuge at Point Judith (Figure 40). The 6,970-ft-long V-shaped main, 2,240-ft-long east shore arm, and 3,640-ft-long west shore arm breakwaters were built during 1891-99, 1903-09, and 1911-14, respectively. The main breakwater was constructed in water depths from 18 to 34 ft (relative to mhw), and the east and west shore arms were built in depths of up to 26 and 18 ft, respectively. The design cross section for the main and east shore arm breakwaters (Figure 40, inset) had a +10 ft mhw crown elevation, a 20-ft crown width, a 1V:1H harbor side slope, and a composite sea-side slope of 1V:2H and 1V:1H above and below -12 ft mhw, respectively. Subsequent to construction of the main breakwater (date unknown), the design sea-side slope on its west arm was changed to <b>1V:1.5H</b>. Two design cross sections were used on the west shore arm breakwater (Figure 40, inset). The landward 940 ft had an 8-ft crown width and a +8 ft mhw crown elevation, and the remaining seaward section had a 15-ft crown width and a +10 ft mhw crown elevation. Slopes on both sections were 1V:1H and 1V:2H on the harbor and sea sides, respectively. Core stone (size unknown) was placed to mhw on all sections and facing stone (i.e. cover stone, size unknown) was placed to a thickness of 10 ft on all sections, except on the west shore arm's landward section where the thickness was 8 ft. A total of 1,421,500 tons of stone was placed at total construction costs of \$2,149,500. Starting in 1905, repairs were made on previously completed portions of the breakwaters by adding and resetting stone. Most of the repairs were located on the east arm of the main breakwater and the east shore arm breakwater. These areas were exposed to the largest waves generated by several winter storms which occurred during this period. Maintenance costs totaled approximately \$190,000 using an additional 36,400 tons of stone.</p>

1927- 1929	<p>Repairs were made to the main and east shore arm breakwaters which had numerous deficiencies in cross section due to wave attack. The west shore arm breakwater was in good condition. Approximately 40,000 tons of stone were used for a total cost of \$203,400.</p>
1935	<p>The main breakwater was repaired using 6,760 tons of stone for a total cost of \$23,000.</p>
1939- 1941	<p>Damaged sections of the main and east shore arm breakwaters, sustained during a 1938 hurricane, were repaired using new and reset stone. A total of 46,700 tons of new stone and 4,980 tons of salvaged stone were placed for a total cost of \$253,400.</p>

Figure 40. Plan view and typical sections of breakwaters at Point Judith Harbor of Refuge, R.I.

1961- 1963	<p>The breakwaters were rehabilitated (Figure 40, inset) using 119,000 tons of stone for a total cost of \$1,771,900. The east shore arm was repaired from 9+50 to the reconstructed seaward end at 20+00. The main breakwater was repaired from the seaward end of the west arm at 0+00 to 4+00, at 10+50, and from 31+00 to the seaward end of the east arm at 69+25. Eleven areas, the largest covering 60 lin ft, of the west shore arm were repaired between 12+80 and the seaward end at 36+10. Stone placed on the structures weighed 12 to 15 tons, except for several sections along the east arm where a 15-ton minimum was specified. The repair areas required a +10 ft mlw crown elevation. The east and east shore arm repairs required a 15-ft crown width and 1V:2H side slopes. The west and west shore arm repairs specified 20- and 15-ft crown widths, respectively, with slopes of 1V:1.5H and 1V:1H on their sea and harbor sides, respectively. Prior to rehabilitation, crown elevations within the repair areas were typically from +4 to +9 ft mlw on the east and west arms, 0 to +8 ft mlw on the east shore arm, and +7 to +10 on the west shore arm. Crown elevations outside the repair areas were typically within 2 ft of the +8 and +10 ft mlw design elevations. Overall, the east arm and outer half of the east shore arm were the most deteriorated sections of the breakwaters prior to rehabilitation.</p>

1964- 1978	<p>Visual inspections show a gradual deterioration of the main and east shore arm breakwaters. The west shore arm had some displaced stone but was otherwise considered to be in good condition. By 1978, the</p>

Date( s)	Construction and Rehabilitation History
1964- 1978 (cont.)	main and east shore arm breakwaters were in poor to very poor condition with numerous deficiencies in cross section, and there were significant amounts of displaced stone on the harbor side of the structures at several locations.
1983- 1984	The east shore arm breakwater was repaired, and the main breakwater repairs were started but were not completed due to contractual difficulties. The east shore arm repairs were made using 12- to 15-ton stone and resetting existing stone. The majority of the repairs were located on the seaward half of the breakwater from 10+50 to 20+30. The breakwater was rebuilt to a +10 ft mlw crown elevation, a 20-ft crown width, and slopes of 1V:2H and 1V:1H on the sea side and harbor side, respectively. The cost of repairs was \$702,500 for 20,275 tons of new stone and \$81,870 for resetting existing stone. The incomplete main breakwater repairs were identical to the east shore arm repairs in stone weight and cross section geometry, except for the side slopes which were 1V:1.5H from 0+00 to 20+34 and 1V:2H from 20+34 to 67+25. The contract, awarded in the amount of \$2,275,000, called for placing 57,600 tons of stone and resetting existing stone.

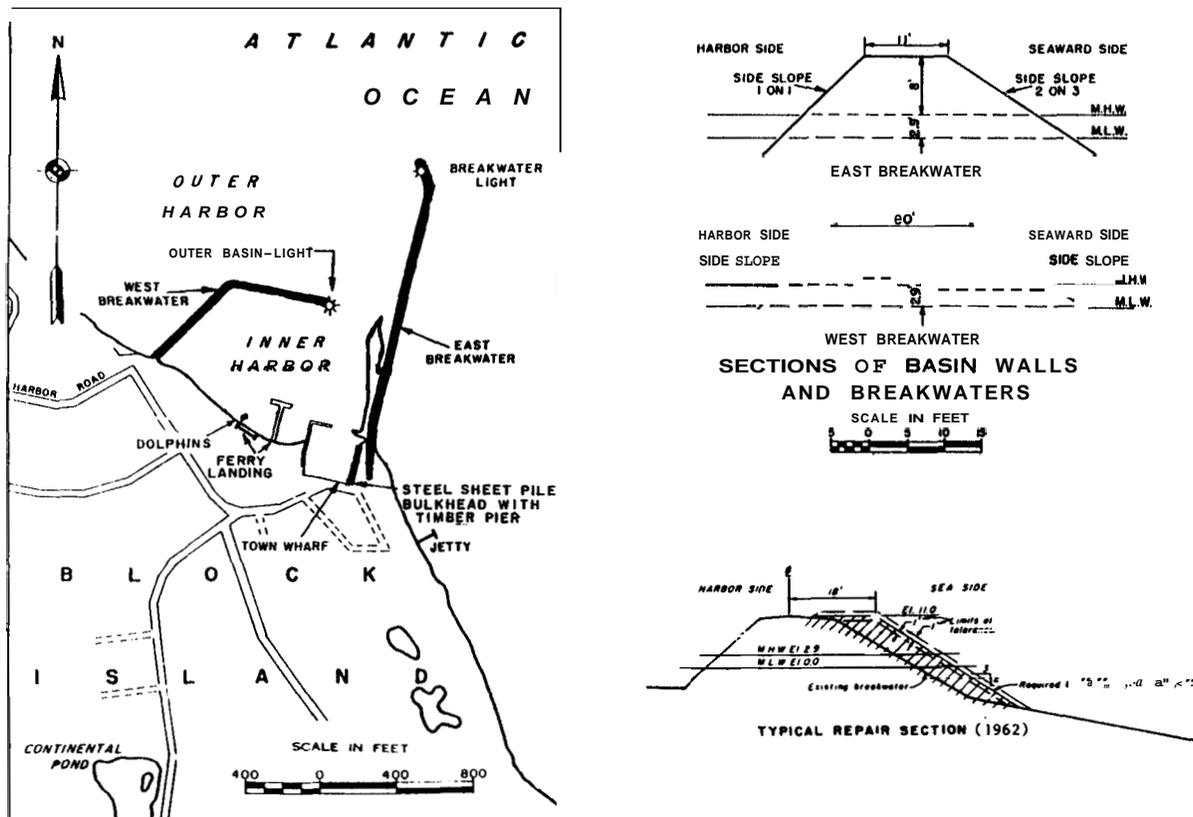
<u>Date(s)</u>	<u>Construction and Rehabilitation History</u>
1870- 1894	The east and west rubble-mound breakwaters were constructed to lengths of 1,950 and 1,100 ft, respectively (Figure 41, plan view). The east breakwater was built to +10.9 ft mlw with an 11-ft top width, and the west breakwater was built to +8.9 ft mlw with a 20-ft crest width. The sea and harbor side slopes on both structures were <b>1V:1.5H</b> and 1V:1H, respectively. A total of 107,400 tons of stone was used in constructing the east breakwater, and at least 18,400 tons of stone were used on the west breakwater. In 1890 minor repairs were made to the east breakwater using 420 tons of stone.
1903- 1906	The east breakwater was repaired using a total of 19,970 tons of stone at a total cost of \$42,900.
1914- 1916	Repairs were made at the landward and seaward ends of the east breakwater using a total of 5,930 tons of stone.

1939	Repairs were made to the east breakwater using 3,360 tons of stone for a total cost of \$21,000.
1950	The west breakwater was repaired to its design cross section using 0.25- to 6-ton cover stone and "run of quarry" core stone. Typical crest elevations prior to repairs were from 1.5 to 3.0 ft below the design elevation of +8.9 ft mlw. Total cost of the repair was \$127,100 using 12,900 tons of stone.
1955	An 800-ft section of east breakwater was repaired and sand tightened by placing 0.75-in. to 200-lb core stone and 1- to 6-ton cover stone. The stone was placed on the breakwater's seaward side slope beginning at a point opposite the northeast corner of the inner basin and terminating about 750 ft from the structure's seaward end. The cross section had a crown elevation of +11 ft mlw, the crown width extended seaward 25 ft from the existing breakwater center line, and the side slope was <b>1V:1.5H</b> . A total of 12,000 tons of stone was placed for a total cost of \$125,000.

1962- 1963	The seaward 842 ft of the east breakwater were repaired using 4- to 8-ton stone. Prior to repair, center-line elevations were from +9 to -2 ft mlw on the seawardmost 200 ft, +9 to +12 ft mlw along the remaining 642 ft of repairs, and +10 to +12 ft mlw landward of the repairs. The repair crown section consisted of a +11 ft mlw crown elevation, an 18-ft crown width, and slopes of 1V:1H and <b>1V:1.5H</b> on the harbor and sea sides, respectively. Most of the stone was placed on the sea-side slope. A total of 11,700 tons of stone was used for a total cost of \$138,000.

Date(s)	Construction and Rehabilitation History
1977	Inspections up to this time indicated the west breakwater was in good condition and the east breakwater was in fair to good condition. Repair work was needed on the seaward 150 ft of the east breakwater where settlement and loss of sea-side slope stone had occurred since the 1962-63 repairs. Maintenance was subsequently performed.
1984-1987	Yearly visual inspections indicated the breakwaters were considered to be in good condition.

Figure 41. Plan view and typical sections of breakwaters at Block Island Harbor of Refuge, R.I.

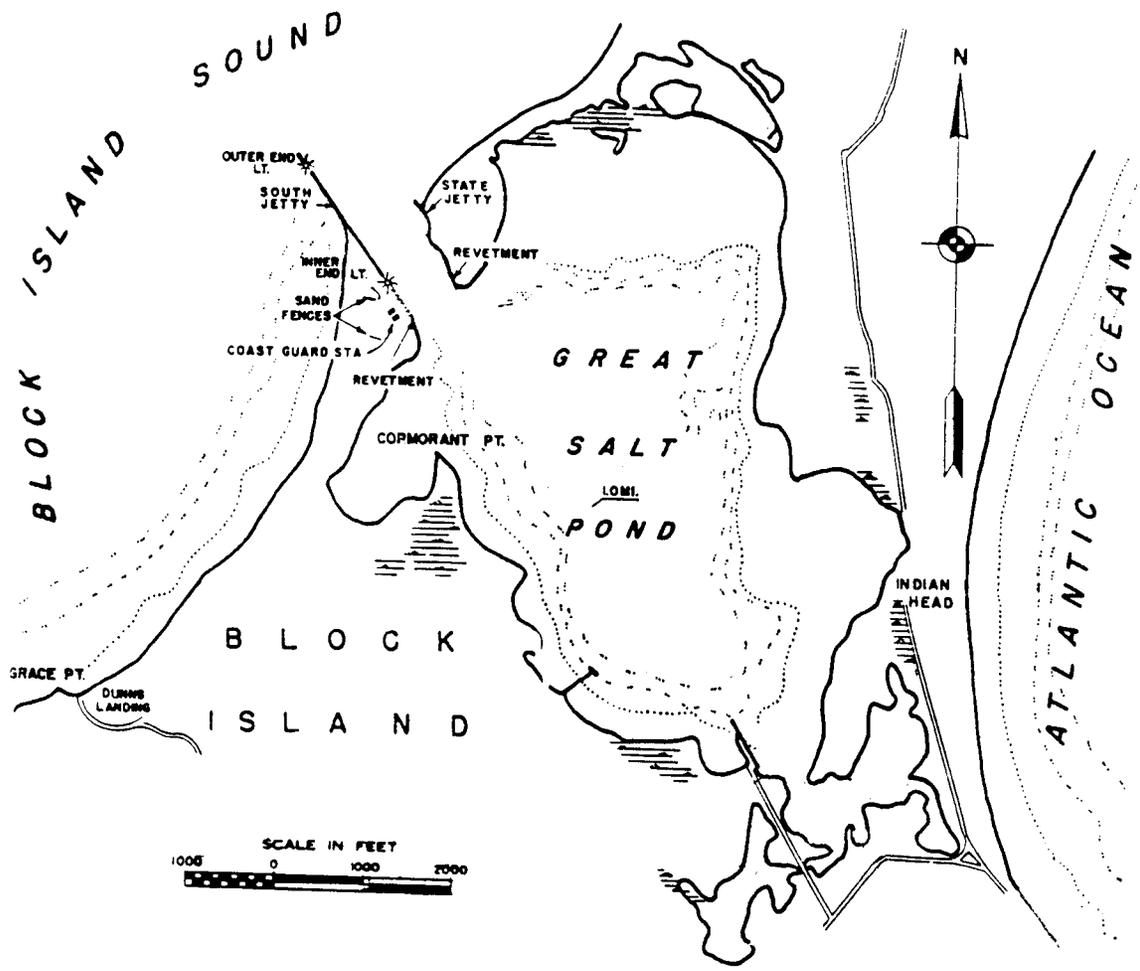
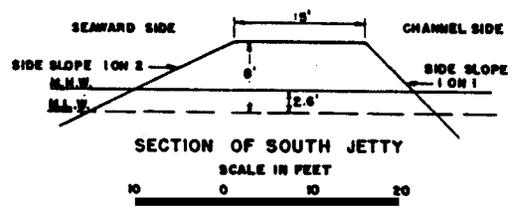
Date(s)	Construction and Rehabilitation History
1896- 1905	A 1,690-ft-long rubble-mound jetty was constructed on the south side of the inlet to Great Salt Pond (Figure 42). The design cross section consisted of a +8 ft mhw crown elevation, a 15-ft crown width, and slopes of 1V:2H and 1V:1H on the sea and channel sides, respectively. The structure's seaward end extended approximately 400 ft beyond the -18 ft mhw contour. A total of 66,860 tons of stone were placed at a cost of \$84,900.
1935	Minor repairs were made to the jetty using 1,600 tons of stone for a cost of \$5,700.
1965- 1977	Visual inspections indicated the jetty was in poor to fair condition and in need of repairs. The outer half of the jetty had many void spaces and areas of displaced stone. Subsequent repair work was performed.
1982	Annual visual inspection indicated the jetty to be in good condition.
1986	The present condition of the jetty is not known.

Figure 42. Plan view and cross section of south jetty at Great Salt Pond, Block Island, R.I.

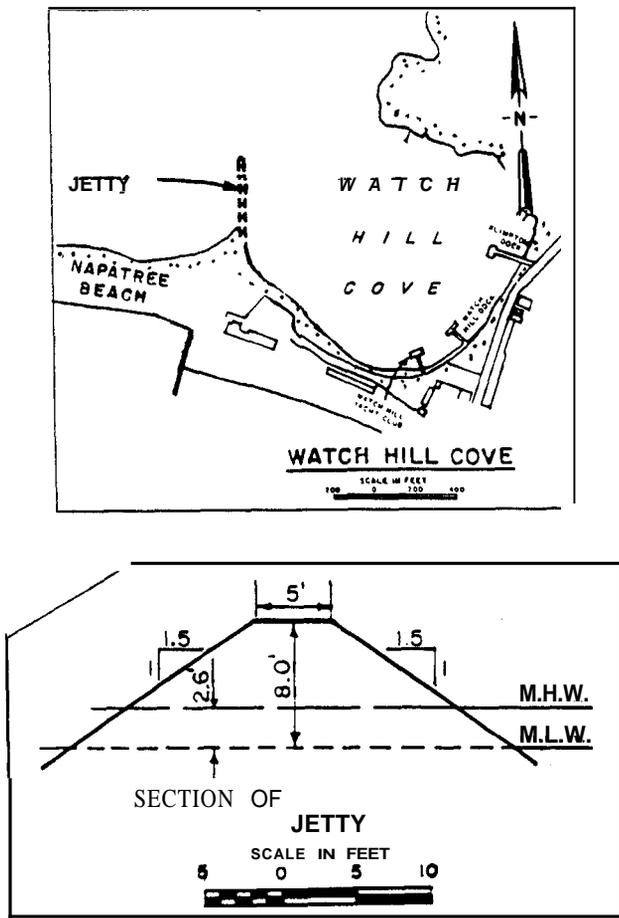
Construction and Rehabilitation History	
1948	A 400-ft-long rubble-mound jetty was constructed on the west side of Watch Hill Cove (Figure 43). The jetty was built to an elevation of +8.0 ft mlw, a top width of 5 ft, and 1V:1.5H side slopes. The core consisted of run of quarry stone and cover stone weighed between 600 lb and 2 tons. The cost for placing 456 tons of stone was \$3,990.
1974	The jetty was in good condition, with only minor displacement of stone noted along its outer 150 ft.
1982- 1986	Annual visual inspections indicated the jetty was in good condition.

Figure 43. Jetty at Watch Hill Cove, R.I.

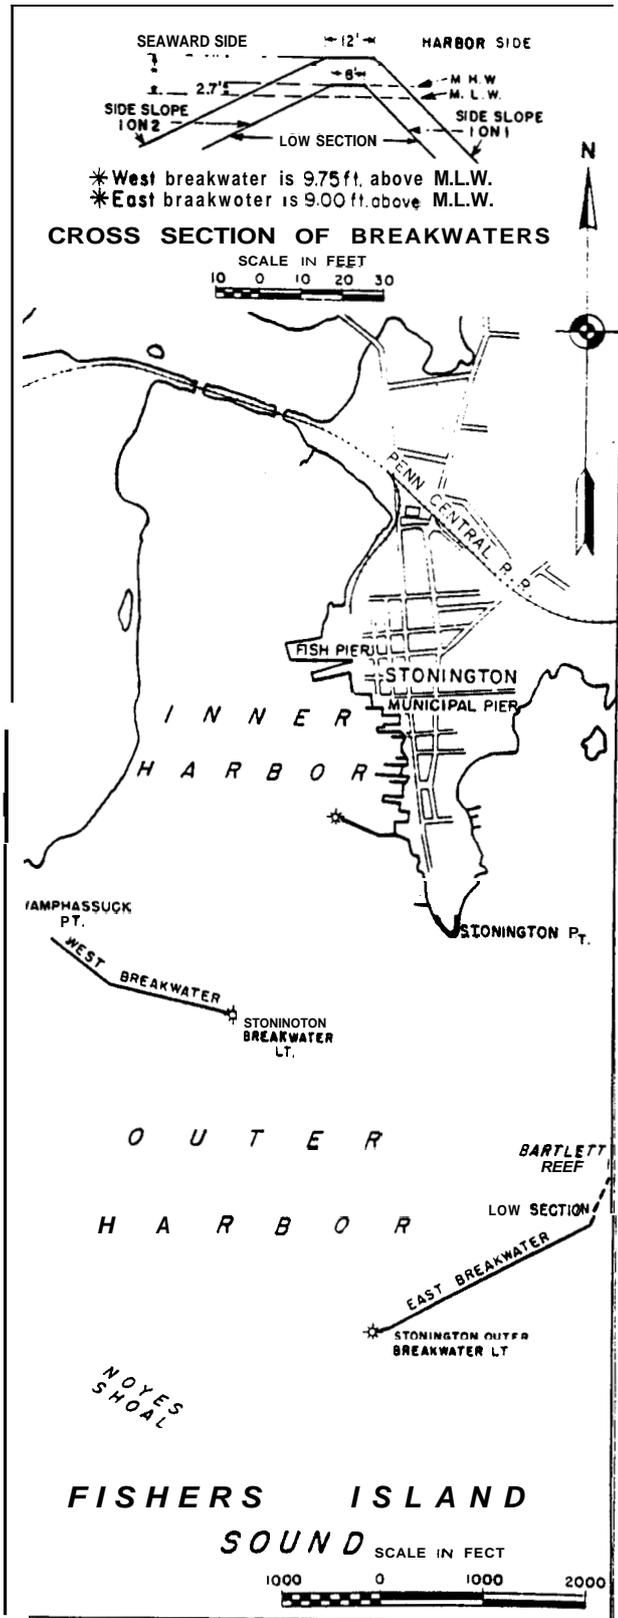
<u>Date(s)</u>	<u>Construction and Rehabilitation History</u>
1875- 1894	The west and east breakwaters, 2,025 and 2,900 ft long, respectively, were constructed using total stone quantities of 94,200, and 118,500 tons, respectively (Figure 44). The structures crown widths were 12 ft, and side slopes were 1V:2H and 1V:1H on the sea and harbor sides, respectively. The east and west breakwater crown elevations were +9 and +9.75 ft mlw, respectively. The easternmost 500 ft of the east breakwater was built lower than the remaining breakwater, having a crown elevation of +2.7 ft mlw and an 8-ft crown width. Total construction costs were approximately \$210,000.
1958	The breakwaters were repaired using 0.5- to 4-ton stone. Approximately 4000 tons of stone were placed to bring low sections up to their original design geometries (Figure 44, insert). The total repair cost was \$38,000.
1962- 1977	Visual inspections indicated the breakwaters were in good condition.

1984	Yearly visual inspections indicated that the breakwater was in good condition.

Figure 44. Plan view and cross sections of breakwaters at Stonington Harbor, Conn.

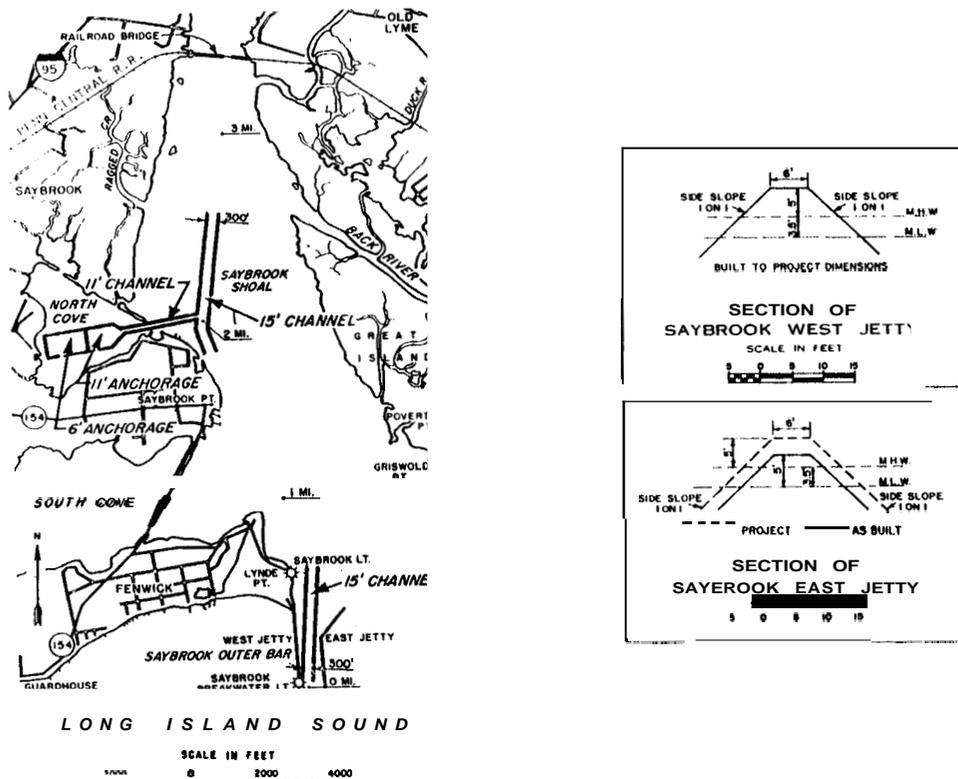
Date(s)	Construction and Rehabilitation History
1873-1885	The east and west jetties were constructed at the mouth of the Connecticut River to lengths of 2,300 and 2,250 ft, respectively (Figure 45). The jetties had +5 ft mhw crown elevations, 6-ft crown widths, and 1V:1H side slopes.
1904-1905	The jetties were repaired using 7,650 tons of stone for a total cost of \$9,400. The jetties were restored to crown elevations of +5 to +6 ft mhw and crown widths of 6 ft,
1914-1916	The west jetty was repaired and raised to a crown elevation of +8.5 ft mhw. Approximately 16,000 tons of stone were used and 85 cu yd of concrete were placed at the landward end for a total cost of \$26,000.
1966-1978	The jetties were considered to be in good condition during visual inspections.
1984	Annual visual inspection of the jetties indicated they were in good condition. The jetties do not appear to have a repair history subsequent to 1916.

Figure 45. Plan view and design sections of jetties at the mouth of the Connecticut River, Saybrook, Conn.

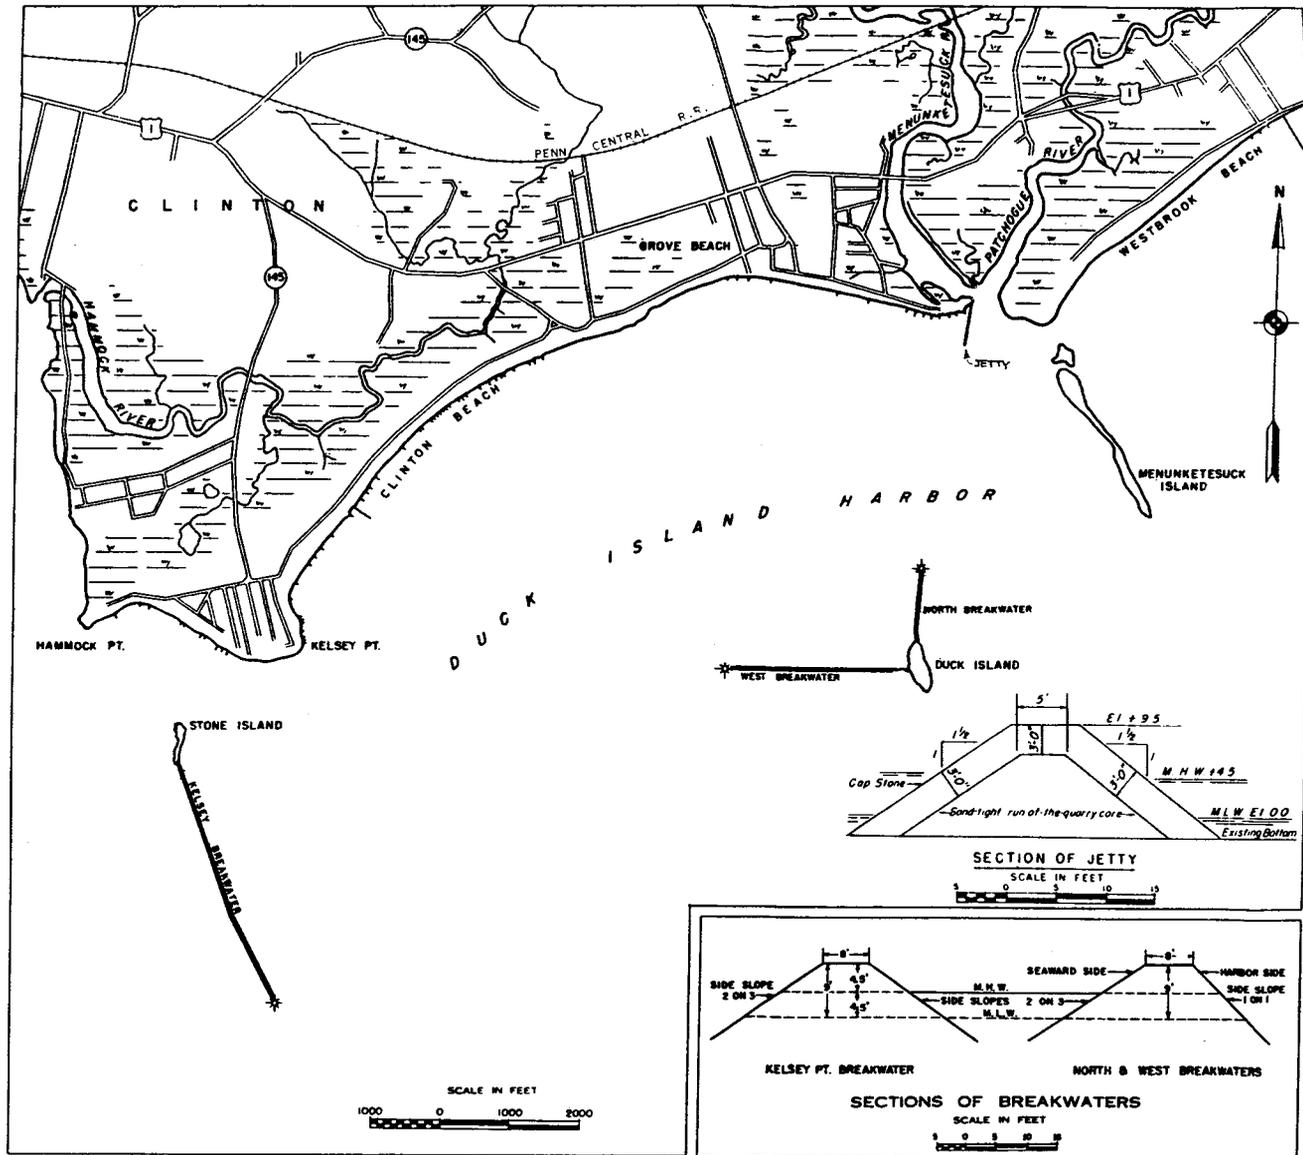
<u>Date(s)</u>	<u>Construction and Rehabilitation History</u>
1891- 1915	Three rubble-mound breakwaters were constructed; one north from Duck Island (1,100ft long), one west from Duck Island (2,697ft long), and one south from Stone Island (3,750 ft long) (Figure 46). The breakwaters provide protection for the 16-ft-deep anchorage area behind Duck Island. The Duck Island breakwaters were built to a crown elevation of +9 ft mlw, an 8-ft crown width, and side slopes of <b>1V:1.5H</b> and 1V:1H on the sea and harbor sides, respectively. The Kelsey (Stone Island) breakwater differed only in using <b>1V:1.5H</b> side slopes throughout the cross section. The total stone quantities placed in the north, west, and Kelsey breakwaters were 23,100, 139,800, and 244,400 tons, respectively. Minor repairs were made to the west breakwater in 1905, 1909, and 1915 using a total of about 10,000 tons of stone. The Kelsey breakwater was also repaired in 1915 using 460 tons of stone.

1939	Repairs were made to the west and Kelsey breakwaters using 4,500 tons of stone for a total cost of \$25,600.
1962- 1977	Visual inspections showed the Duck Island breakwaters were in good condition while the Kelsey breakwater was rated from poor to good condition at various times. Subsequent repairs were performed.
1985	Yearly visual inspection of the structures revealed they were in good condition.
1986	Field surveys indicated the breakwaters were found to be in good condition.

Figure 46. Location map and typical sections of Patchogue River jetty and Duck Island Harbor breakwaters, Westbrook and Clinton, Conn.

<u>Date(s)</u>	<u>Construction and Rehabilitation History</u>
1956	A 600-ft-long rubble-mound jetty was constructed on the west side of the mouth of the Patchogue and Menunketesuck Rivers, providing protection to the 8-ft-deep Patchogue entrance channel (Figure 46). The design section consisted of a +9.5 ft mhw crown elevation, a 7-ft crown width, and <b>1V:1.5H</b> side slopes. The jetty was built with a sand-tight core of 3-in. to 200-lb stone and covered with a 3-ft-thick layer of 1- to 6-ton stone. The cost for placing 6,470 tons of stone was \$45,100.
1962- 1977	Visual inspections indicated the jetty was in excellent condition.
1985	Annual visual inspections of the jetty indicated it was in good condition.

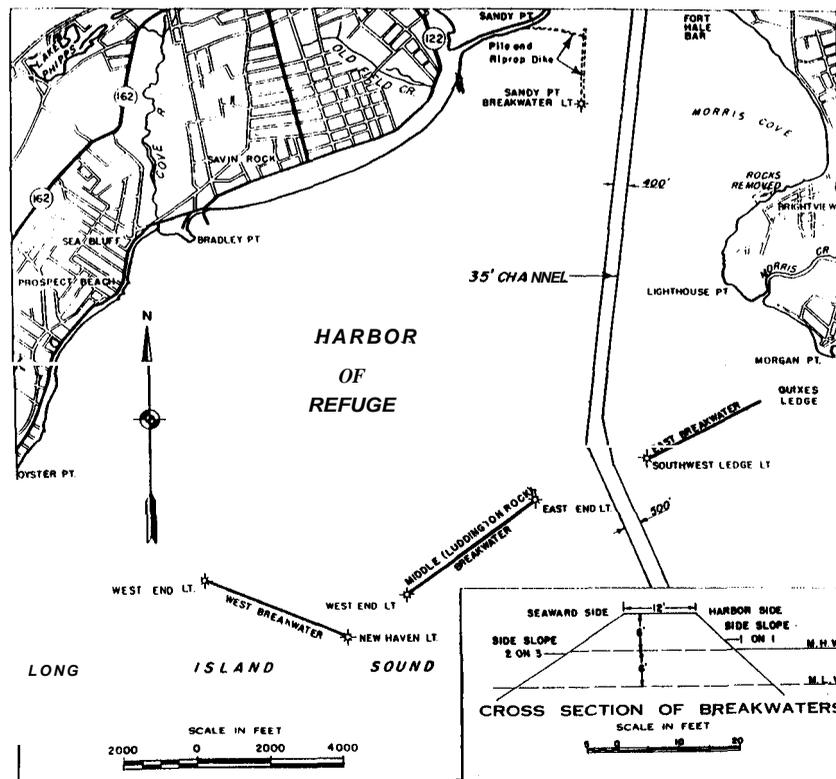
Figure 47. Breakwaters at New Haven Harbor of Refuge, Conn.

Date(s)	Construction and Rehabilitation History
1880-1915	Three rubble-mound breakwaters were constructed as part of the Harbor of Refuge at New Haven (Figure 47). The breakwaters were constructed to a crown elevation of +12 ft m.l.w., a 12-ft crown width, and slopes of 1V:1H and 1V:1.5H on the harbor and sea sides, respectively. The 3,450-ft long east breakwater was built during 1880-90 using 293,800 tons of stone and repaired in 1911 using 2,900 tons of stone. The 4,500-ft-long middle breakwater was built during 1891-96 using 339,000 tons of stone and repaired in 1911 and 1915 using 10,600 and 12,000 tons of stone, respectively. The 4,200-ft-long west breakwater was built during 1896-97 and 1907-11 using 478,100 tons of stone and repaired in 1915 using 14,300 tons of stone. The breakwater's construction costs during this period were approximately \$1,120,000.
1935	The breakwaters were repaired using 6,720 tons of stone for a total cost of \$18,500.

1960-1974	The breakwaters were considered to be in fair to good condition during several visual inspections taken over this period.
1984	Yearly visual inspection of breakwaters indicated they were in good condition.

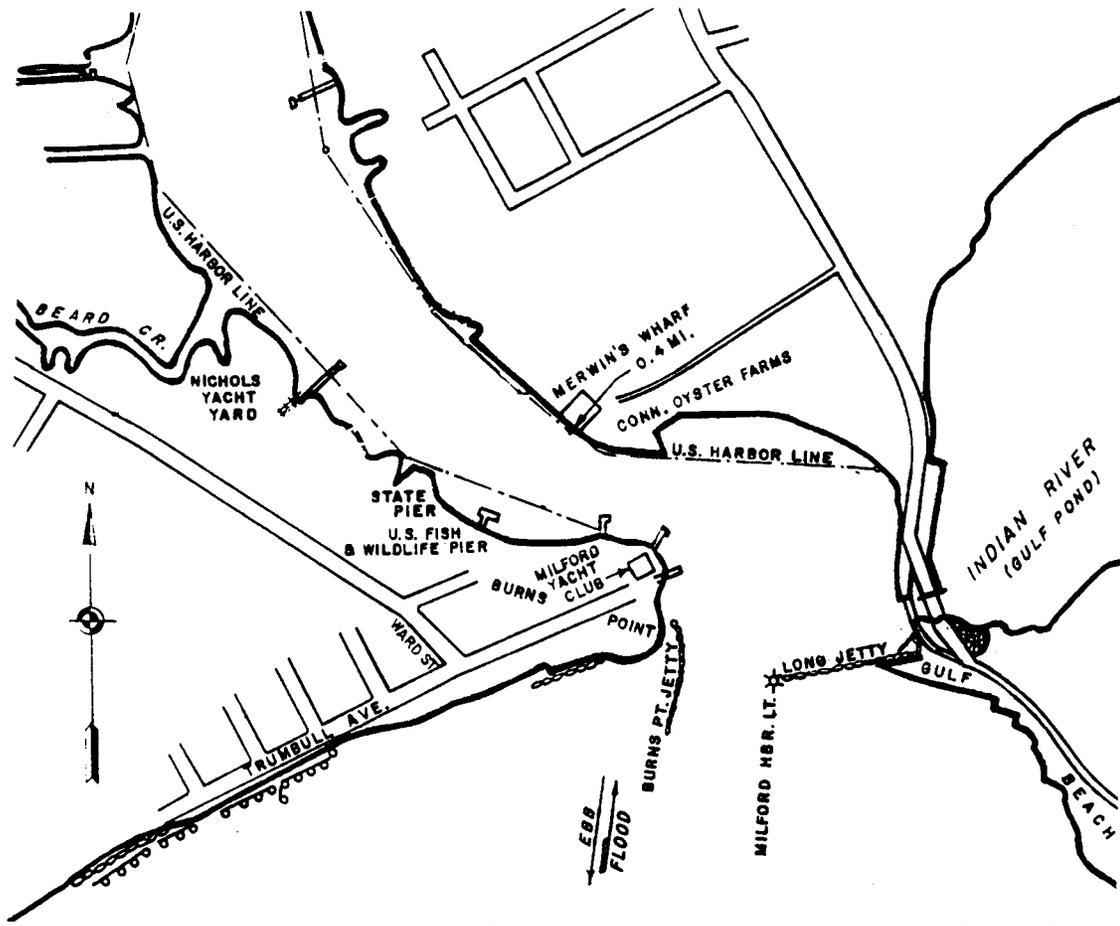
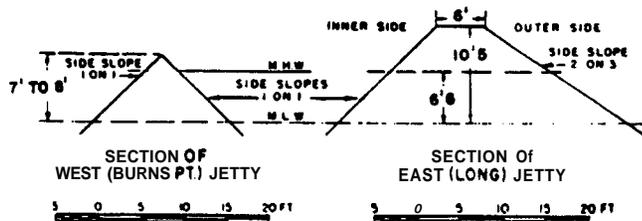
Figure 48. Plan view and cross sections of jetties at Milford Harbor, Conn.

<u>Date( s)</u>	<u>Construction and Rehabilitation History</u>
1875- 1980	To provide protection to Milford Harbor and its entrance channel the Long (east) and Burns Point (west) jetties were constructed to lengths of 510 and 350 ft, respectively, using 4,100 and 900 tons of stone, respectively. The triangular cross section of the west jetty had a crown elevation between +7 and +8 ft mlw and 1V:1H side slopes. The east jetty cross section had a +10.5 ft mlw crown elevation, a 6-ft crown width, and slopes of 1V:1H and 1V:1.5H on the harbor and sea sides, respectively.
1948	The jetties were repaired using 1,153 tons of 0.5- to 2-ton stone. The east jetty was repaired to the original cross section, and the west jetty was built up to +7 ft mlw with a 2-ft crown width and 1V:1H side slopes. The repaired lengths of the east and west jetties were 500 and 350 ft, respectively. The total repair cost was \$13,700.

1963	The west jetty was repaired using 0.5- to 2-ton stone placed to the 1948 repair cross section. The contract cost for placing an estimated 1,450 tons of stone was \$19,400.
1965	The State of Connecticut rebuilt the east jetty and, near its outer end, constructed a 166-ft-long rubble-mound groin. The groin extended seaward in a nearly perpendicular direction from the jetty axis.
1968- 1978	Inspections indicated the jetties were in good condition with some minor repairs needed on both.
1984	Annual visual inspections indicated the jetties were in good condition.

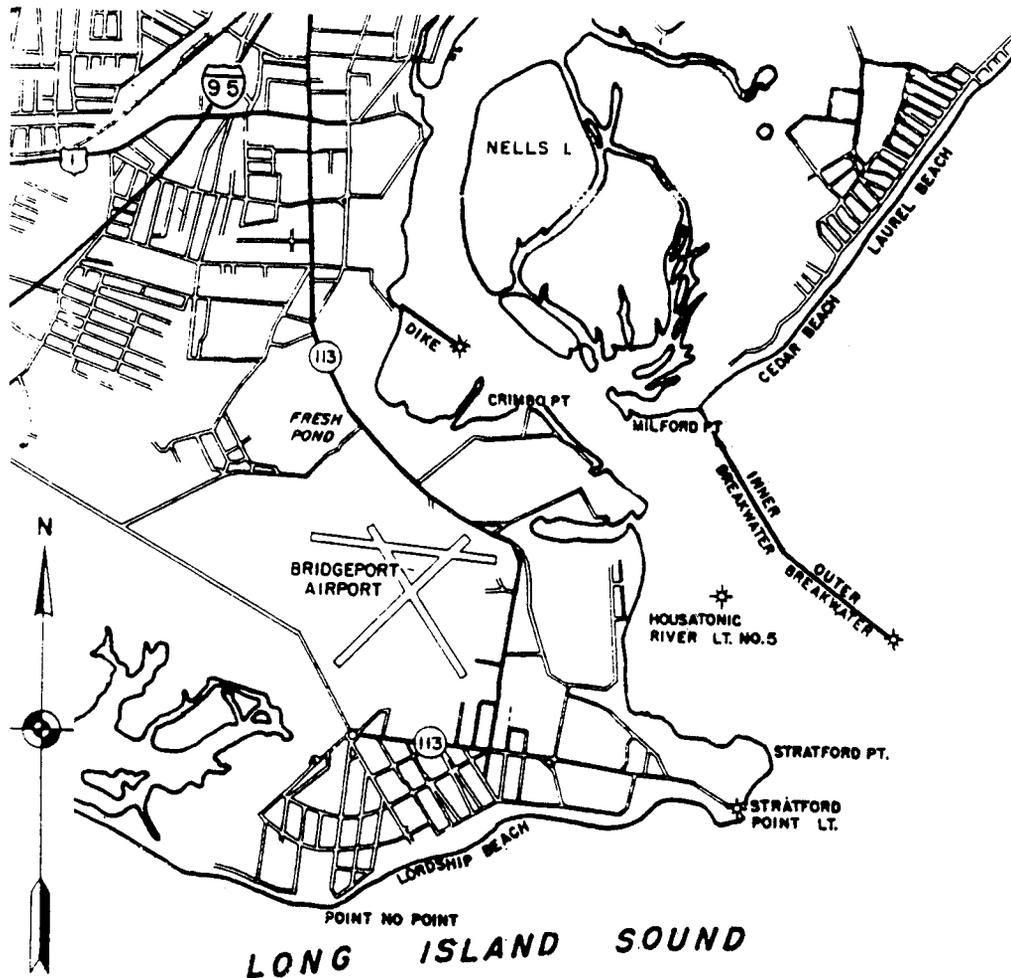
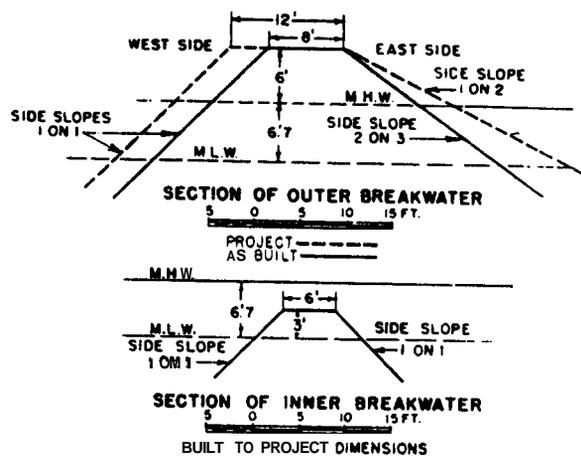
Figure 49. Plan view and cross sections of breakwater at the mouth of the Housatonic River, Conn.

Date(s)	Construction and Rehabilitation History
1889- 1895	The inner and outer arms of the Housatonic breakwater (Figure 49), 3,250 and 2,570 ft long respectively, were constructed using 12,500 and 44,560 tons of stone, respectively. The inner arm was built to approximately mid-tide level with a crown elevation of +3 ft mlw, a 6-ft crown width, and 1V:1H side slopes. The outer arm was constructed to a crown elevation of +12.7 ft mlw, and 8-ft crown width, and slopes of 1V:1H and <b>1V:1.5H</b> on the channel and sea sides, respectively. The construction costs totaled approximately \$75,000.
1905- 1906	Repairs were made to both arms of the breakwater using a total of 3,990 tons of stone.
1911- 1916	During this period, the outer breakwater arm was extensively repaired using a total of 16,200 tons of stone. The crest width was increased to 12 ft, and side slopes of 1V:2H were placed on the sea side. In 1914, the inner arm was repaired using 1,000 tons of stone. Total repair costs were \$26,200.

1940- 1941	The outer arm was repaired using 1,350 tons of stone for a cost of \$6,700.
1960- 1977	Visual inspections showed the outer arm was in good condition, and only minor repairs were needed at the seaward end. The inner arm was in poor condition and needed repairs throughout its length.
1986	The present condition of the breakwater is not known.

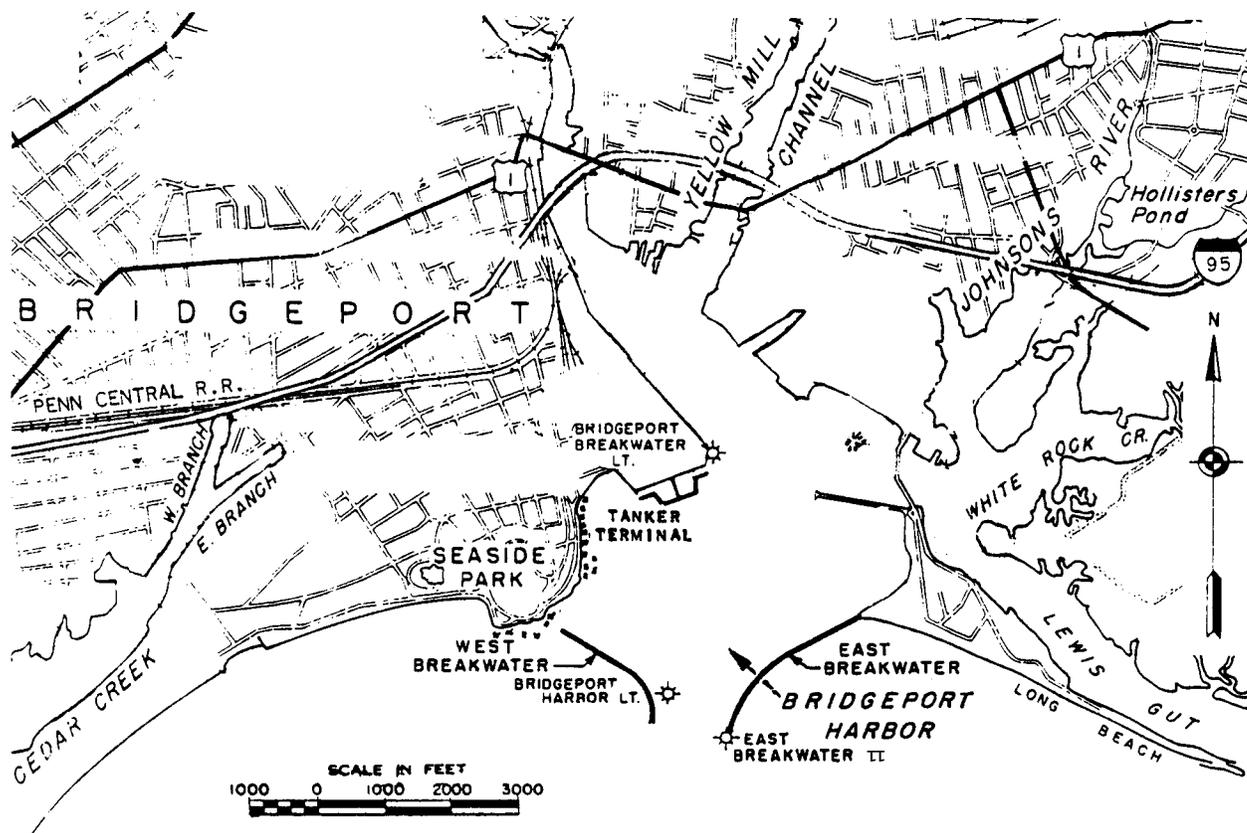
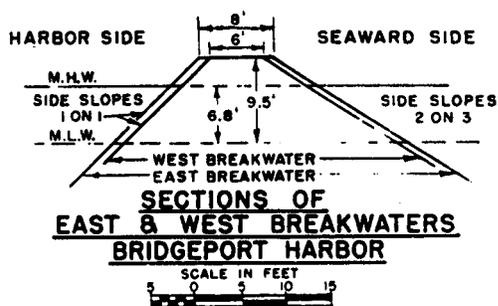
Figure 50. Breakwaters at Bridgeport Harbor, Conn.

<u>Date(s)</u>	<u>Construction and Rehabilitation History</u>
1871- 1973	The Bridgeport Harbor east breakwater was built to a length of <b>1,380 ft</b> (Figure 50).
1900	The east breakwater was extended <b>380 ft</b> using <b>5,080 tons</b> of stone for a total cost of <b>\$10,200</b> .
1907- 1908	The east breakwater was extended to a total length of <b>3,823 ft</b> using <b>43,560 tons</b> of stone. The completed breakwater cross section consisted of a <b>+9.5 ft</b> mlw crown elevation, an 8-ft crown width, and slopes of <b>1V:1H</b> and <b>1V:1.5H</b> on the harbor and sea sides, respectively. Total cost of placing <b>43,560 tons</b> of stone in the extension was <b>\$51,000</b> .
1908- 1909	The west breakwater was constructed to a length of <b>2,110 ft</b> using <b>39,290 tons</b> of stone for a total cost of <b>\$46,000</b> . The design section was identical to that of the east breakwater, except for the crown width which was <b>6 ft</b> .

1935	The breakwaters were repaired for a total cost of <b>\$12,500</b> . Stone quantities placed on the east and west breakwaters were <b>3,300</b> and <b>1,170 tons</b> , respectively.
1941	The east breakwater was repaired using <b>2,650 tons</b> of stone for a total cost of <b>\$13,000</b> .
1960- 1978	Several visual inspections were made, and the breakwaters were generally in good condition. By <b>1978</b> the inspectors recommended the structures be considered for future maintenance.
1986	Present conditions of the breakwaters are not known.

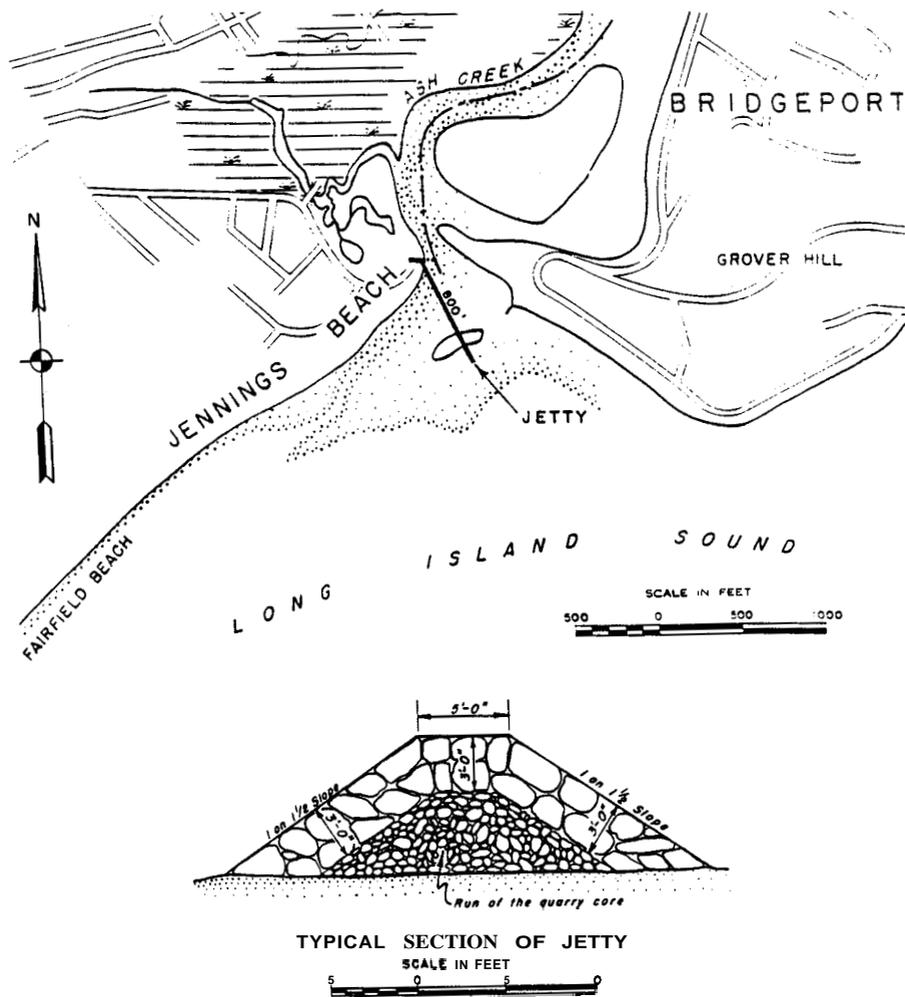
Figure 51. Plan view and cross section of jetty at Jennings Beach and Ash Creek, Conn.

Date(s)	Construction and Rehabilitation History
1951	An 800-ft-long sand-tight jetty was constructed on the west side (Jennings Beach) of the mouth of Ash Creek (Figure 50). The jetty cross section consisted of a +9 ft mlw crown elevation, a 5-ft crown width, and side slopes of 1V:1.5H. The jetty had a run of quarry core and a 3-ft-thick double layer of cover stone (size not known). The jetty was built by local interests who were reimbursed one-third the first cost of construction by the Federal government.
1986	The jetty has no known repair history, and its present condition is not known.

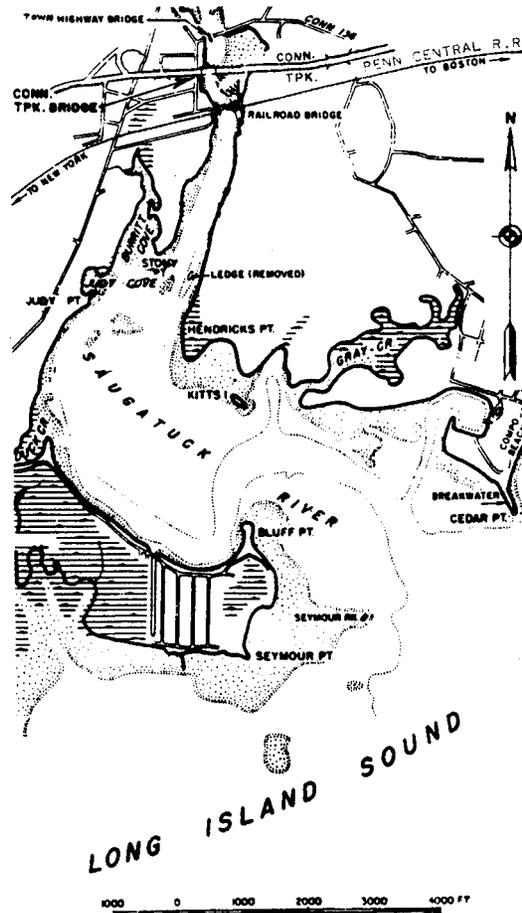
Figure 53. Cedar Point breakwater, mouth of the Saugatuck River, Conn.

Date(s)	Construction and Rehabilitation History
1896	A 600-ft-long rubble-mound breakwater was constructed on the east side of the Saugatuck River's mouth (Figure 53). The crown elevation and width were +11 ft mhw and 10 ft, respectively.
1986	The breakwater has no known repair history, and its present condition is unknown.

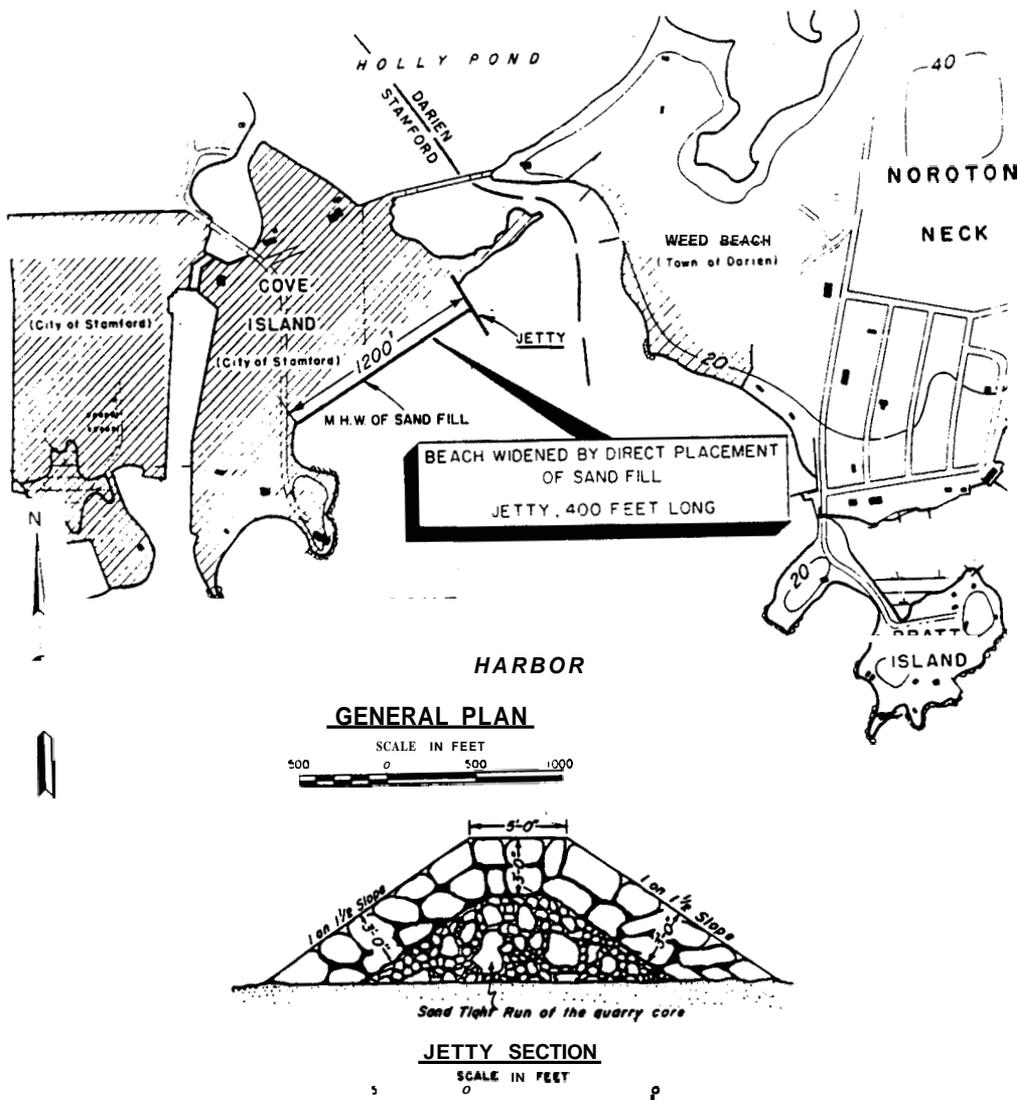
Figure 54. Cove Harbor Jetty, Cove Island, Conn.

Date(s)	Construction and Rehabilitation History
1958	A 400-ft-long jetty was constructed on the east side of Cove Island (Figure 54). The jetty consisted of a +10 ft crown elevation, a 5-ft crown width, 1V:1.5H side slopes, a sand-tight run of quarry core, and a 3-ft-thick double layer of cover stone. The State of Connecticut, which constructed the jetty, was reimbursed by the Federal government for one-third of the project cost.
1986	The jetty has no known repair history, and its present condition is unknown.

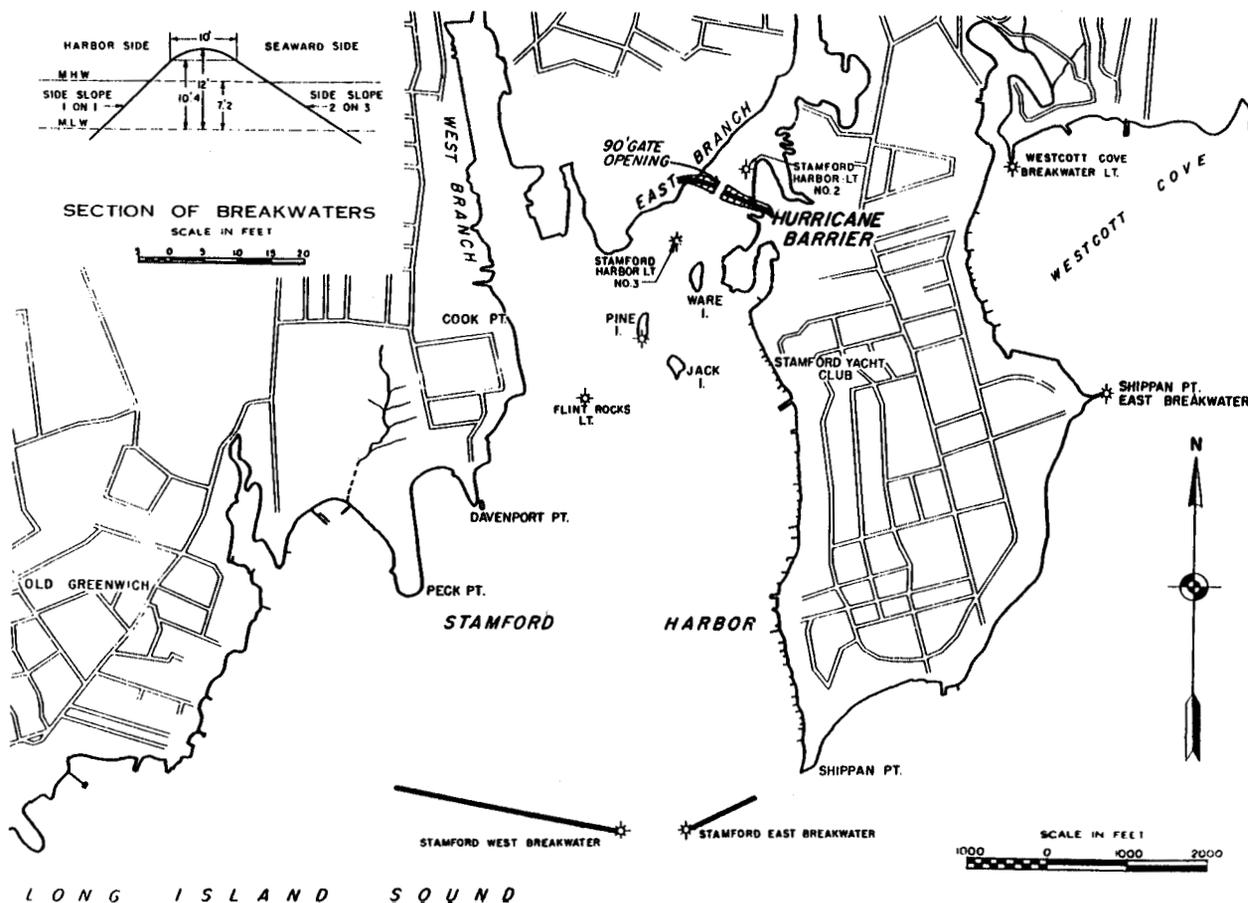
Figure 55. Plan view of breakwaters at Stamford Harbor, Conn.

Date(s)	Construction and Rehabilitation History
1940- 1941	The east and west breakwaters (Figure 55) were constructed to lengths of 1,200 and 2,900 ft, respectively, using 40,100 and 118,100 tons of stone, respectively. The cross section had a maximum crown elevation of +12 ft mlw, a 10-ft crown width at +10.4 ft mlw, and slopes of 1V:1H and 1V:1.5H on the harbor and sea sides, respectively. The total construction cost was \$398,900.
1960- 1977	Visual inspections indicate the breakwaters were in fair to good condition.
1986	Present conditions of the breakwaters are not known.
