Table 98  
Wilson Harbor Piers  
Wilson, New York

Table 99  
Olcott Harbor Piers  
Olcott, New York

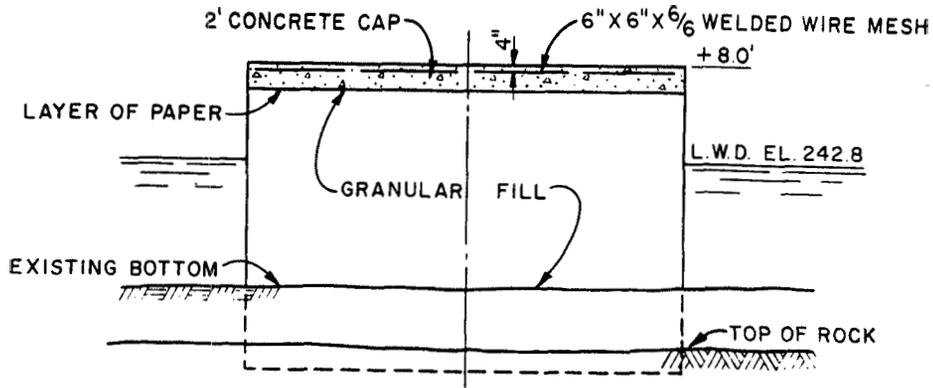
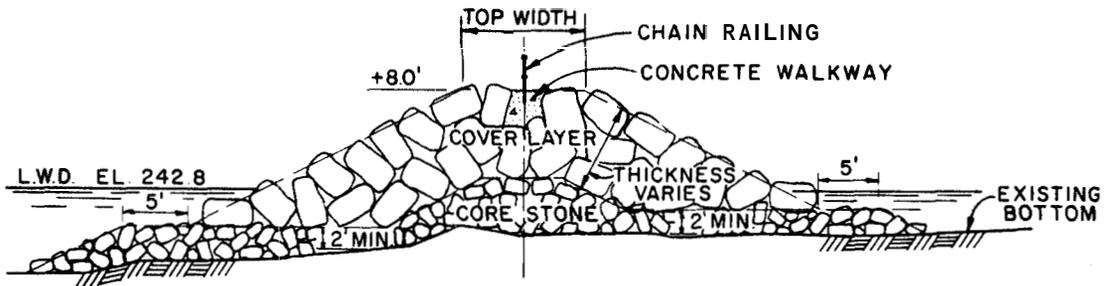
Figure 279. Typical structure cross sections, Oak Orchard Harbor, New York

**TYPICAL SECTION OF CELLULAR STEEL SHEET PILE DETACHED BREAKWATER**

**TYPICAL SECTION OF EAST AND WEST JETTIES**

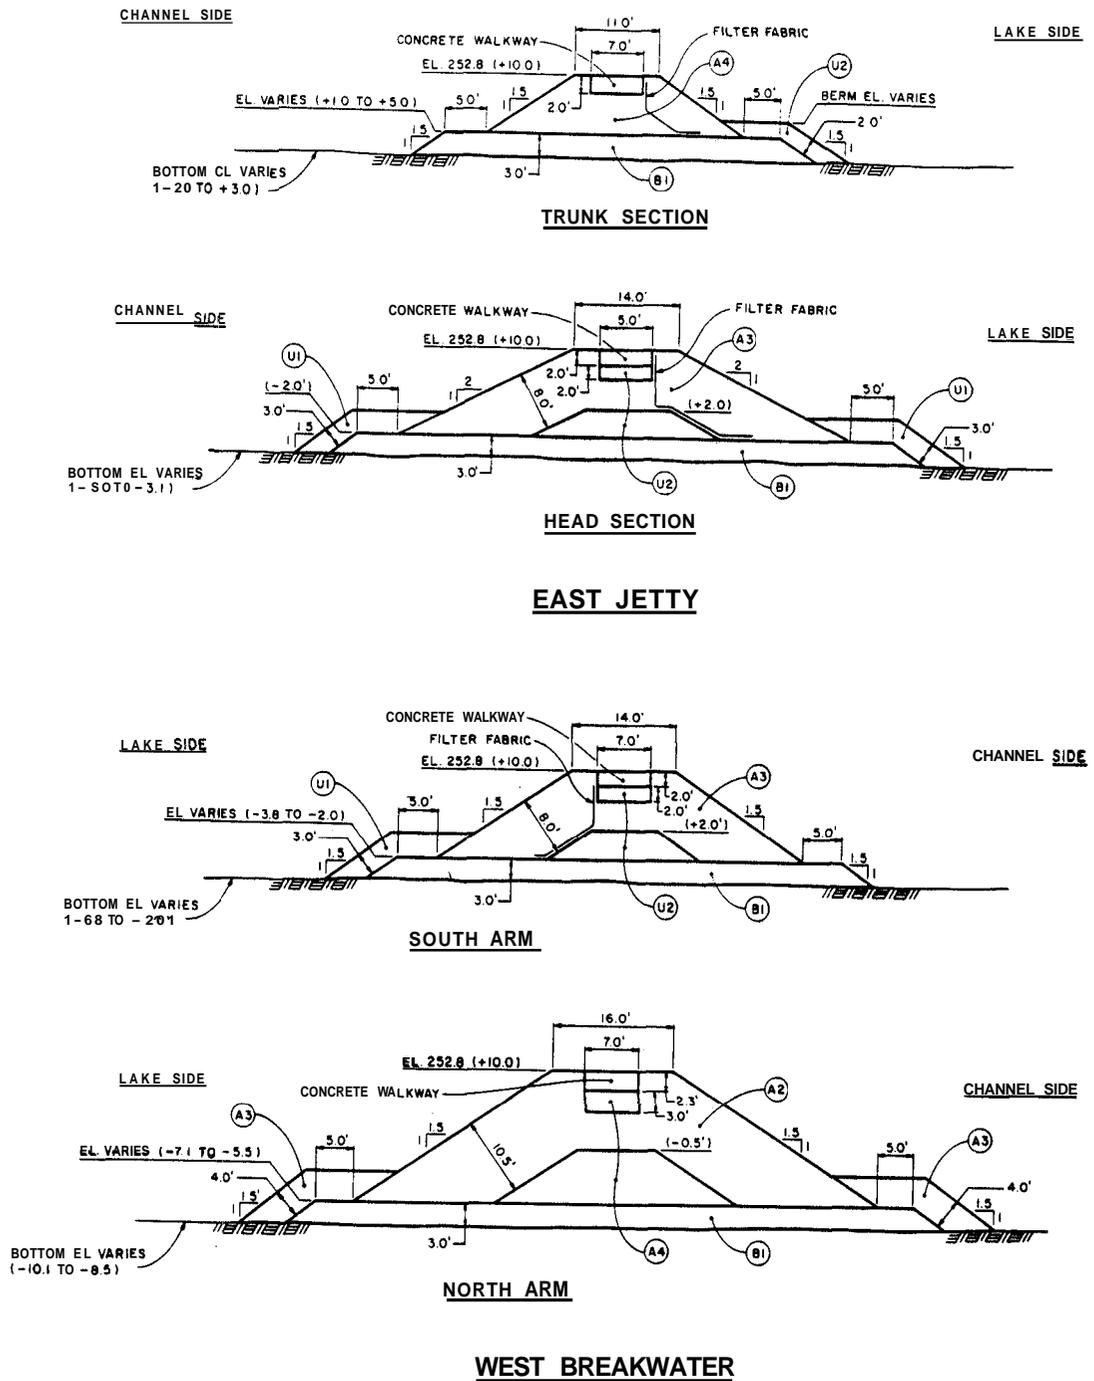
Figure 285. Typical structure cross sections, Irondequoit Bay, New York

A2	ARMOR STONE	70 TO 15.5 TONS
A3		30 TO 6.5 TONS
A4		05 TO 15 TONS
B1	BEDDING MATERIAL	0 TO 15 IN
U1	UNDERLAYER STONE	1500 TO 5000 LBS
u2		400 TO 1300 LBS

Date(s)	Construction and Rehabilitation History
1985	<p>Construction of a 1,350-ft-long west breakwater and a 750-ft-long east jetty (Figure 284) was completed. The structures were built of rubble-mound materials with crest els of +10 ft lwd (Figure 285). The trunk section of the east jetty had an 11-ft-wide crest width, 1-V:1.5-H side slopes, and 0.5- to 1.5-ton armor stone. The east jetty head section and the shoreward arm of the west breakwater had crest widths of 14 ft and armor stones ranging from 3.0 to 6.5 tons. The head section of the east jetty had side slopes of 1V:2H. The lakeward arm of the west breakwater included armor stone ranging from 7 to 15.5 tons and a crest width of 16 ft. Side slopes of the west breakwater were 1V:1.5H, with the exception of the head which had 1-V:2-H slopes. An aerial view of the Irondequoit Bay structures taken during construction is shown in Figure 286. (Note the channel had not been dredged.)</p>

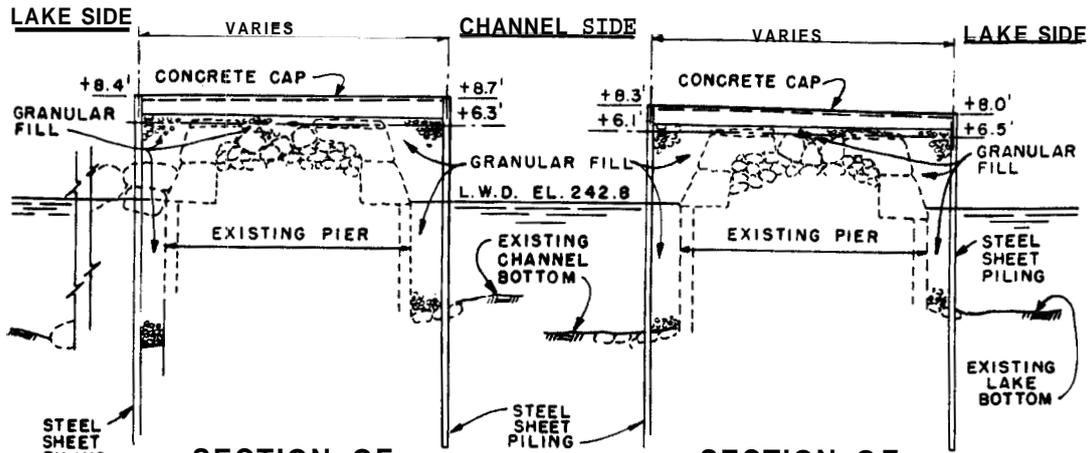
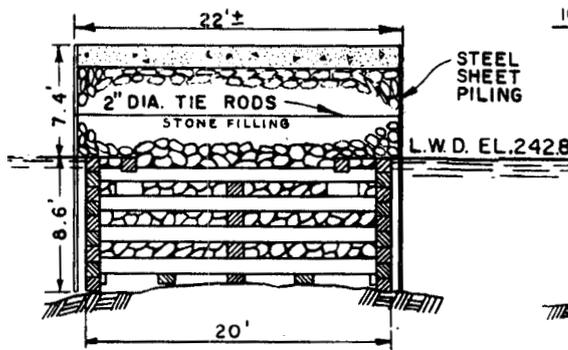
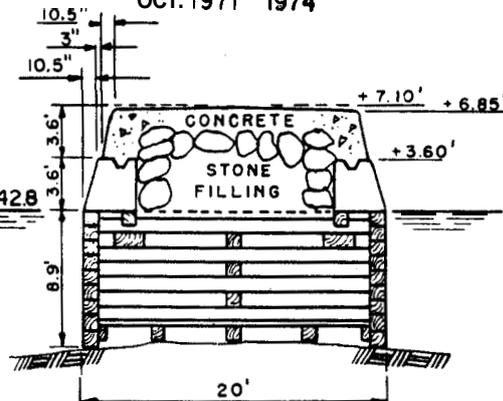
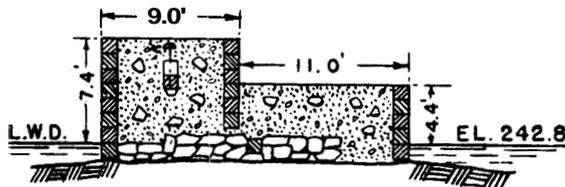
Figure 291. Typical structure cross sections, Little Sodus Bay Harbor, New York

**SECTION OF WEST PIER REPAIRS**

REHABILITATION WORK INITIATED IN SEPT 1965 AND COMPLETED IN JULY 1967

**SECTION OF EAST PIER REPAIRS**

MAY - JULY 1967  
OCT. 1971 - 1974

**SECTION OF REPAIRS**

MADE TO EAST PIER IN 1945

**SECTION OF PIERS**

(BUILT 1867-1906)  
SUPERSTRUCTURE 1913

**SECTION OF EAST BREAKWATER**

(BUILT 1873-1885)  
SUPERSTRUCTURE 1916

Date(s)	Construction and Rehabilitation History
1867- 1906	Construction of a 1,810-ft-long east pier and a 1,747-ft-long west pier (Figure 290) was completed during this period. The structures were stone-filled timber cribs with widths of 20 ft (Figure 291).
1873- 1885	Construction of a 1,680-ft-long east breakwater (Figure 290) was completed during this time. The breakwater was constructed with stone-filled timber cribs that were 20 ft in width (Figure 291).
1913	The east and west piers were capped with a concrete and stone superstructure (Figure 291). The el of the piers was +7.1 ft lwd.
1916	The east breakwater was capped with a concrete superstructure (Figure 291). Of the 20-ft width of the breakwater, 9 ft had an el of +7.4 ft lwd, and the remaining 11 ft had an el of +4.4 ft lwd.
1945	Rehabilitation of 272 ft of the east pier (Figure 290) was completed. Repairs consisted of driving steel sheet-pile walls on each side of the pier sections, filling the voids between the new steel pile walls with stone, and placing a concrete cap (Figure 291). The width of the repaired sections was about 22 ft, and the crest el was +7.4 ft lwd.

1967	Repairs to 300 ft of the east pier and 1,127 ft of the west pier (Figure 290) were completed. They included encasing the existing structures with steel sheet-pile walls, filling the voids between the new sheetpiling and the existing pier with granular fill, and capping the structure with concrete (Figure 291). The crest el of the east pier was +8.3 ft lwd, and the west structure had an el of +8.7 ft lwd.
1971- 1972	Rehabilitation of another 626 ft of the east pier (Figure 290) was completed. Repairs were similar to those completed in 1967 (Figure 291).
1974	Remaining portions of the east pier (those not rehabilitated at an earlier date) were repaired (Figure 290). Rehabilitation consisted of similar construction methods used in earlier repairs which included steel sheet-pile walls, granular fill, and concrete caps (Figure 291).
1978	Repairs to the shoreward 620-ft-long portion of the west pier were completed (Figure 290). Rehabilitation consisted of encasing the existing pier with steel sheet-pile walls, installing granular fill in the voids between the new walls and the old timber crib, and pouring a concrete cap.

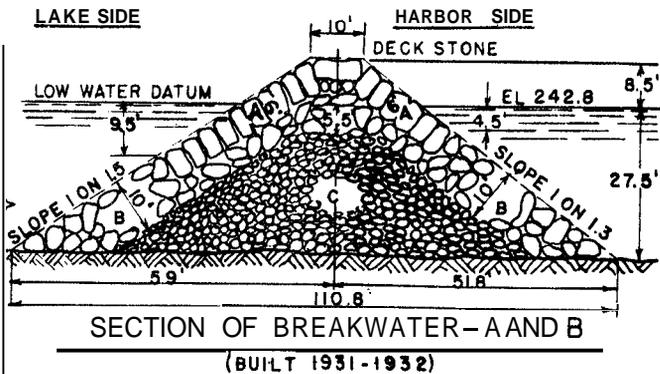
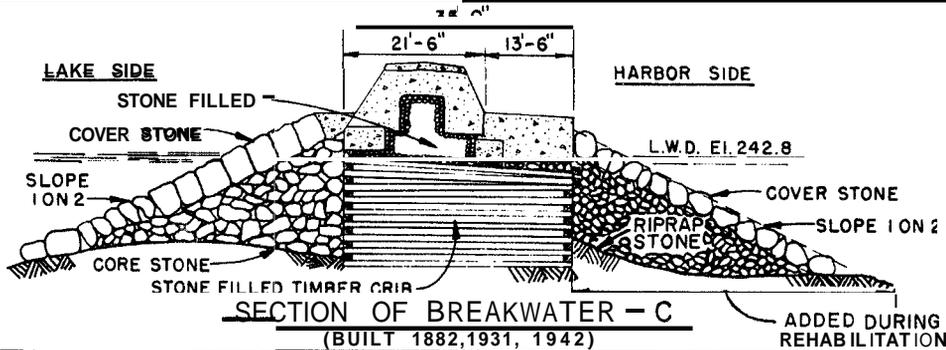
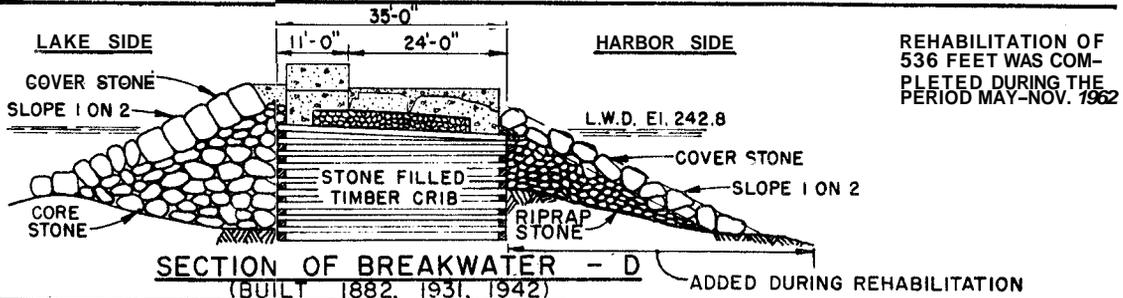
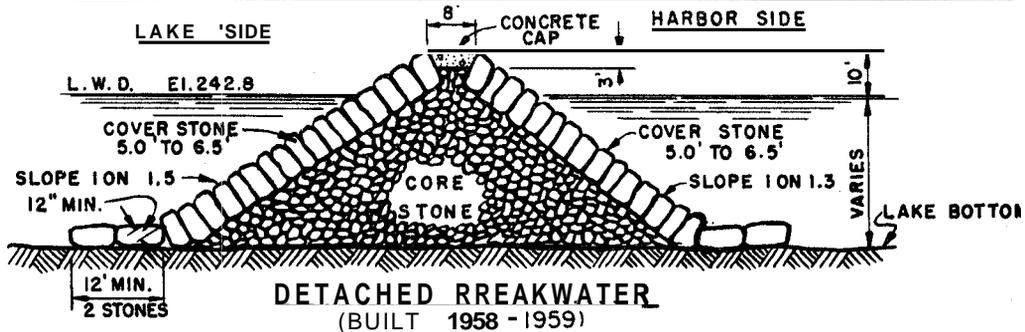
Figure 293. Typical breakwater cross sections, Oswego Harbor, New York

**DECK STONE** Minimum weight 10 tons.  
**COVERING STONE "A"** Minimum weight stone 3 tons, not less than 60% 6 tons or more.  
**COVERING STONE "B"** Minimum weight 100 pounds 50% by weight not less than 3 tons each.  
**CORE STONE "C"** Quarry run stone with not more than 3% in pieces of less than 1 pound in weight, and 50% in pieces weighing more than 100 Pounds.

Date(s)	Construction and Rehabilitation History
1882	Construction of a 4,515-ft-long west breakwater (Figure 292, Sections C and D) was completed. The structures consisted of stone-filled timber cribs with widths of 35 ft (Figure 293, Sections C and D).
1931- 1932	Construction of a stone and concrete superstructure (Figures 292 and 293, Sections C and D) was completed on the existing timber crib structures. A 2,700-ft-long west arrowhead and a 2,200-ft-long east arrowhead breakwater (Figure 292, Sections A and B) were also constructed. The arrowheads were rubble-mound structures with crest els of +8.5 ft lwd and widths of 10 ft. Side slopes were <b>1V:1.5H</b> on the lakeside and <b>1V:1.3H</b> on the harbor side (Figure 293, Sections A and B). Armor stones weighing 3 tons (minimum) with not less than 60 percent of 6 tons or more were used.
1942	Stone was placed along the lakeside of the timber crib west breakwater (Figures 292 and 293, Sections C and D). A slope of 1V:2H was used, and the el at the top of the slope ranged from 6 to 6.5 ft lwd. Cover stone weighed from 3 to 5 tons each.

1958- 1959	Construction of an 850-ft-long detached rubble-mound breakwater (Figure 292) was completed. The crest el of the structure was +10 ft lwd, and its width was 8 ft. Slopes on the lakeside were <b>1V:1.5H</b> , and on the harbor side they were <b>1V:1.3H</b> (Figure 293). Cover stones weighed 7 tons each. This breakwater was model tested prior to construction (Fortson et al 1949).
1962	Rehabilitation of the west breakwater (Figures 292 and 293, Sections C and D) was completed. Repairs consisted of replacement of lost stone on the lake slope, placement of riprap stone on the harbor side, and replacement of portions on the concrete superstructure (over cracked and displaced sections). The weight of the cover stone used on the harbor side ranged from 1 to 3 tons.
1983- 1984	Rehabilitation of the breakwaters was performed. The timber crib structure was replenished with stone fill, and the concrete cap was repaired in various areas. Riprap on the lakeside and harbor side was replaced as needed. Missing armor stones on the rubble-mound sections of the breakwater were replaced as needed.
